IMCA Safety Flash 08/09

June 2009

I Near Miss – Dropped Clump Weight

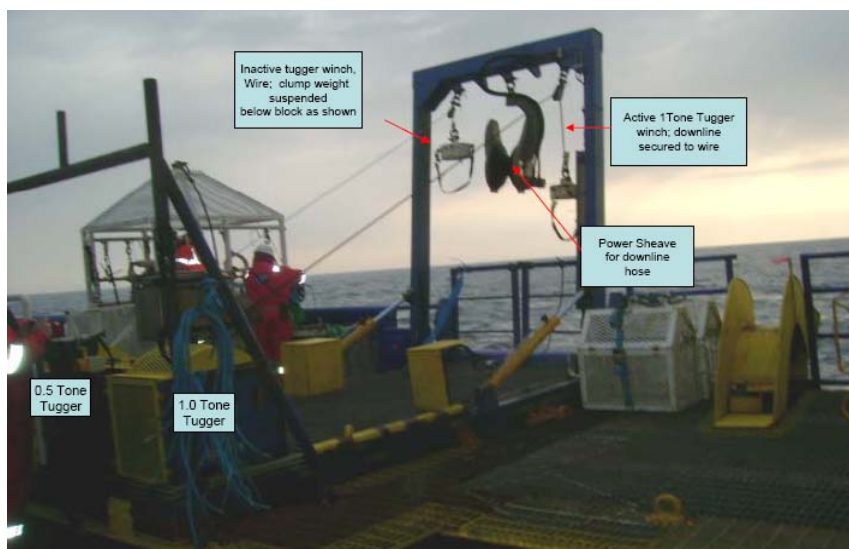
While recovering the tugger wire with downline to the surface, it was noticed that the winch wire clump weight could potentially foul the guard rails on the A-frame. The decision was made to boom out the A-frame further. As the A-frame was boomed out, the clump weight on the inactive wire rode up into the snatch block (because the tugger winch was not paid out as the boom was extended). The winch wire parted and the clump weight dropped to the seabed.

A-frame with tugger winch, snatch block and powered sheave arrangement

- ◆ The supervisor in charge of the operation on deck was himself operating the winch and A-frame rather than supervising 'hands off';
- ◆ The task risk assessment in place for the operation was not complete and did not cover all aspects of hazard and risk;
- ◆ There was no limit switch or proximity device fitted to safeguard against collision;
- ◆ The second tugger clump weight assembly was too close to the A-frame snatch block (when it should have been stowed with sufficient slack to take up any extension);
- ◆ There was a lack of awareness regarding the position of the second tugger winch clump weight and of the potential consequences of letting out the boom on the A-frame.

- ◆ Review of operating procedures and risk assessments for the use of lifting appliances incorporating independent hydraulic ram and winch controls, including:

- awareness of hook/load position when operating A-frame
 - position of divers – exclusion zone for divers to be determined from dropped object analysis and this should be written into operating procedures and risk assessments

- warning notices to be posted on A-frames
 - deck crew to be familiarised and deemed competent to operate equipment;
- ◆ Supervisors should remain 'hands off' and in a position to monitor and control operations;

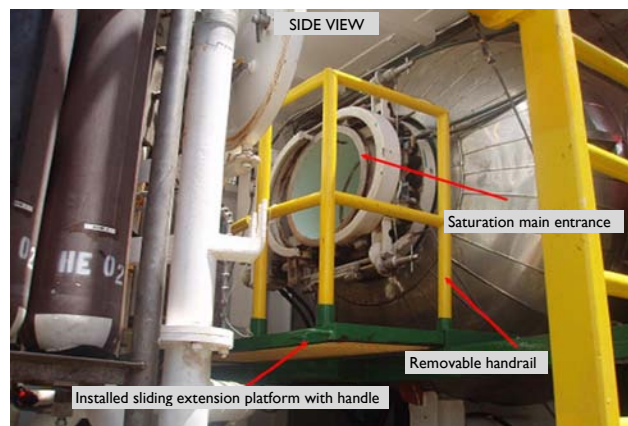
Movable platform to allow safe access to saturation chamber

- ◆ Reinforce the importance of management of change procedures;
- ◆ Ensure the correct fixed handholds are used when accessing or exiting a saturation chamber;
- ◆ Ensure all relevant personnel are aware of the location and use of the correct handholds;
- ◆ Construct a removable platform with additional edge protection to facilitate access to and from the chamber when the bell is not present (see second picture).
