## IMCA Safety Flash 18/09

December 2009

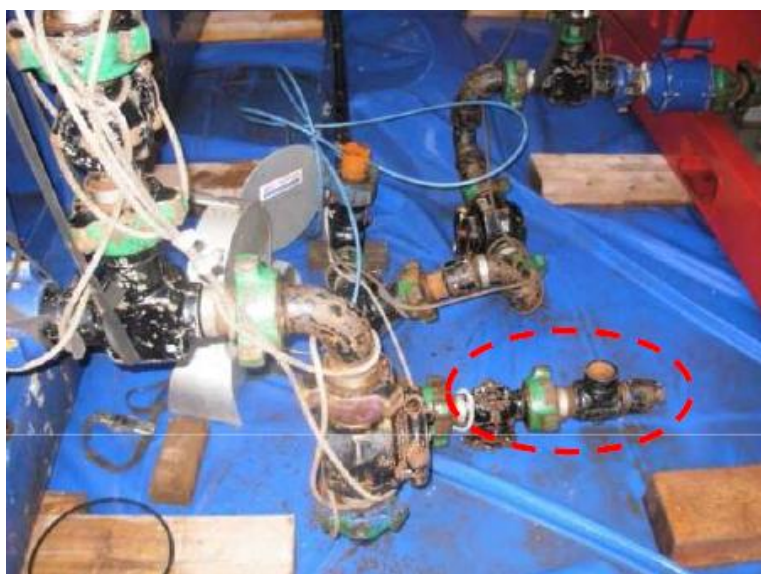
During a pressure test with nitrogen, a pressure relief valve in the treating line vented. The valve was rigged up in a vertical position approximately 60cm above the height of the line. As the valve vented, the assembly rotated through 90 degrees and hit the deck of the rig. During this rotation the assembly struck a crew member on the temple causing a fatal injury.

*Valve equipment that moved following release of high pressure*

- ◆ As the valve vented, the force caused the vertical stack to rotate through 90 degrees until it came into contact with the deck;
- ◆ The crew member was in the high pressure area while pressure was being applied in order to check the pressure on an instrument in the vicinity.

- ◆ Equipment that could move in reaction to the sudden escape of gas under high pressure should, as far as possible, be properly secured, anchored or immobilised. All fittings and connections on pressure test equipment should be rated for the test pressure and adequately secured.

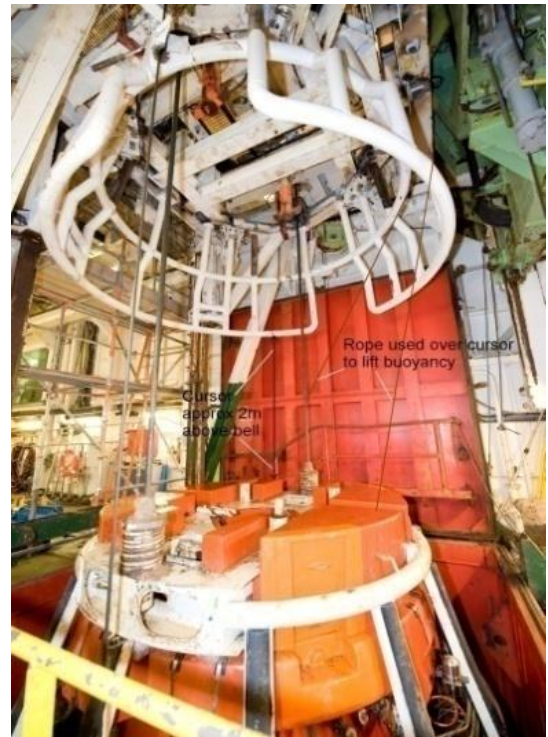
The cursor was suspended above the diving bell by the newly installed winch and it fell as a result of a failure of the hydraulic braking system for that winch. A rigger was working on top of the diving bell modifying some buoyancy units at the time of the accident. Although there were a number of other people in the vicinity and close to the worksite there were no other injuries.

The immediate cause of the winch failure was determined to be a faulty pilot valve in the cursor's winch control system. A technical failure in the pilot valve prevented the automatic brake application on the winch.

- ◆ A faulty pilot valve in the winch system failed, causing the brakes not to be applied in the stop position. This resulted in the hydraulic winch being unable to hold the weight of the cursor, which caused the winch to unwind and drop the cursor;

*Diving bell with cursor above*

- ◆ Measures should be in place to identify and mechanically secure suspended loads before passing beneath.

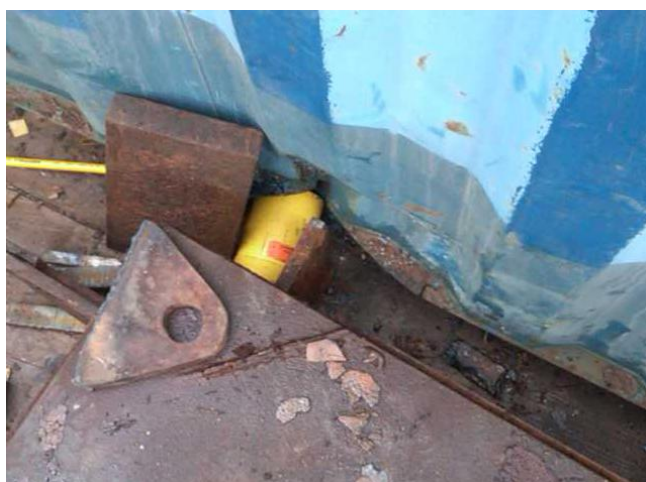
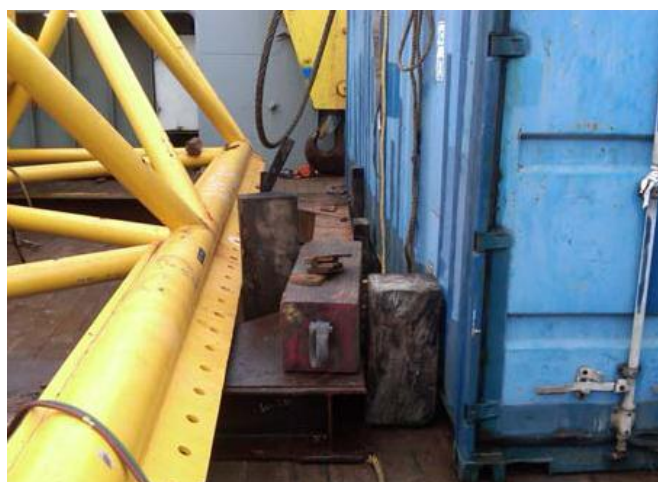
A member has reported an incident in which a sub-contractor's employee suffered a leg injury which was categorised as a lost time injury (LTI). Whilst working on offloading a vessel, the sub-contract employee's left leg above the ankle was pinned between a shifting spreader bar frame and a freight container located adjacent to the spreader bar frame. While one of the seven spreader bars was being lifted and in the air the remaining bars shifted, causing the frame to slide approximately one metre (40 inches) towards the freight container where the employee was standing. Hydraulic power packs were used to help free the trapped employee, who was taken to the local hospital. The employee suffered a hairline fracture of the left ankle and the incident was categorised as an LTI.

*Injured person's ankle was trapped between yellow spreader bars and blue freight container*

- ◆ Installation of clips to secure the load frames to the deck and installed additional safety stops on the load frames to hold the spreader bars from moving
- ◆ Audit of training records of all sub-contractor personnel in order to ensure that personnel without proven competence or proper training were not accepted for work;
- ◆ The sub-contractor was asked to provide full training for all contract personnel, which should be:
  - appropriate to the work being performed
  - compliant with local regulatory safety standards
  - fully verifiable through testing;
- ◆ Senior leadership would provide clear guidance to supervisory personnel that safety processes and procedures could not be cut short.

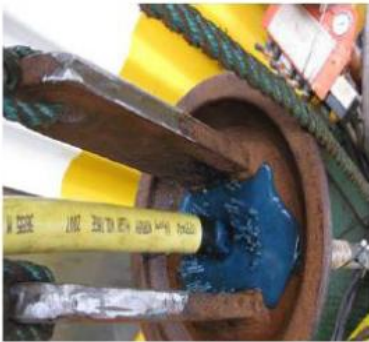
*Picture of cast taken after re-termination*

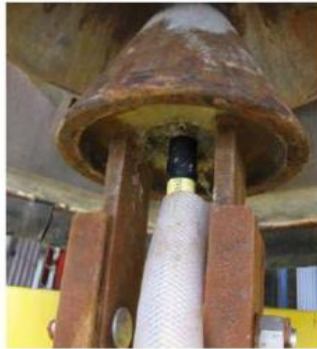
*Two months after the cast was made. The strands show signs of being pulled into the cone. (Random picture available from system)*

- ◆ The friction on the inner wall of the bullet was found to be greater than the combined friction of the strands, with the result that the cast was not able to be drawn down and wedged properly;
- ◆ During the investigation it also became clear that the relevant checkpoint in the maintenance programme was not detailed enough.

- ◆ A new maintenance checkpoint task was added for inspecting the armour strands for any signs of being pulled through the potting;
- ◆ Pictures of the cast structure of the company's entire ROV fleet were initiated immediately following this incident, for further review and technical analysis;
- ◆ Further pictures of the cast structure of every ROV system would be taken on a frequent basis;
- ◆ All bullets made of carbon steel would be changed out and replaced with a new type of bullet made of stainless steel. This would eliminate corrosion and friction to the inner walls of bullet.

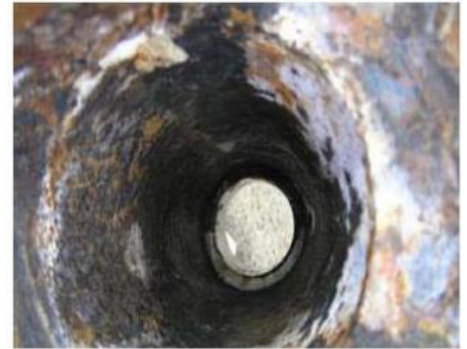
*The surface of the inner cone was corroded and rough, although loose rust was removed*

- ◆ Friction on the inner wall of the bullet was greater than the combined friction of the strands;
- ◆ An important quality control checkpoint lacked clear, and easy to follow, instructions.
