IMCA Safety Flash 15/09

October 2009

I Trapped Diver Umbilical Incident Resulting in Diver Fatality

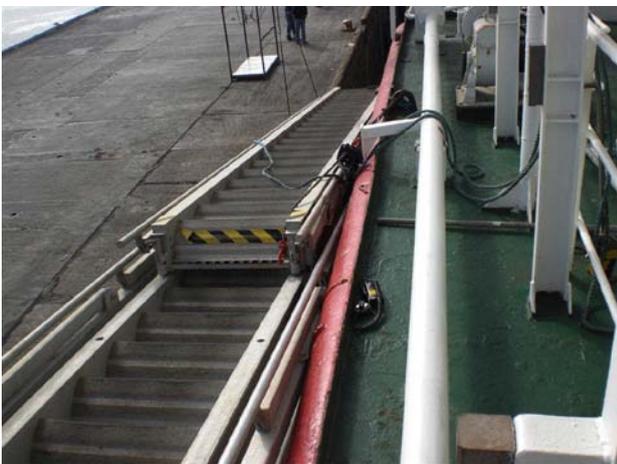
A member has reported an incident in which a person suffered a broken leg during gangway deployment. Prior to arrival at the quayside, a vessel's double sectioned gangway (see Figure 1) was lowered and extended, in readiness for use, in accordance with onboard procedures.

Figure 1 – Double (upper and lower) sectioned gangway

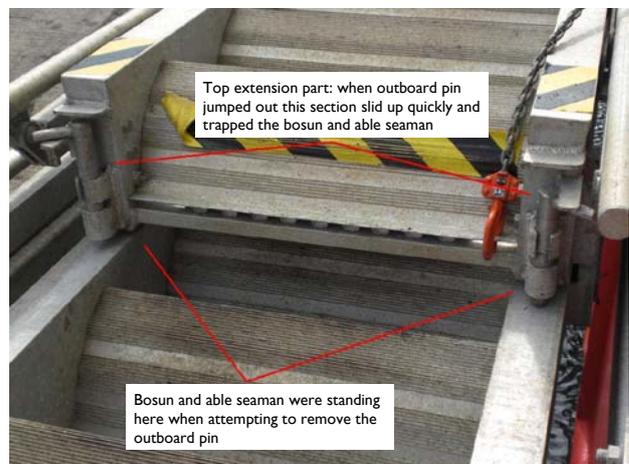
However, the bosun and the AB started to remove the securing pins without first lowering the gangway to take the tension off the lifting wires. The AB removed the inboard pin as this was not under tension and therefore easily removed by hand. The outboard pin was stiff because of the tension on the lifting wires. A crowbar was used to exert pressure on the lower section of the gangway, to allow the outboard pin to be removed. During this process, both the bosun and the AB were standing within the steps of the gangway, as shown in Figure 2.

Figure 2 – Area of entrapment

The expectation was that the pressure applied by the crowbar to the lower section of the gangway would loosen the outboard pin, which could then be removed by hand. Instead, the outboard pin, with the pressure released, jumped out. Because there was still tension on the lifting wires at the lower end of the gangway, the lower extension section of the gangway slid quickly upwards, trapping both the bosun and the AB by the legs.

Urgent assistance was requested and both men were subsequently released by using a lever hoist to relieve the pressure. During subsequent medical attention it was discovered that one of the workers had a serious fracture of the leg. He was taken to hospital ashore.

This extremely serious incident could have been avoided entirely by following the correct procedures.

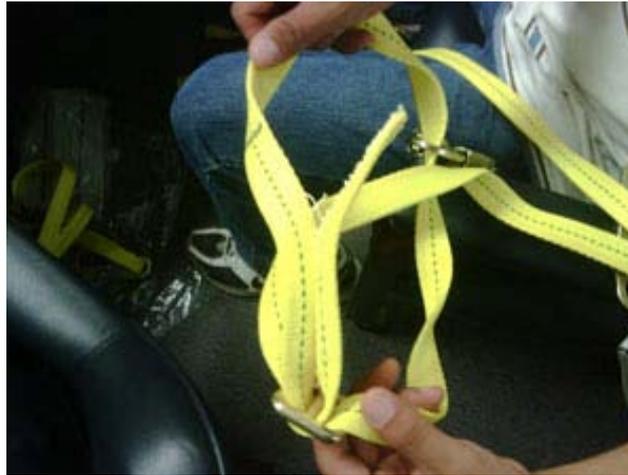
- ◆ Safety Alert 09-17 – Near Miss – New Fall Protection Equipment Failure – published by the International Association of Drilling Contractors (IADC) (attached), notes that a new ‘pass-through tie-off adapter’ was only hot-glued and did not have the required stitching.
- ◆ Whilst teaching a fall protection class an instructor found a new piece of fall protection equipment that was not properly sewn. This equipment was brand new, still in the bag and made by a reliable manufacturer. One of the lanyards was improperly sewn and the webbing could be pulled apart by hand.

Improperly sewn fall protection equipment

Members are encouraged to re-emphasise to their personnel the importance of thorough inspection of all fall protection equipment before and after use.
