## IMCA Safety Flash 03/10

2010

### 1 Incident During Entry to Diving Bell

### 2 Uncontrolled Ascent – Loss of Lift Bag to Surface

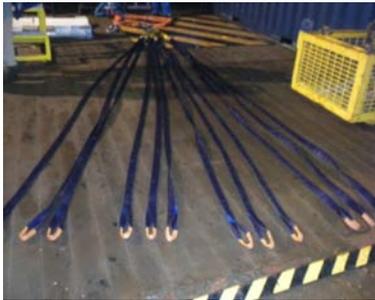
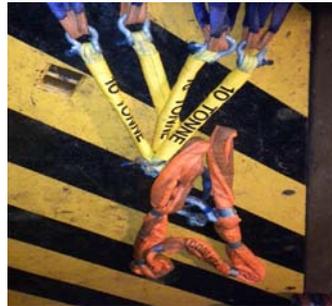
- ◆ The diver reported the loss of control immediately and the bridge was notified;
- ◆ The main rigging and inverter line remained attached to the pipeline;
- ◆ It was determined that the shackle joining the top end "cradle ring strap" had mistakenly been removed 4 hours earlier when the bag had been retrieved to deck from the previous deployment.

1. A lack of awareness on the part of the rigger who had de-rigged the bag;
2. A detailed pre-deployment inspection regime had not been in place;
3. The cradle-ring-strap and single pin shackle arrangement at the top of the bag had routinely been used as a common securing point for both the main rigging and the inverter line which represented a single point failure;
4. The single pin shackle had been easily removed by hand as it did not require a tool, nor did it have any distinguishing markings (e.g. paint) to indicate that it formed an integral component part of the cradle-ring-strap configuration.

All the rigging attached to the lift bag was recovered with no damage or distortion found.

1. Activities were ceased and an investigation carried out which included two onshore managers;
2. The model of bag used was quarantined until further notice;

3. A pre-deployment model specific check list was produced for a similar model lift bag which utilised a continuous loop cradle sling;
4. A 'stand down' was held and personnel involved in all phases of lift bag usage, including the handling and deployment, were familiarised with the safety critical elements and specifics of the equipment;

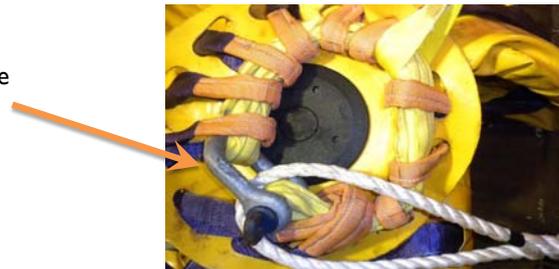
The shackle on the top rigging arrangement of the bag was removed.

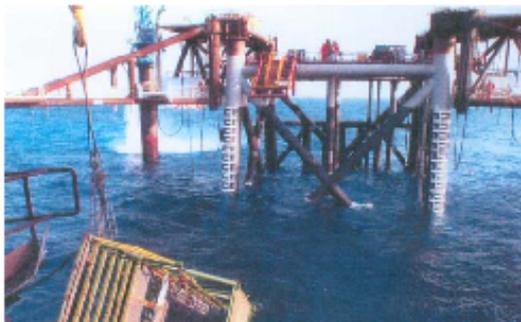
A purpose built project modular gangway for jacket access from a construction barge parted at the jacket end and fell into the water. To allow for movement of the construction barge the gangway had a roller support at the barge end and was supported by a gimbaled joint at the platform end. The failure occurred in the vertical pin of the gimbaled joint.

Although slings and chains were placed on the gangway and connected to the landing platform they were too long to prevent the gangway from dislodging from the landing platform and of insufficient strength to withstand the impact loads and prevent the gangway from falling into the sea.

The gangway collapsed into the sea

2. Secondary fall protection arrangements must be properly engineered and specified in the installation, operation and maintenance procedures for gangways.
3. These procedures need to also provide for close visual inspection at least once per shift when the gangway is in use.
