IMCA Safety Flash 04/11

April 2011

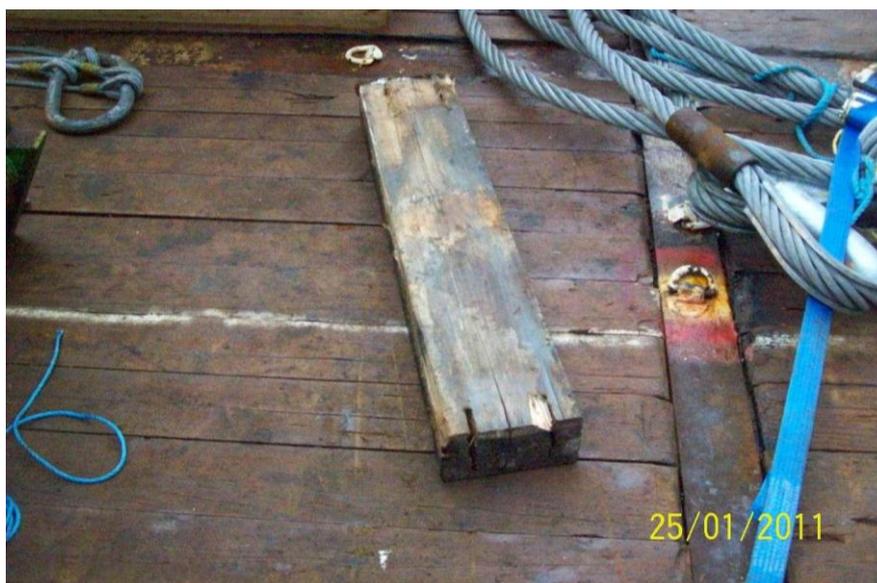
The piece of wood which had been stuck to the crane boom was not noticed by anyone before it fell.

Figure – piece of wood dropped from crane boom

- ◆ The piece of wood was originally secured only by a tack welded strip in position on the crane boom rest;
- ◆ Some other fixings for the piece of wood were missing or rusted, and remaining pieces of wood showed signs of deterioration;
- ◆ A crane operator had reported verbally to the first engineer approximately one week earlier that the piece of wood in the crane boom rest appeared loose. This report was not made through the normal channels and was not formally recorded on a safety observation card for effective follow up;
- ◆ There was a lack of regular inspections to check on the condition of the crane boom rest and fixings;
- ◆ A similar incident had occurred on a similar vessel in the previous year, but this incident had not been effectively communicated to the other vessels in the fleet.

- ◆ Firmly secured the remaining pieces of wood in the crane boom rest;
- ◆ Replaced the existing wood in the crane boom rest with hard wood replacements at the first suitable opportunity, ensuring that these were firmly secured to the crane boom rest;
- ◆ Fabricated and installed a suitable and sufficient access ladder and platform to provide safe access for the inspection of the crane boom rest, and included the relevant inspection regime within the vessel's planned maintenance system;
- ◆ Ensured that information about the incident was widely circulated.

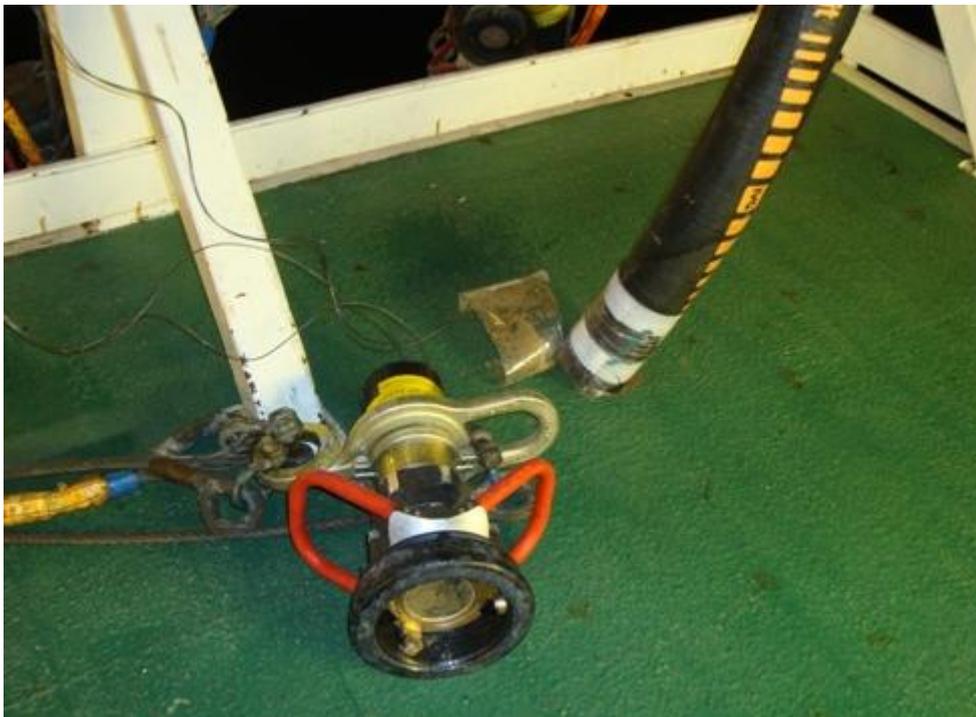
Figure – Mud hose and connector following incident

- ◆ Procedures not understood – the crane operator may not have been aware that the hose was lashed to the vessel;
- ◆ There was poor visibility at the time of the incident owing to heavy rain.

- ◆ Communication between workgroups was not effective – poor visibility noted at the time of the incident, and the crane driver may not have seen the stop sign by the banksman. The banksman did not have direct very high frequency (VHF) communication with the crane operator.

- ◆ There should be clear and continuous radio communication between vessel master and the crane operator and banksman during lifting operations;
- ◆ Hand signals can be used provided the banksman can always be clearly seen by the crane operator. In conditions of poor visibility, radio communication between banksman and crane operator should be clear and continuous.
