## IMCA Safety Flash 13/12

December 2012

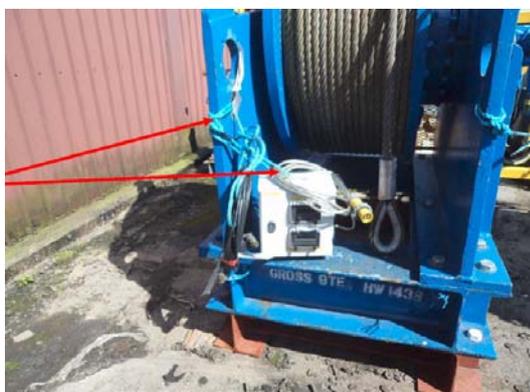
A member has reported an incident in which equipment being back-loaded was found to be incorrectly and unsafely secured. The incident occurred during demobilisation of a third-party winch and running line monitor power supply unit (RLM PSU). It was noticed when this equipment was returned to the third party base that the RLM PSU had been secured to the winch frame using polypropylene rope in an unsafe manner. This could have resulted in the power pack becoming a potential dropped object or being damaged in transit.

*Red arrows illustrating how RLM PSU was secured to winch frame using polypropylene rope*

- ◆ There was no identified storage area for the RLM PSU prior to the backload taking place. Appropriate storage areas should be identified for all third party equipment;
- ◆ Third party equipment such as the RLM PSU should be correctly packaged and secured before equipment load out/backload;
- ◆ All items should be thoroughly checked before lifting to ensure that appropriate securing arrangements are in place.

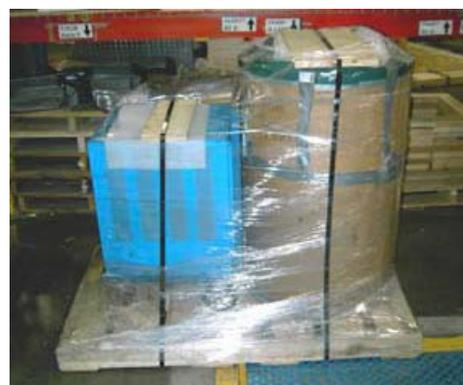
*Items appropriately secured with securing straps in place*

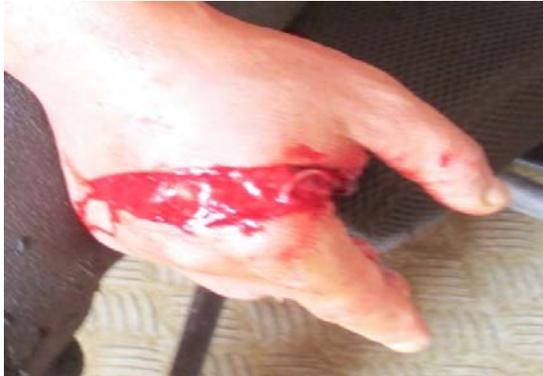
A member has reported an incident in which a diver injured his hand during subsea lifting operations. A diver was about to pull a 4m round sling (20 ton SWL) through a master link. While he was hanging the two-headed sling eyes on the corresponding hang-off point, his right hand thumb and index finger were sandwiched between the sling and hang-off point, resulting in a crush injury. The diver reported this to the dive supervisor immediately, and the supervisor arranged for emergency recovery of the injured diver. After he was recovered to surface, he received emergency medical treatment before being evacuated ashore by helicopter.

Injured hand

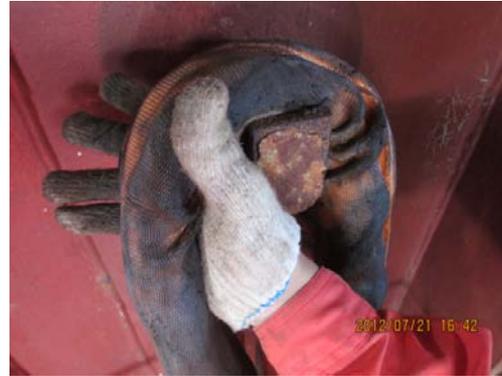
Illustration of the right hand position holding the sling (simulated)

- ◆ The hang-off point was relatively short, approximately 13cm (see figure above right), while the diameter of the sling was 6cm, and the thickness of the two-headed sling eyes was 12cm;
- ◆ The sling had a tendency to come off the hook under the influence of wave surge;
- ◆ The moment the diver finished and left the area to wait for the lifting operation, the sling became unhooked, resulting in it being necessary for him to return and repeat the operation several times;
- ◆ After repeating the operation several times, the diver became irritable and grasped the sling in an incorrect way, putting himself in danger, resulting in the injury;
- ◆ The diver was working in the splash zone; the swell made it very difficult for him to control himself. The diver had reported that his bailout cylinder and helmet frequently hit the underwater structure.

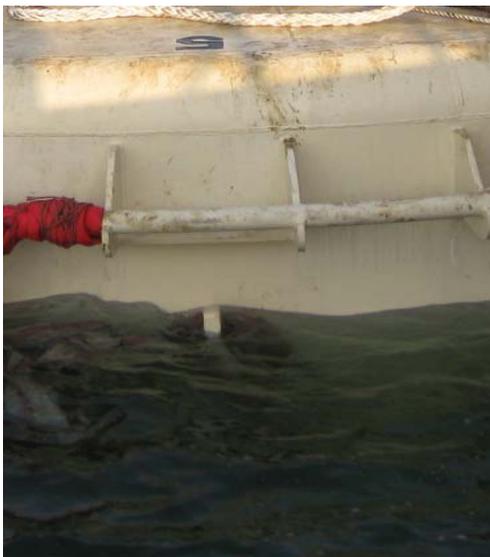
Hook-off point in splash zone

- ◆ Banded the 4m x 20Te SWL round sling and created plan to use two tail ropes to pull the round sling, avoiding the occurrence of unhook;
- ◆ Ensured all the divers understood about the change in work procedures.

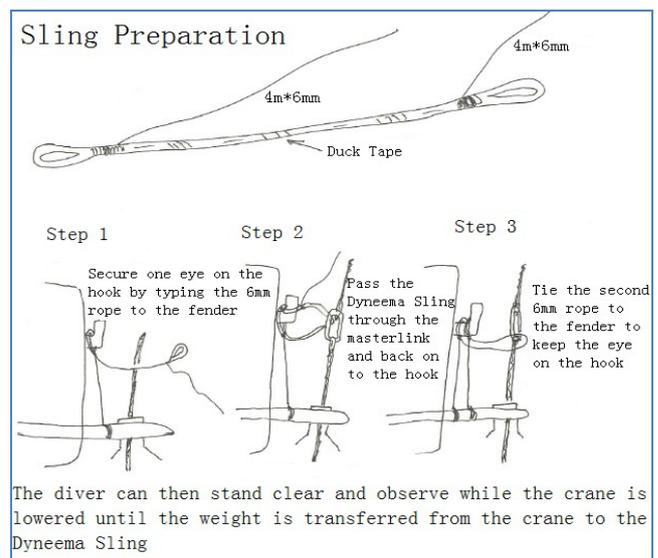
Diagram of revised operation procedure

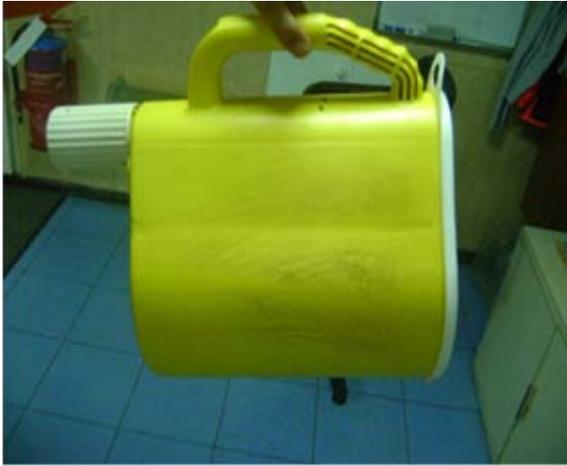
*Line throwing apparatus*

- ◆ The LTA was uncontrolled and was not on any inventory list;
- ◆ The LTA had no safety pin or markings indicating date of manufacture, operating instructions or expiry date;
- ◆ There was inadequate control of spares and stock leading to a shortage of rope for the task in hand;
- ◆ The crew member took no account of the possible risk to himself and others in handling an explosive device.

- ◆ Pyrotechnics should be controlled items, stored in a safe place, and only used by appropriately trained personnel;
- ◆ Pyrotechnics should be used only for the purpose for which they were intended or manufactured;
- ◆ Expired or 'out of date' pyrotechnics should be disposed of according to local regulatory requirements, and vessel crew should be fully familiar with company procedures and requirements for disposal;

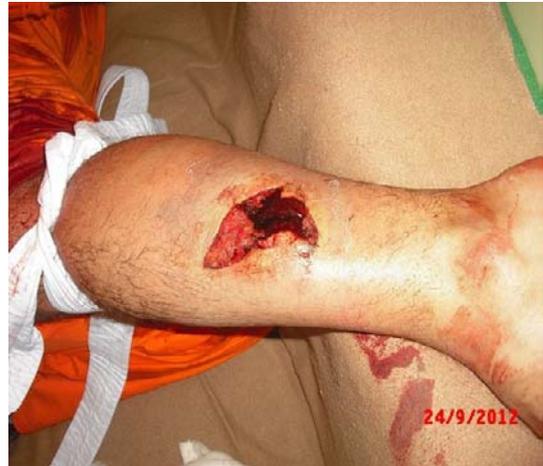
A member has reported an incident in which a crewman was seriously injured when inadvertently struck by a line throwing rocket. The incident occurred when a search was made for a small diameter rope for use as a plumb line. Since no suitable rope was easily available, a member of the crew decided, without consulting anybody else, that the small diameter line from an old rocket assisted line throwing apparatus (LTA) could be used. Whilst trying to retrieve the line from the device, it slipped from the crew member's hands, dropped to the deck and unfortunately went off. A crew member was working nearby and was inadvertently struck, causing a deep cut on his left leg near the shin.

*Injured person's shin*
