## IMCA Safety Flash 10/13

June 2013

### I High Potential Near Miss – Lifting Equipment Failure

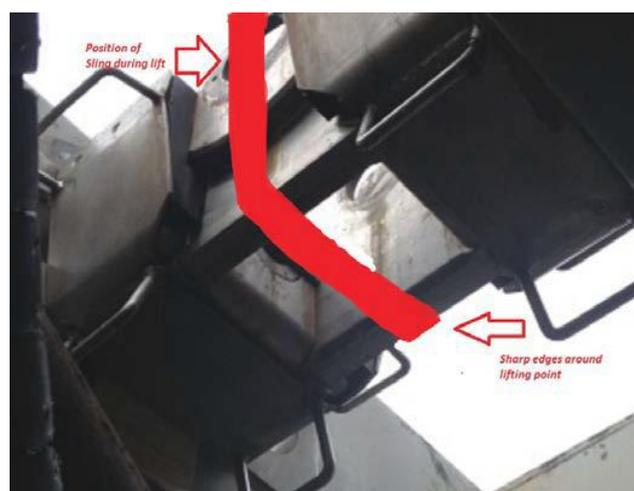
A member has reported an incident in which there was a potentially catastrophic failure of a lifting sling. The incident occurred during repair and maintenance operations for a trenching ROV, when the trencher was being lifted onto axle stands to assist with on-going maintenance. The crew planned the lift using a single sling, as standard lifting strops were missing. The single sling was placed around the box section and it was identified that the lift point had a sharp edge which could have damaged the lifting sling. It was decided to pad the sharp edge with wadding to prevent damage to the sling. The crane started to take the weight of the trencher, and when it reached approximately 18T of tension, the sling failed. Upon inspection, it was found that the sharp edge identified had cut through the padding and sliced the sling causing it to part under load. No damage occurred as the trencher was never lifted off the ground.

Figure: Showing initial lifting point arrangement used during incident

- ◆ Inadequate planning – other lift points were available to complete the lift without the sharp edge affecting the lift;
- ◆ No management of change or 'stop the job' completed – the 'stop the job' process should have been implemented as soon as the missing strops were identified;
- ◆ Planned method continued despite identification of sharp edge – crew assumed that padding the sharp edge would be sufficient to complete the lift safely;
- ◆ No specific planned method was identified for completion of the lifts – planning was completed at site as requirements developed.

- ◆ Inadequate equipment available
  - There was insufficient lifting equipment to complete the assigned tasks, leaving the crew to borrow equipment from elsewhere; the job should have been stopped in this context;

- ◆ Poor pre-work planning
  - There was no lift plan developed before arrival at site;
  - Correct lift points were not identified;
  - Lift plan was developed at site developed with available rigging in mind, rather than correct lift points in mind.
- ◆ Lack of situational awareness
  - All aspects of health and safety planning were completed, as required with regards to lift plans, job safety analysis and tool-box talk; however, an assumption was made regarding the application of padding around the sharp edge.

- ◆ Ensure sufficient and appropriate lifting equipment is always available;
- ◆ Reiterate importance of ‘stop the job’ and management of change processes;
- ◆ Ensure lift planning is conducted with reference to correct and safe lifting, rather than “making do” with what is available on site;
- ◆ Members may wish to refer to [IMCA SEL 019 - Guidelines for lifting operations](#) for further information.

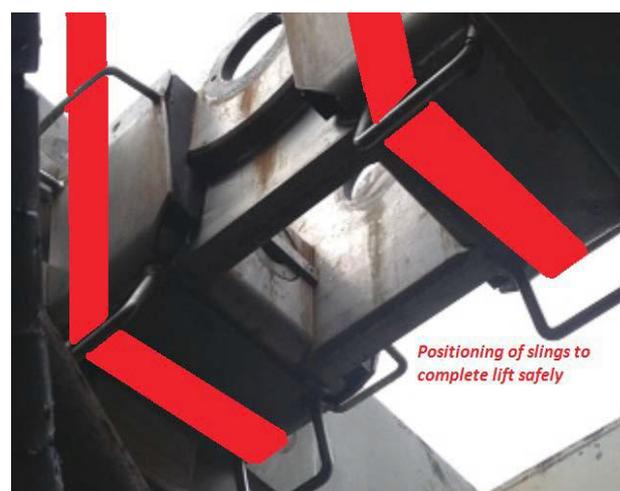
Figure: Showing re-assessed lifting point arrangement used after incident

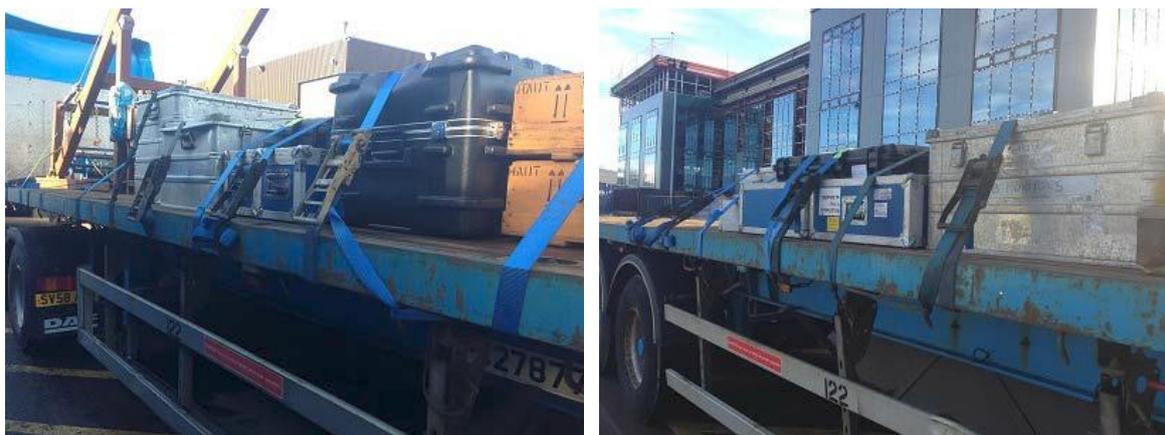
A member has highlighted two recent occasions in which containers and vehicles were inappropriately loaded and transported with their contents unsecured, which resulted in unnecessary manual handling of cargo. Unsafe packing of containers and loading of vehicles is something that still occurs. The potential exists for injury, environmental impact or equipment damage caused by unsecured cargo and/or not loading vehicles correctly.

Figures: Showing items loaded directly onto a trailer with no pallets (making further manual handling by yard crew necessary)

- ◆ Place items being shipped in suitable containers, giving consideration to the possible cargo handling capabilities of those receiving the load (i.e. forklift availability, access, container type);

- ◆ Ensure loads are distributed in a balanced and even way;
- ◆ Place heavier items at the bottom with lighter items on top – do not place heavy cargo on top of fragile cargo;

- ◆ Use packing to prevent damage between items of cargo;
- ◆ Lash down (and wedge if necessary) cargo, to prevent movement in transit;
- ◆ Do not pack sharp items next to soft skinned drums;

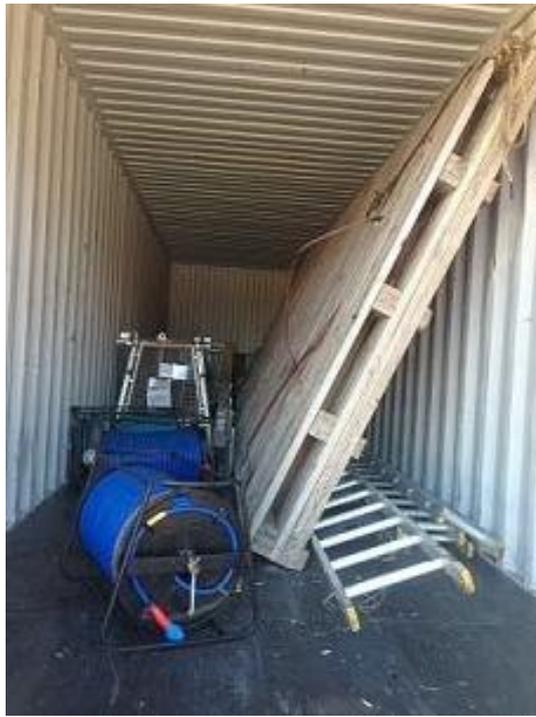
Figure: Equipment packed into a container unsecured

- ◆ Ensure the doors and locking mechanisms are secure with locking device attached (including secondary securing device) and, where applicable, use door safety nets;

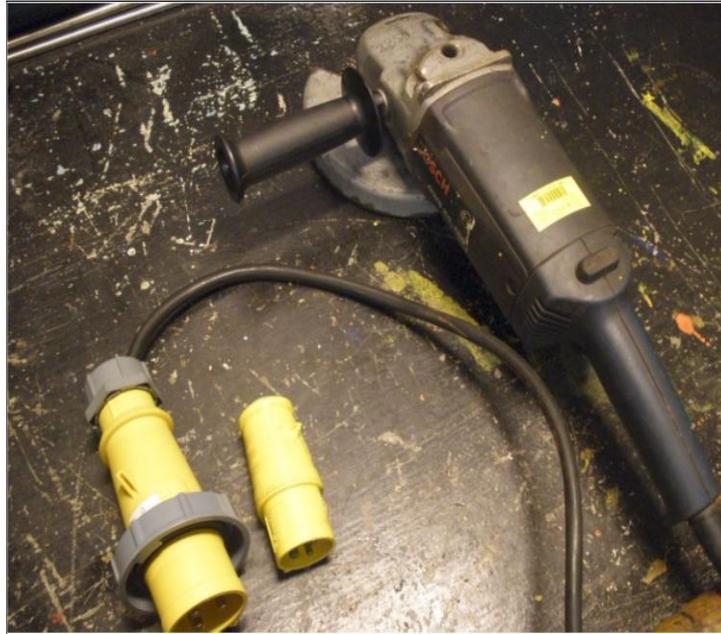
During routine portable appliance testing, it was found that plugs and sockets on portable electrical equipment used in the deck environment had an IP44 ingress and integrity rating, which is not sufficient for use on the back deck or an open deck marine environment. Also, it was found that 9" grinders with a rating of 2000W and 19A had their 32A plugs removed and 16A plugs fitted instead, with subsequent potential for overheating, burns or electric shock.

Figure: 110v/2000W/19A 9” grinder with 32amp IP67 plug and the IP44 16amp plug removed.

- ◆ Socket outlets, appliance inlets and portable equipment operated in an open marine environment should have a minimum IP rating of IP56; alternatively the socket should be located inside an enclosure with a minimum ingress integrity rating of IP56;

- ◆ Regular checks should be made of hand tools and extension leads, to ensure portable equipment and extension leads to be used on the back deck are fitted with suitable IP 56 plugs and sockets, (IEC plugs and sockets are usually rated IP44 or IP67; the more robust IP67 ones should be used);

- ◆ Incorrect equipment should either be removed from use and fitted with the correctly rated plugs/sockets, or substituted with equipment that is correctly rated (i.e. the appliance in use may have been taken from a workshop to be used on the open deck, the IP rating is adequate for indoors, but not outdoors);
