IMCA Safety Flash 08/14

June 2014

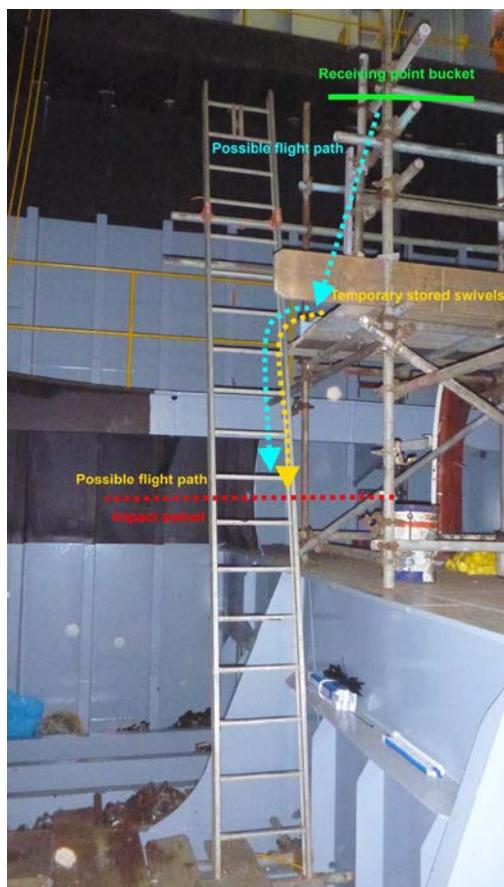
Figure 1: Showing worksite at time of incident

- ◆ The origin of the swivel could have been:
 - A swivel fell from the bucket
 - A swivel laying on the scaffold board fell. (Possibly kicked but unlikely due to kick plate and gate)
 - While emptying the bucket a swivel bounced and fell;
- ◆ Direct cause:
 - Improper lifting, handling or storage - improper lifting equipment was used to transport the scaffolding materials down (buckets attached to approximately 20 metre rope)
 - Poor housekeeping - some swivels were left behind next to the access gate near the ladder;
- ◆ Root cause:
 - Improper handling of materials - lowering scaffold materials (approximately 20m) down from height with buckets attached to a rope
 - Improper storage of materials - The temporary stored swivel couplers were stored too close to the ladder access/entrance of the platform.

The crewman descended the ladder to investigate the object that had struck him and found that it was a swivel coupler (scaffold material). He 'stopped the job', informed a nearby foreman, and asked other crewmen working in the vicinity of the tank if they had witnessed the incident; unfortunately no one saw exactly what happened, and therefore the origin of the dropped swivel is unknown. The foreman made a fresh visual risk assessment of the scene which included proper housekeeping (swivels stored on the boards next to gate/access) and discussion of the potential consequences of dropped objects. The importance of using correct lifting equipment (in this case, soft scaffolding lift sacks) rather than buckets was reinforced.

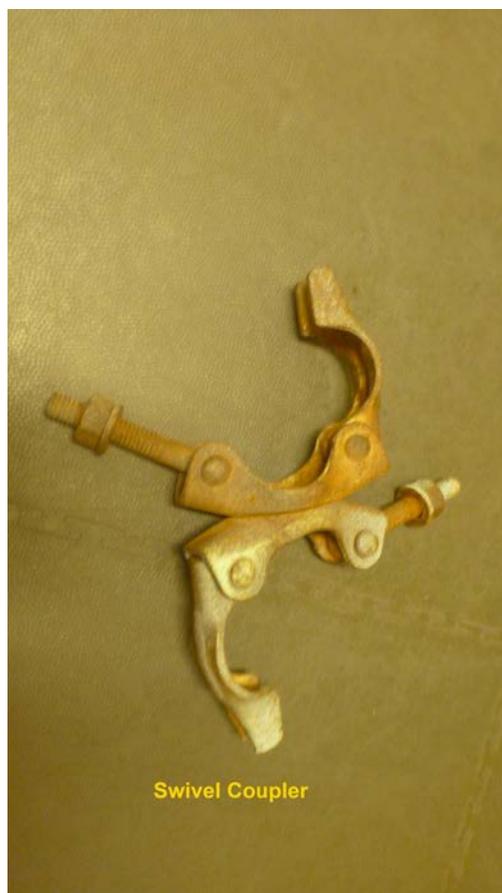
A member has reported a high potential incident in which a crewman was struck by a dropped object. The incident occurred when the crewman was ascending a ladder to reach the access/egress of a scaffold platform, and he was struck on his right arm by a dropped object. After the object struck the person it fell down under the scaffold platform. The person looked up and saw another crewman standing on the scaffold platform receiving a bucket with scaffolding materials from further above. The bucket was being lowered on a rope from a windlass room.

Figure 2: Swivel coupler

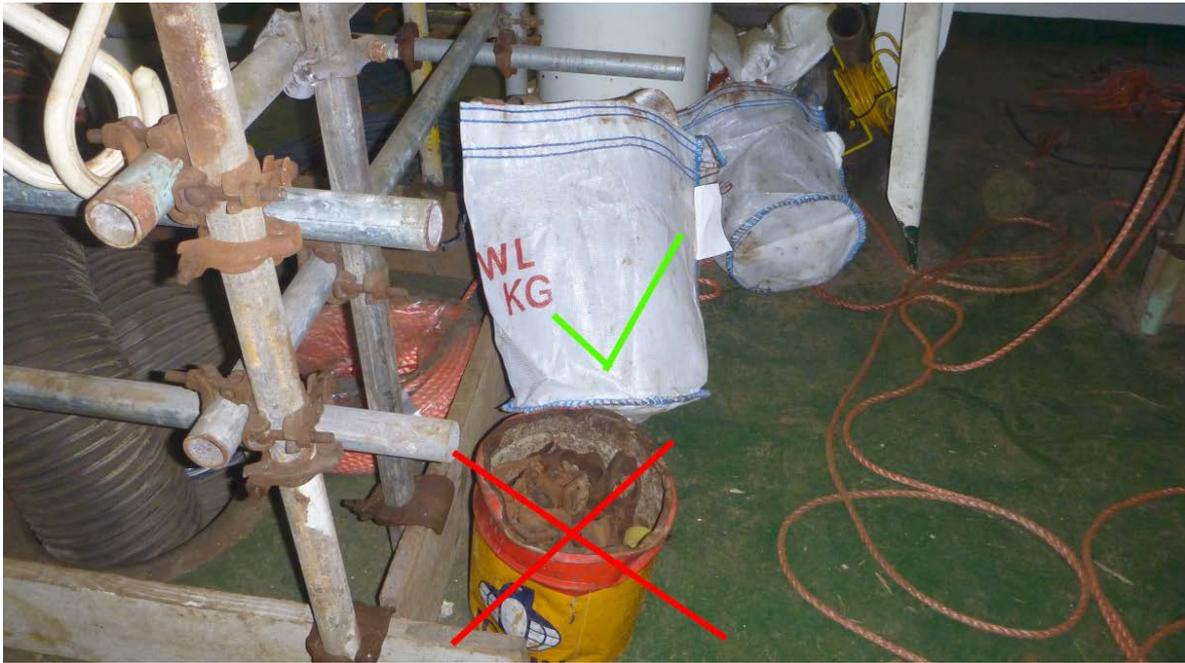
Figure 3: Illustrating buckets (wrong) and soft-sided sacks (better) for lifting

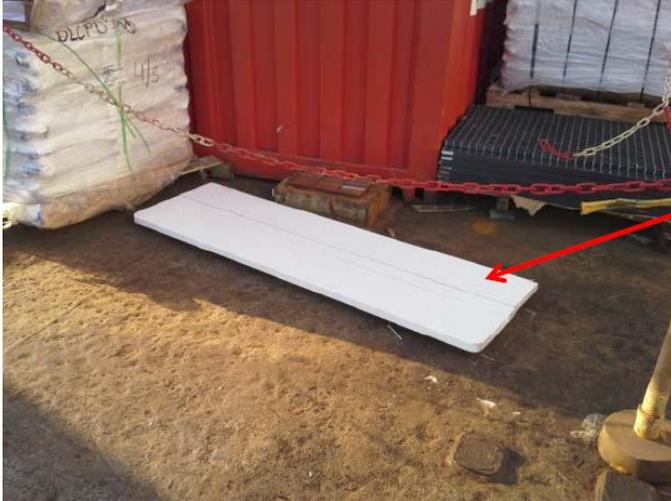
Figure 1: The cover of the bench on deck

- ◆ The immediate cause of the incident was **failure to secure the object** - the cover of the bench was not secured nor was a requirement for this identified during inspections;

- ◆ The root cause of the incident was:
 - **Inadequate verification of design** – the benches were made for an area affected by downwash during helicopter approach over starboard towards the aiming circle of the helideck. The design of the benches failed to include hinges or securing aids

- ◆ Performed additional inspections to verify if all equipment and materials are properly secured;
- ◆ Ensured that placement of additional/new equipment on or near helideck would be properly risk-assessed before installation.

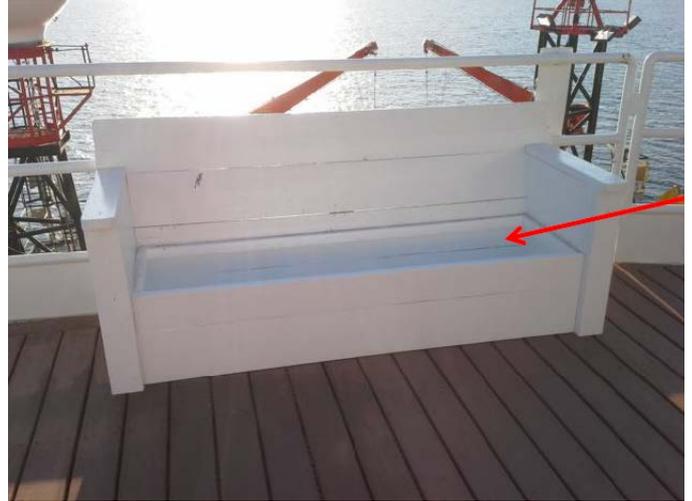
Figure 2: The bench without the cover on

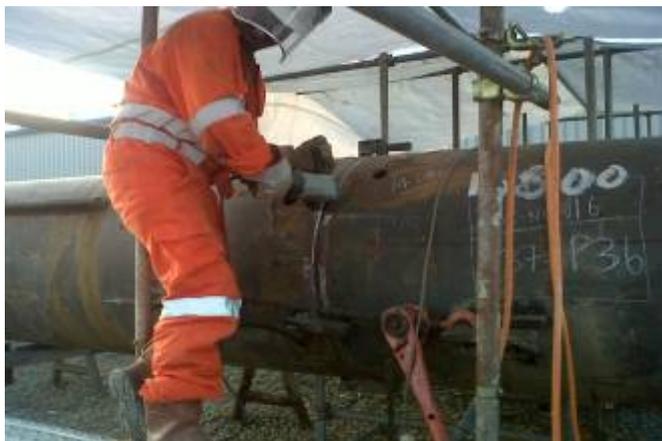
Figure 1: Position of the injured person while cutting the bevel's gap. Person stands in unstable position where he bent a little bit forward his left leg and his knee totally lean onto the pipe.

- ◆ The injured person was performing cutting activity standing on a portable scaffold platform that was not adjusted properly for the work;
- ◆ The scaffold was not suitable for the working height and the distance for the pipe that needed to be cut;
- ◆ This inadequate scaffold adjustment forced the injured person to stand in an unstable body position where his left leg was bent a little bit forward and the knee totally leaning on the pipe;
- ◆ The injured person had 18 months experience in this function;
- ◆ He was wearing the correct PPE;
- ◆ The grinder had been inspected before the job and all proper safeguards were found to be correctly fitted and in place;

- ◆ **Immediate cause: improper position for task** – the injured person was standing in an unstable position where he was bent forward with his left knee leaning fully on the pipe;
- ◆ **Immediate cause: poor judgement** - the injured person or his supervisor should have stopped the job and made sure the portable scaffold was adjusted properly for the work;
- ◆ **Root cause: inadequate design criteria** - the scaffold was not suitable for the working height and the distance for the pipe that needed to be cut.

- ◆ Further safety discussion and toolbox talks;
- ◆ Proper training with the focus topic being that proper position of equipment and personnel is critical to a safe work site;
- ◆ Ensure proper working platform to be provided for working at height.

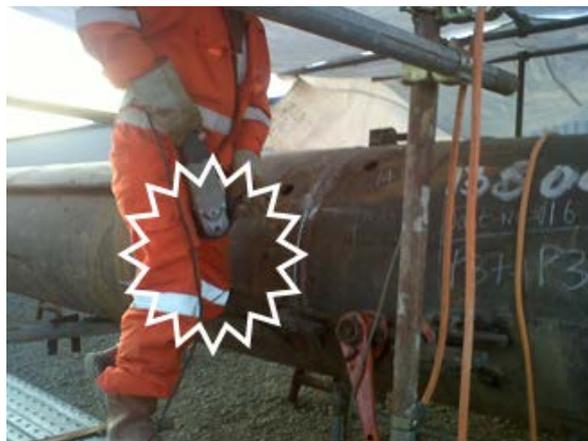
Figure 2: (RECONSTRUCTION) Position of the injured person while the grinder accidentally hit on his right inner thigh (both hands still hold the grinder)

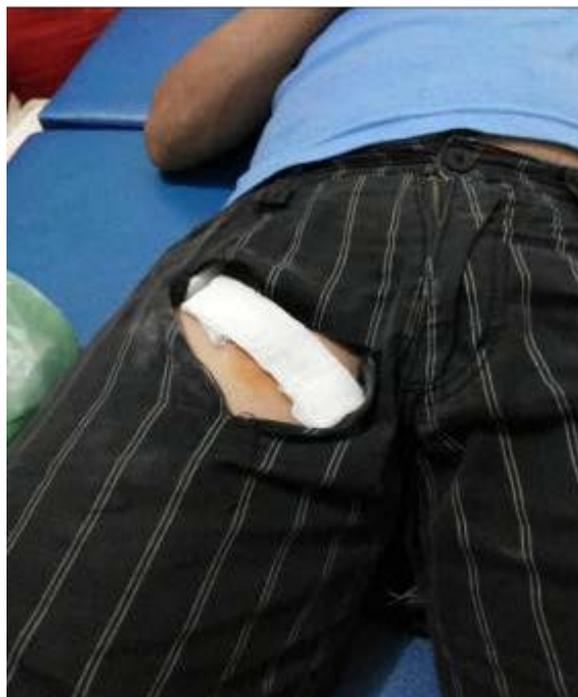
Figure 3: Injured area, right inner thigh
