IMCA Safety Flash 10/14

June 2014

This safety flash concentrates on one single issue - fires in engine room spaces – as there have been several such incidents reported recently.

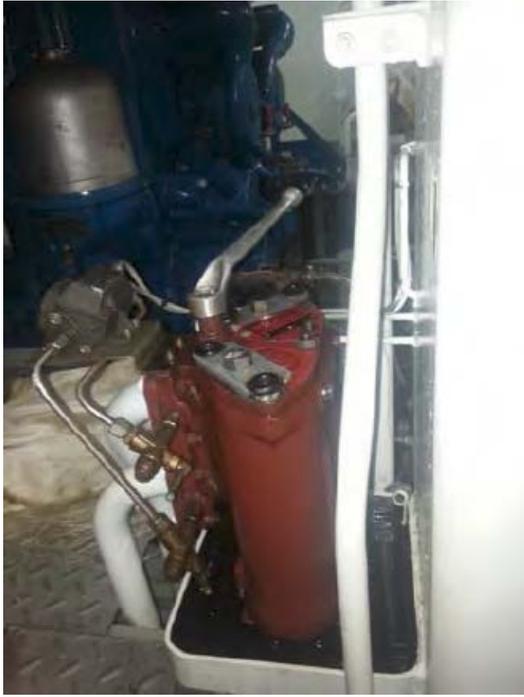
Figure 1: Typical fuel filter of the sort that failed

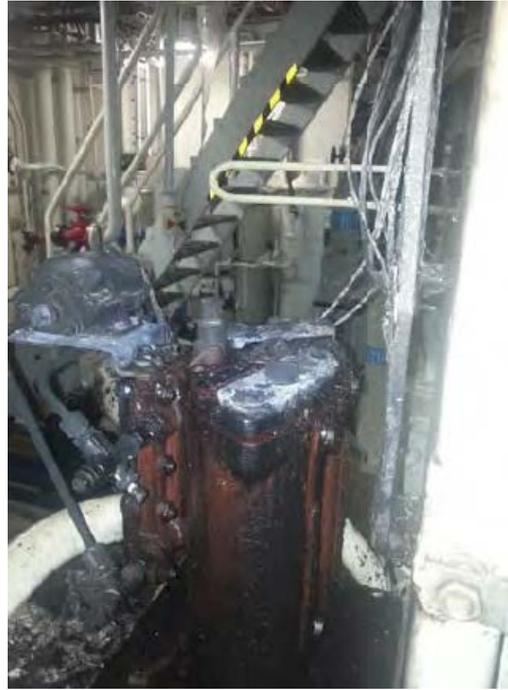
Figure 2: Failed fuel filter unit

- ◆ The **immediate cause** of the incident was found to be:
 - One of the three filter housing cover stud bolts failed by high cycle, low stress fatigue as a result of insufficient preload tension in the studs due to insufficient tightening. This led to a loss of pressure integrity of the filter housing and the 'O' ring seal was extruded through the housing/lid interface. This allowed fuel at pressure to spray onto a turbo charger exhaust manifold, causing a fire;

- ◆ Immediate full visual inspection of all stud bolts in all other fuel filter units;
- ◆ Replaced all studs in filter assemblies and tightened sufficiently to attain pre-load tension. Supplied information back to the fuel filter manufacturer such that torque settings were provided and included in the manual;
- ◆ Fire retardant blankets were placed over remaining in-service filter housing in an attempt to prevent a similar event from occurring.

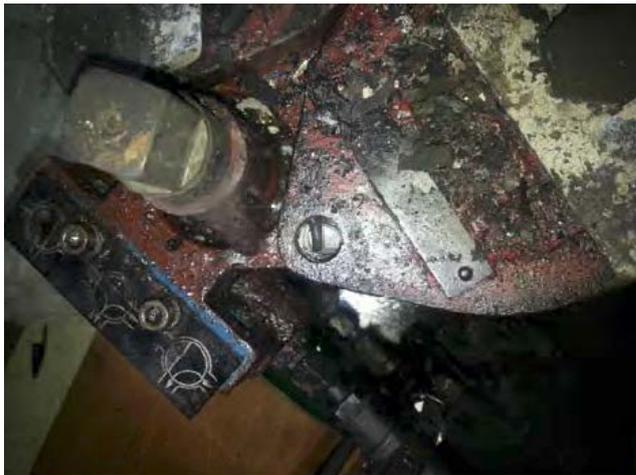
Figure 3: Top of filter showing bolt hole and extruded O ring

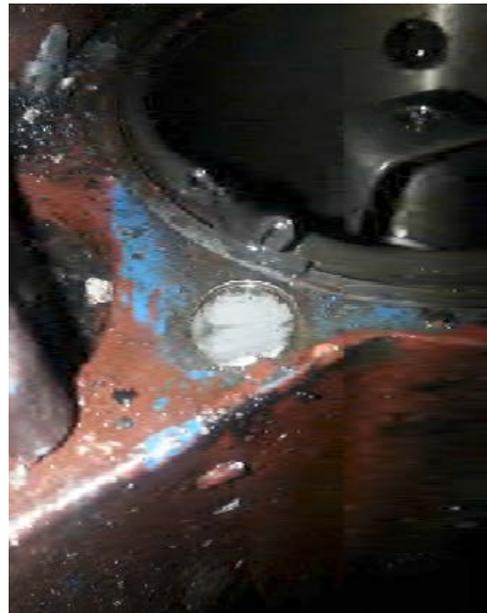
Figure 4: Sheared bolt

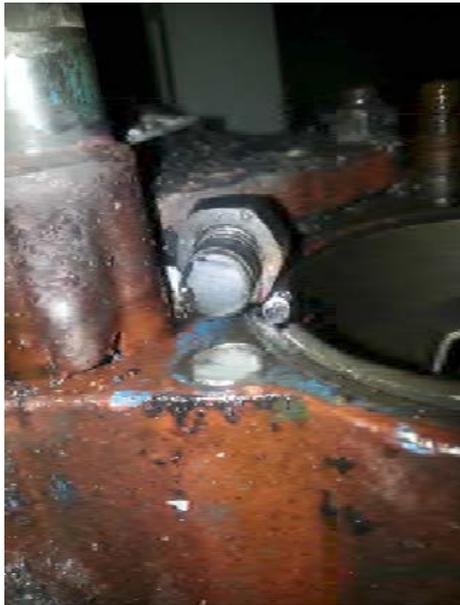
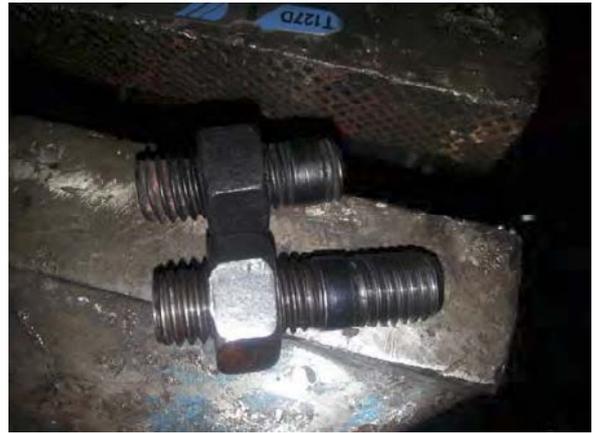
Figures 5 and 6: Failed stud

- Detailed analysis of the failed stud showed that:
 - One of the three studs broke by high cycle low stress fatigue
 - One stud contained a short fatigue crack

- The primary cause of cracking was insufficient preload tension in the studs due to insufficient tightening of the nuts
 - The stud was manufactured from good quality creep resistant steel;

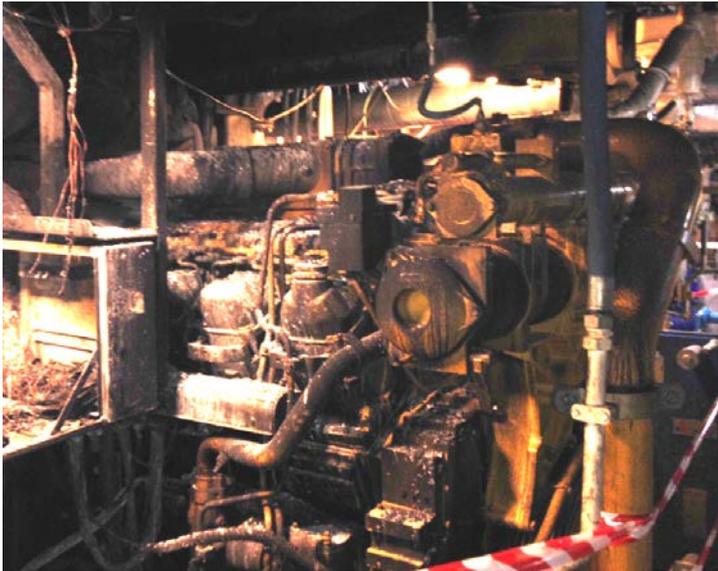
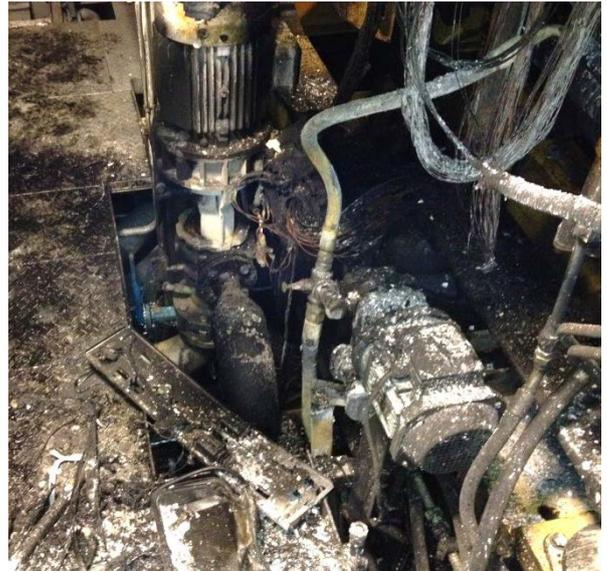
Whilst there were no injuries, there was significant damage caused by the fire. A lot of power and signalling cabling was destroyed, resulting in the vessel losing propulsion and manoeuvring ability. A tug boat was ordered and the vessel was towed to a shipyard for repairs. This resulted in six weeks off hire for the vessel.

Figures 7 and 8: showing damage to the engine room following the fire

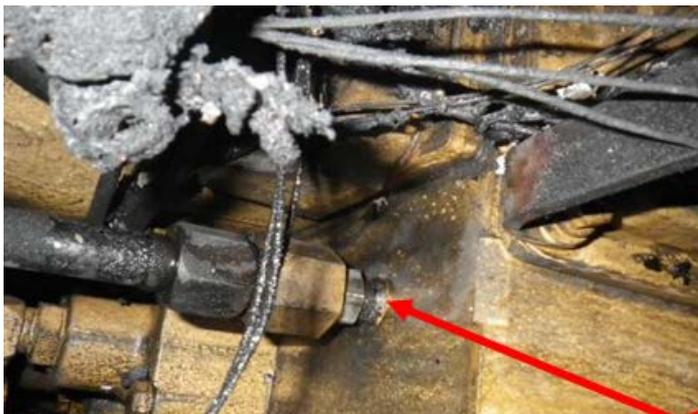
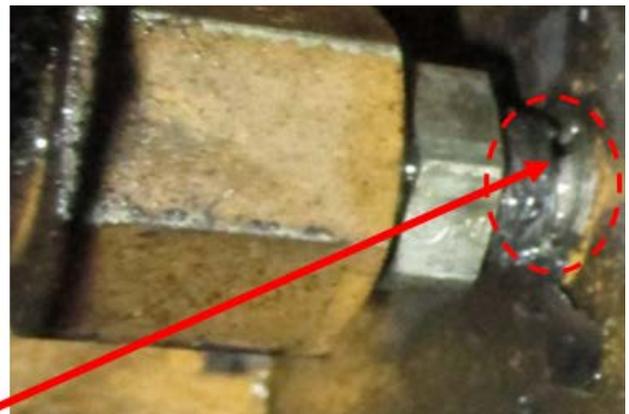
Figures 9 and 10: showing the broken nipple on the lubrication oil pipe which led to the oil leakage

- ◆ The **direct cause** of the fire was discovered to be a broken lubrication oil pipe fitting leading from the generator's engine block to a lubricating oil cyclone filter. This had resulted into an oil mist spraying out from the broken pipe. This oil mist was ignited by a source on the diesel generator or near by the generator;

- ◆ The **root causes** of the fire were determined to be:
 - **Design weakness** - The piping arrangement of the lubrication system had a weakness on a pipe nipple which resulted in to an oil leakage
 - **Location of the smoke/fire detectors** – When two of the fire detectors were activated the ‘flexi fog’ should automatically be released. It was considered that this did not occur because the fire was not detected by one of detectors above the generator - due to a poor location.

- ◆ The oil cyclone filter and associated piping was removed and the lubrication oil pipe connection on the engine block permanently blanked off. This was done after the manufacturer of the engine was consulted about the necessity of the lubrication oil cyclone filter;
- ◆ The location and direction of the existing fire detectors was adjusted;
- ◆ Additional fire detectors were installed in the engine room to ensure enhanced fire monitoring and detection.

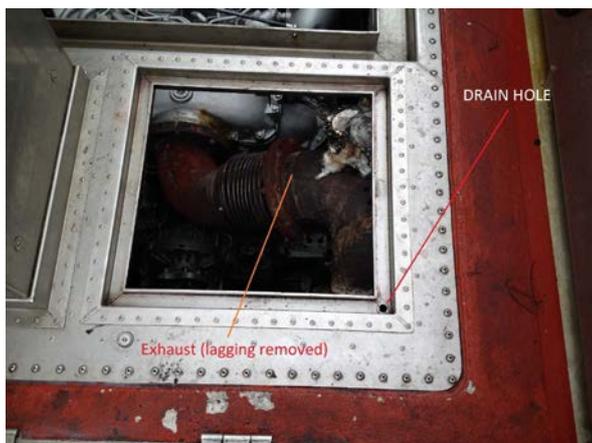
Figure 11: Drain hole from which smoke was sighted

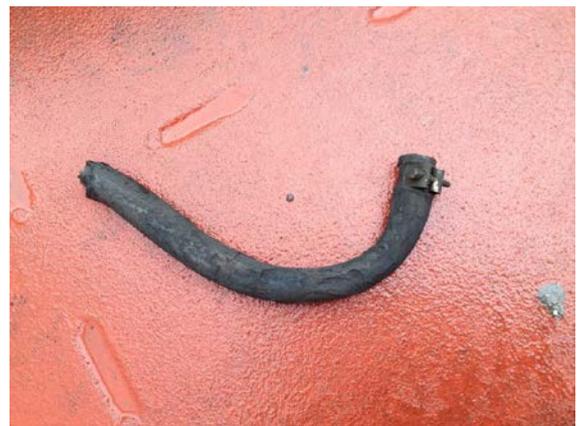
- ◆ Normal checks on the engines and inspection of the engine and jet spaces had been carried out before the voyage, and all was found to be in order;
- ◆ The **immediate cause** of the fire was a rubber drain hose from a hatch combing catching fire as it was in contact with the exhaust system;
- ◆ Although the drain pipe was heat resistant and the main engine exhaust was covered in thermal insulation, the drain pipe was badly positioned, crossing over the exhaust system;
- ◆ The flames from the burning pipe were extinguished by oxygen starvation as a result of the shutdown of the engine fans and ventilators. The CO₂ smothering system was not actually deployed.

Figure 12: Scorched drain pipe which was immediate cause of fire

- ◆ Drain pipe on both engines replaced with a suitable thermally protected pipe which was run clear of any possible exposure to damage from the exhaust system;
- ◆ A general focus on pipe inspections was produced and circulated;
- ◆ Fire drills and specific vessel training to be updated to reflect lessons learnt from this incident.

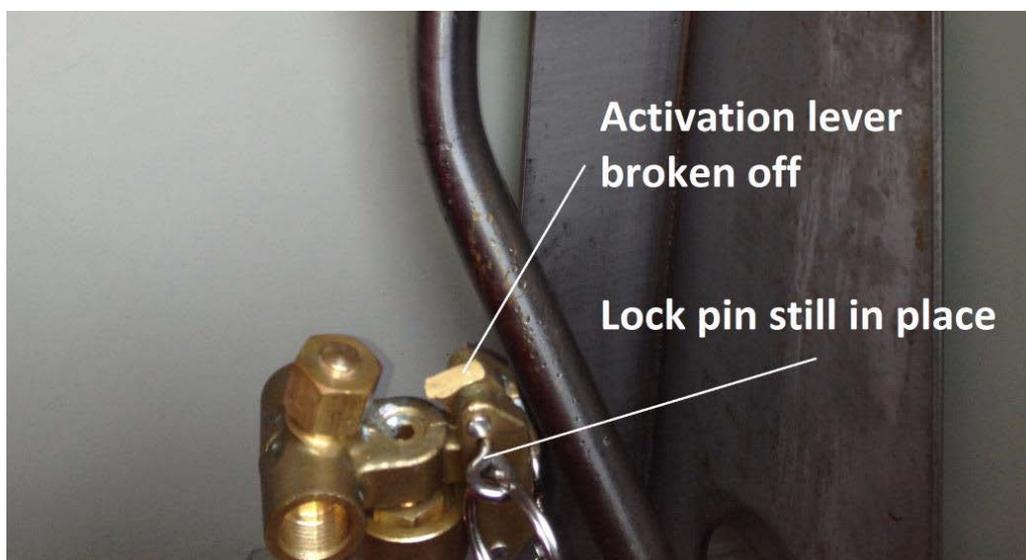
- ◆ A brass lever had been forced in the wrong direction causing it to shear;
- ◆ The instructions for the activation and effective use of the CO₂ system were not adequate to purpose;
- ◆ They were located on the external surface of the drop down access door;
- ◆ They are not readily visible to crew operating the system;
- ◆ They did not highlight the need to remove the safety pin on the activation lever of the cylinder;

Figure 13: The activation lever on the starboard cylinder was broken off but the cylinder had not been activated

- ◆ Better and more detailed operating instructions issued to vessels with similar CO₂ smothering systems – including pictorial instructions for use;
- ◆ Ensured that all crew members were fully conversant with the fixed fire fighting system fitted to the vessel and how to operate that fire fighting system.

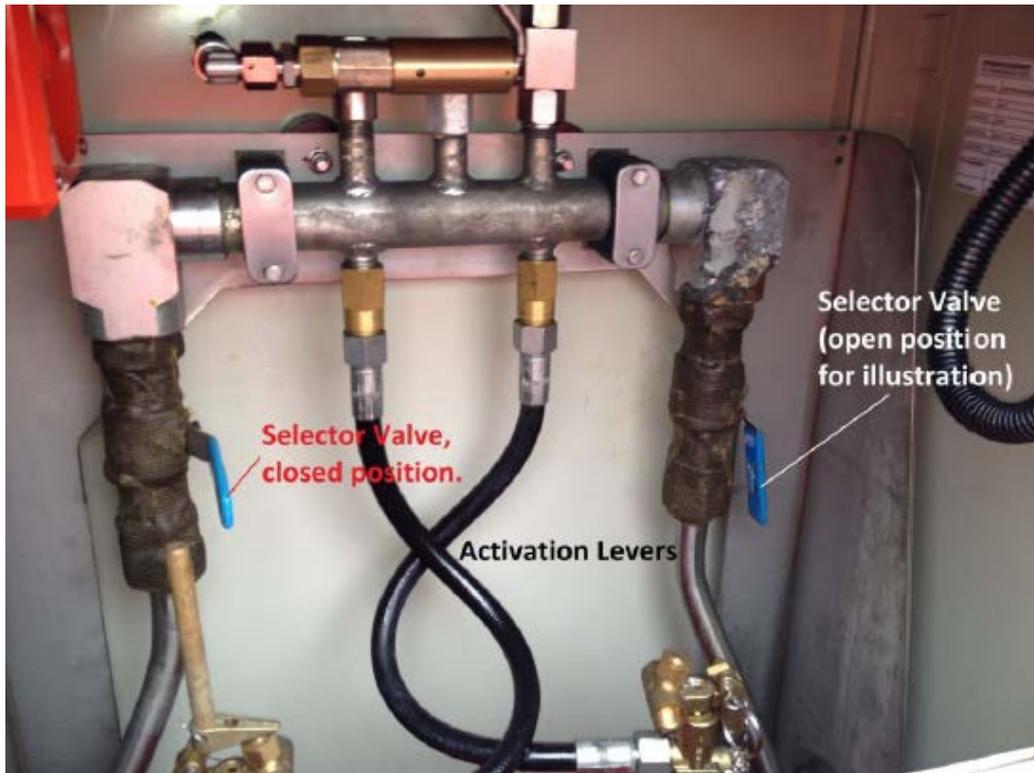
- ◆ The valve to the engine space had not been opened;
- ◆ The pin had not been removed from the valve head;

Figure 14: Both selector valves to the port and starboard engine were in the closed position
