IMCA Safety Flash 12/14

July 2014

I Engine Room Fire

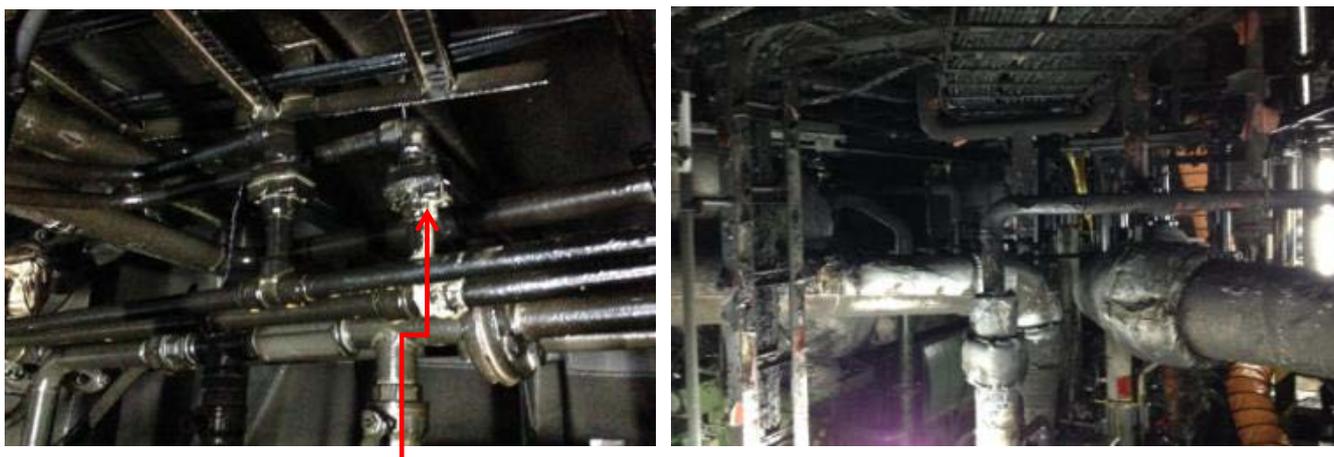
Figures (L): Hydraulic power pack unit flange (R) Engine room

- ◆ The hydraulic power pack unit for the tug's deck winch and windlass operations was initially leaking lightly; this became a sudden heavy leakage on the day of the incident (fuel source);
- ◆ The port main engine exhaust manifold insulation was leaking with the hot surfaces exposed (heat source);
- ◆ The darkened state of the engine room due to the exhaust gas was a hazard that the crews were not aware of;
- ◆ Crews did not execute the necessary actions to control the fire such as:
 - Stop engine room blowers from continuously feeding fire with oxygen
 - Stop all oil pumps in engine room from running and feeding the fire with hydraulic oil
 - Close all engine room fire flaps on deck (many were found seized)
 - Activate the fuel oil quick closing valves (generators were running throughout).

- ◆ Engine room equipment defects rectified as soon as possible;

- ◆ Insulation checks/repairs carried out;
- ◆ Ensure all oil lines are in satisfactory conditions;
- ◆ Ensure engine room is sufficiently lighted to maintain safe working conditions;
- ◆ Ensure all engine room fire flaps on deck are in safe working condition;
- ◆ Ensure all emergency shutdown trips are tested at regular intervals by the ship's crew;
- ◆ Ensure monthly fire drills are carried out on board and that all crew are familiarised with the emergency duties/equipment's operations.

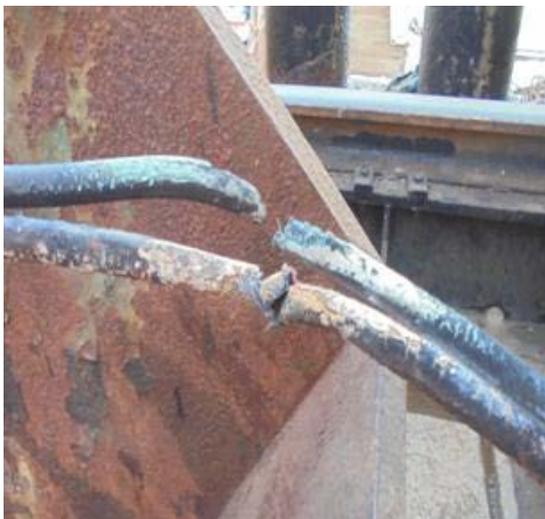
Showing punctured and burned hose.

- ◆ Poor practices of routing and protecting hoses had subjected them to damage;
- ◆ The acetylene hose was connected and run out in the vicinity of a workshop and subjected to uncontrolled sparks. Escaping gas was ignited resulting in a flash fire.

- ◆ The hose was of inferior quality and had been poorly treated;
- ◆ The hose was recently brought into service and already sustained damage resulting in the escape of acetylene gas;
- ◆ Pre and post inspections had not been adequately carried out. Had they been completed, this would have raised concerns about the structural integrity of the hose.

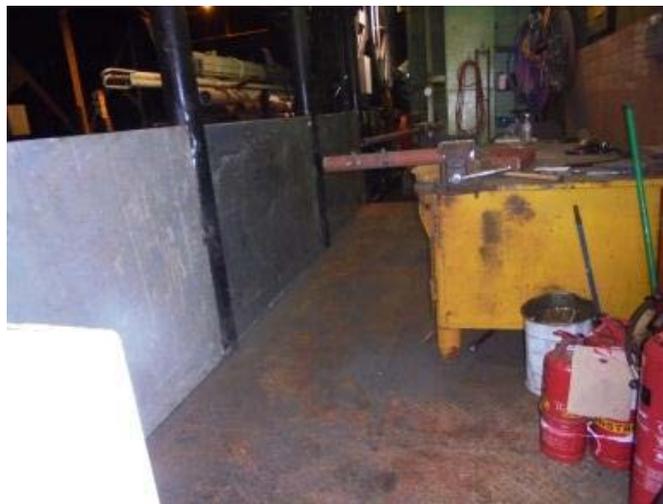
Showing new galvanized blinding to control sparks added.

- ◆ Provide adequate blinding/coverings in the nearby carpentry workshop to prevent sparks and heat from going outside of the contained area;
- ◆ Training and toolbox talk reviewing the incident and stressing cable and hose management, pre and post task inspection and removing damaged equipment from service;
- ◆ All hoses and equipment to undergo routine maintenance inspections and be colour coded to enable personnel see the equipment is valid to use;
- ◆ Several other damaged hoses were removed and replaced;
- ◆ A pre- and post-task welding hose checklist was created and made part of the permit to work process.

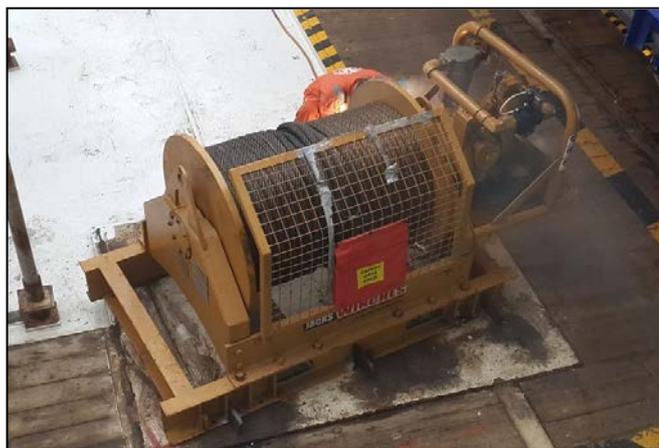
The rental winch installed before the incident

- ◆ A repeatedly malfunctioning 32t constant-tension lay system winch had been replaced with a 10t air tugger non-constant tension winch for use in offloading pipeline. The 10t winch had been initially installed for loading purposes, and then maintained for offloading, as the 32t winch had not been repaired;
- ◆ Approximately two months before the incident the winch base plate and winch attachments deflected under load. Additional fastenings were welded from the winch frame to the base plate;
- ◆ Eight days prior to the incident the rental 10t winch had been installed, and MPI (magnetic particle inspection) checks [of the welding] were done between winch and base plate fastenings.

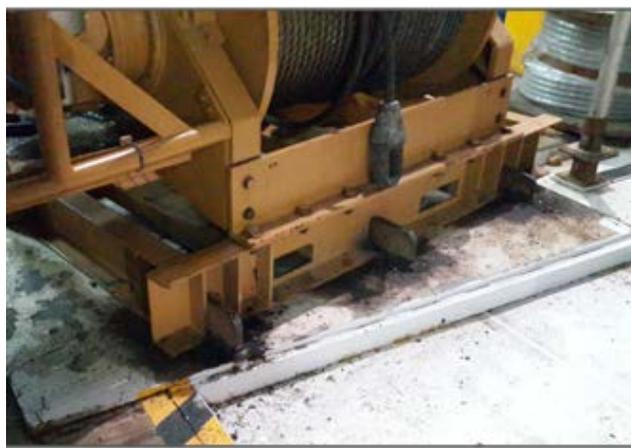
Magnetic particle inspection (MPI) checks done between winch and base plate before the incident

- ◆ Identify and correct shortcomings in MOC requirements;
- ◆ Ensure that non-destructive testing be carried out on all welds between winch base plates and decks whenever a winch is installed onto a base plate;
- ◆ Review and revise Pipe Loading and Offloading procedures to eliminate identified causal factors;
- ◆ Ensure vessel management and crew are fully apprised of 'Stop the job' or 'Stop Work Authority' policies and procedures;
- ◆ Re-design the lay system so that aligner load cells can be calibrated to allow tension checks for lower tower angles;
- ◆ Revise applicable procedures to include 'Hold Points' when load cells must be calibrated before undertaking any installation work involving the tower, including any work that requires the tower to go below 80 degrees.

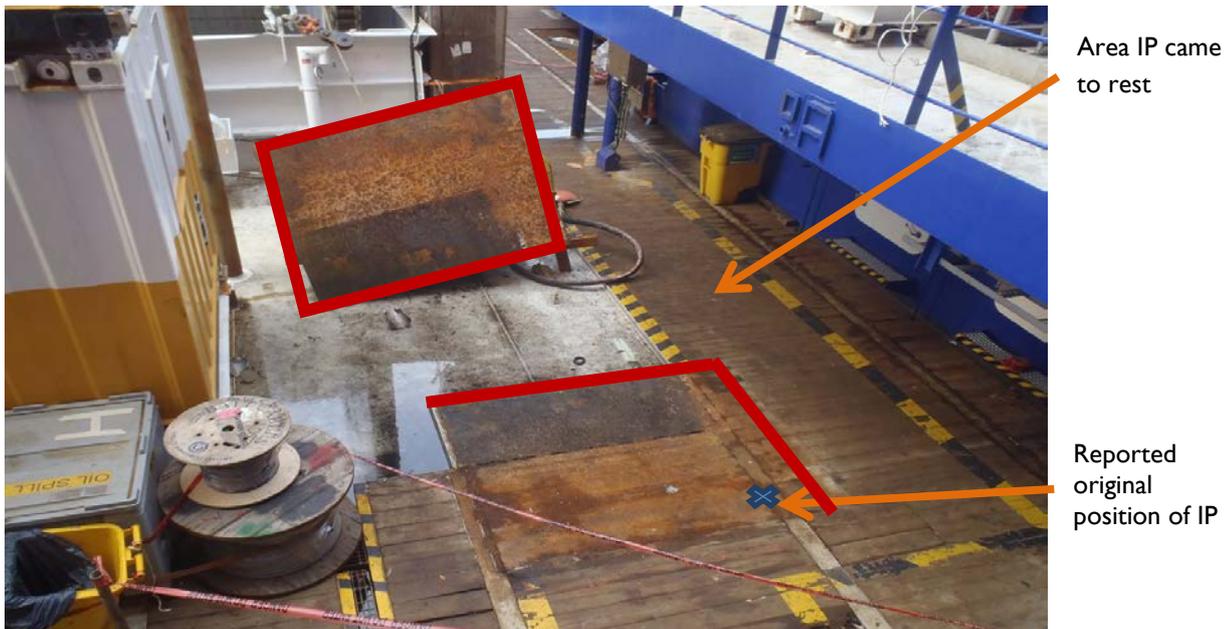
Rental winch and base plate after the incident

- ◆ A 32t constant-tension winch repeatedly malfunctioned, was removed from service, and had been replaced with a 10t tugger winch;
- ◆ Management of Change (MOC) procedure raised but did not include design calculations for welded installation of base plate, attached between main deck and 10t winch;
- ◆ Replacement winch was not constant tension nor fitted with a tension measurement device;
- ◆ Cause of base plate deflection occurring two months prior to incident was not investigated and corrected;
- ◆ Inability of aligner load cells to accurately check tension at smaller tower angle (less than 80°);
- ◆ Calibration validation process had not been completed due to a load cell failure incident.

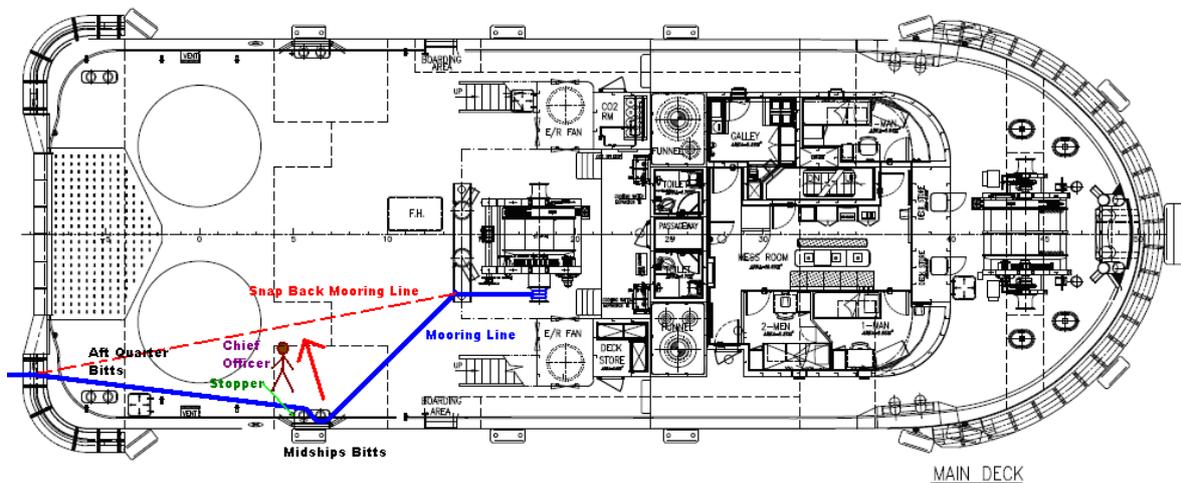
Plan view of back deck showing location of injured person

- ◆ The mooring arrangement used required the Chief Officer to work in the snap back zone;
- ◆ The mooring arrangement used facilitated a vertical movement upwards (The midship bitts have a slight inboard inclination, the height difference between the mooring roller and midship bitts created an angle and the length of the horizontal extension arm is not long enough to present a sufficient safety guard);

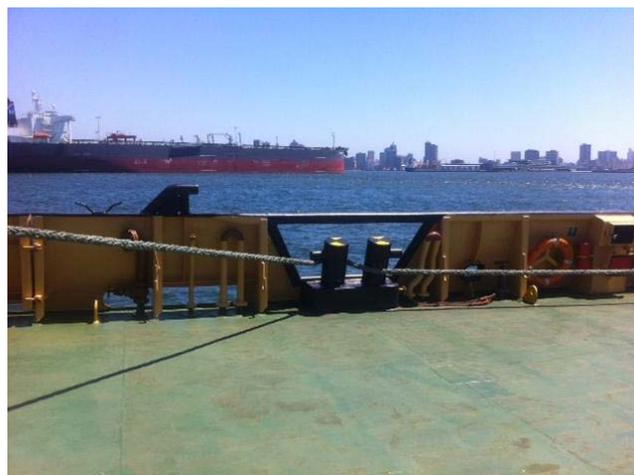
Showing mooring lines as in incident (reconstruction)

- ◆ There was a deviation from normal operating procedure – inadequate MOC.

- ◆ Reiterated importance of being able to STOP THE JOB in case of unsafe operations;
- ◆ Took steps to ensure crew were fully informed of risk and control measures;
- ◆ In cases where deviating from an agreed plan of operations, stop the job, re-assess and communicate the additional hazards and control measures via a toolbox meeting;
- ◆ Ensured all personnel involved in the activity or completing simultaneous operations take part in the toolbox meeting;
- ◆ Ensured personnel were trained and have sufficient experience and knowledge to carry out a task;
- ◆ Implement formal MOC process for changes/deviations to normal operating procedures and changes to design of the ship.

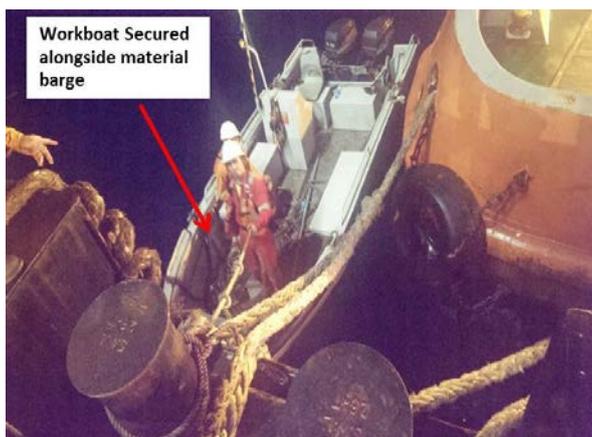
Showing workboat moored alongside material barge

- ◆ Ensure deployed workboats are crewed by a minimum of two persons or retrieved back onto deck. If this is not practical, ensure workboat is properly secured;
- ◆ Ensure personnel deployed on material barges and remote sites carry a radio at all times;
- ◆ Deck watch and gangway watch with access to radio to be maintained at all times;

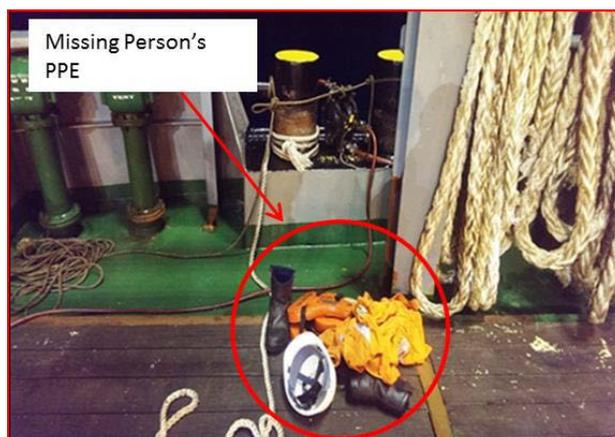
Showing missing person's PPE
