IMCA Safety Flash 03/15

March 2015

I Capstan Wire Parted during Deployment of Anchor Buoy

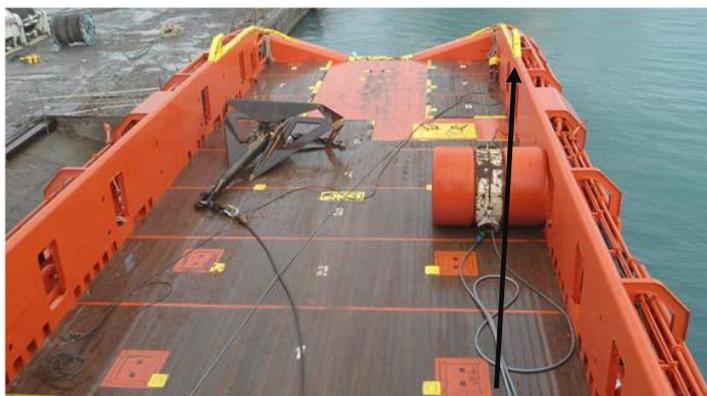
A member has reported an incident in which a wire parted whilst dragging an anchor buoy on deck. The incident occurred when a vessel was involved in a Delta Flipper anchor drag test operation. The operation consisted of deployment one after the other, of an anchor buoy and a Delta Flipper type anchor, using two capstan wires, and then recovery back to deck using the main tow wire. Three tests were carried out successfully. During the fourth test, the port side capstan wire parted whilst dragging the anchor buoy on deck. There were no injuries.

Figure: view of back deck showing Delta Flipper anchor (left) and Anchor Buoy (right) and Capstan (arrow)

- ◆ SWL requirements should always be considered when rigging/towing operations on deck. Ensure that the capstans rated pull is below the certified SWL of the capstan wire. The capstan should stall before the wire fails;
- ◆ Anchors should be moved on deck only with tugger wires connected either through towing pins or snatch blocks fixed on the pad eyes next to the stern roller, ensuring that all pinch points for the wires are identified and avoided;
- ◆ Capstan winches should not be used as a substitute for a deck tugger;
- ◆ When using capstans, care should be taken with wire lead in and lead out angles to avoid wire abrasion from the capstan flanges;
- ◆ Avoid excessive wraps on the capstan drum which would cause knifing damage of the wire and subsequently reduce the wire SWL;

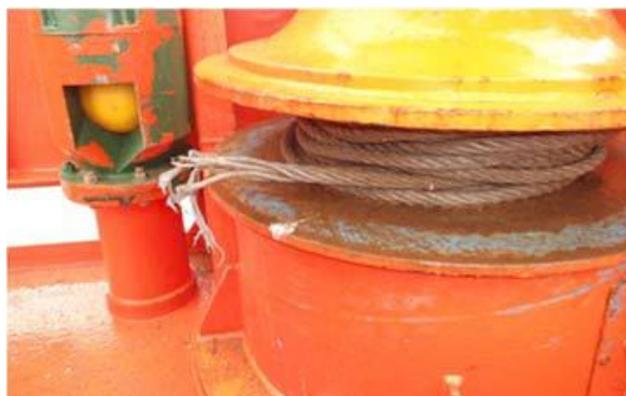
Figure: capstan showing parted wire

- ◆ A clear deck policy was constantly followed;
- ◆ The certified safe working load (SWL) of the capstan wire was below the rated pull;
- ◆ Tear and wear – friction of capstan wire rope on the edging of capstan flanges;
- ◆ There had been no visual checks for tear and wear of wires made by the crew after each anchor drag test;
- ◆ Another, more preferable and safer, option of using tugger winches had not been considered for this operation.

- ◆ Visual checks: checks of the tugger/capstan wires and other rigging/towing equipment should be carried out by the crew before every test, and checks made of wire ropes SWLs on other anchor handling tug supply (AHTS) vessels for any wire underrating issues to identify/investigate and address each particular case;
- ◆ Vessel should carry at least one spare tugger and certified capstan wire to allow replacement of damaged wires immediately;
- ◆ Revised risk assessment for anchor drag test operations to include identified additional hazards and control measures;
- ◆ Ensure vessel personnel involved in rigging and lifting operations receive appropriate training;
- ◆ Design/size of the stern roller to be adequate to allow the Delta Flipper type anchor to go through it easily without getting stuck.

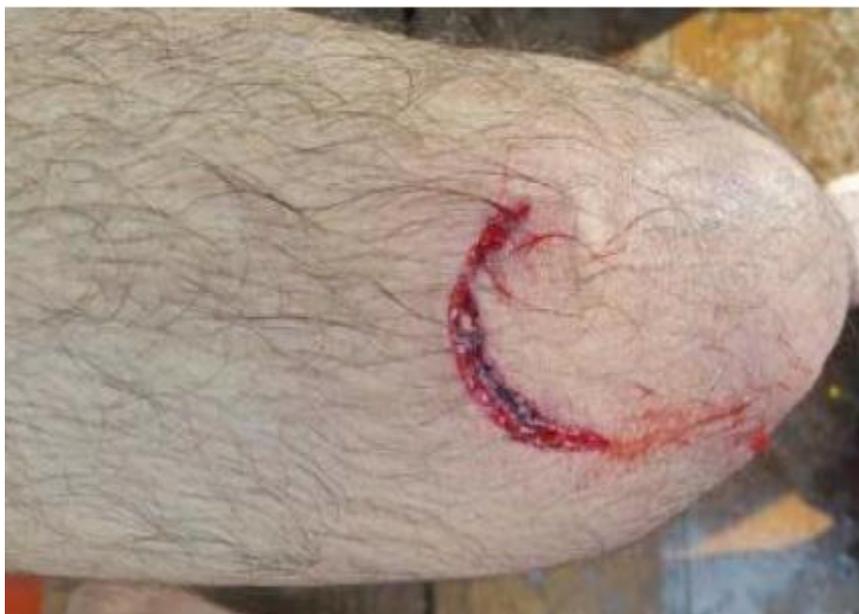
A member has reported an incident in which a diver injured himself using a water jetting tool. The incident occurred during the removal of marine growth from the leg of an offshore platform. When the diver was shifting the water jet from one side to another, the trigger was accidentally pressed as the nozzle passed over the diver's knee. No injury was felt or noticed by the diver at that time and the diver continued working. On returning to the surface on completion of the dive, the diver felt pain whilst undressing and an acute injury was noticed about 7.5cm long and about 2mm deep approximately 5cm above the left knee.

Figure: showing injury to diver

- ◆ During the water jetting dive the diver had on a wetsuit and a diving denim coverall for his protection;
- ◆ The safety lock was not activated on the water jet, allowing it to trigger whilst shifting position or location in water.

- ◆ The supervisor to give additional briefing before use of high pressure water jetting equipment;
- ◆ Divers should ask for the water jet to be 'made cold' or pressure turned off, before moving locations.

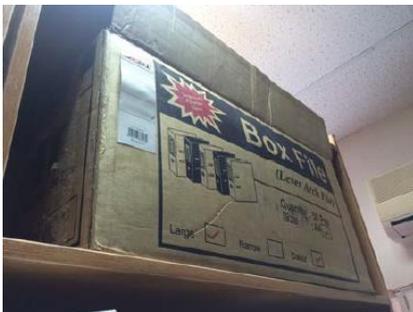
A member has reported a near miss incident in which a box of fluorescent tubes very nearly fell on someone’s head. The incident occurred in an office location when someone was searching for something in a store room. An unmarked cardboard box, initially used for folders delivery, was stored on a high top shelf (above eye level for the average person). As the box was moved, a fluorescent tube started sliding from the box towards the face and eyes of the person moving the box. On the end of this type of the tube there were two contact pins, which could have caused serious injury to the face and eyes. The quick reactions of the person meant that this was narrowly avoided – nothing fell and there were no injuries.

Figure: box as stored on high shelf

- ◆ The person involved used improper manual handling techniques, trying to move box from the top shelf position without any assistance and without using a ladder, which was available in the store room;
- ◆ The fluorescent tubes were stored in an unsafe way in an open unmarked cardboard box on the top shelf.

- ◆ Reviewed contents of store room and ensured that all items in the store room were properly marked, closed and stored in a safe and appropriate manner to prevent any further potential falling and/or moving of stored items. Unnecessary items were disposed of or sent away for storage elsewhere;
- ◆ Members may wish to review IMCA Safety Poster SPPI, *Manual handling* www.imca-int.com/media/102365/imcaspp01.pdf.

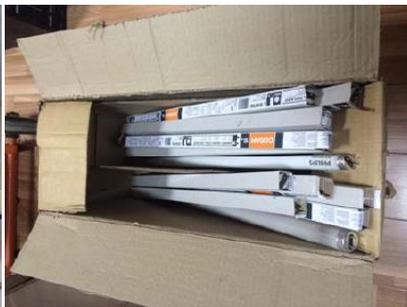
Figure: showing open box with fluorescent tubes

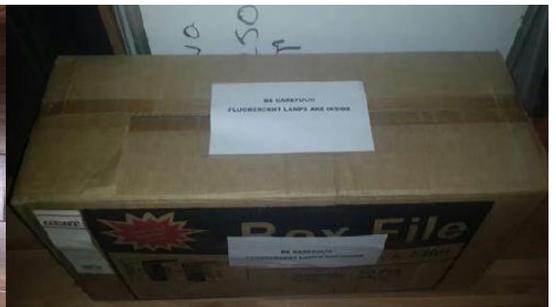
Figure: box appropriately sealed and labelled

The person involved sought further assistance, and using a ladder, the box was sealed up, appropriately marked as containing fluorescent tubes, and moved to a safer location at floor level.

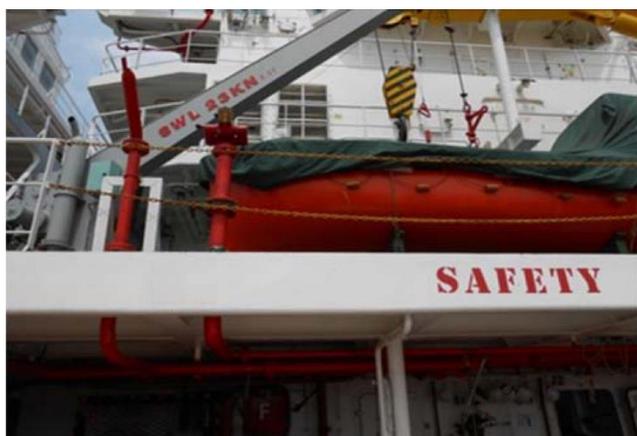
Figure: showing safety chains installed

The crew reported this as a near miss and the short term solution will be to wear a safety harness when launching and securing the rescue craft. Arrangements were made to fabricate and fit a chain rail and stanchion to prevent recurrence.

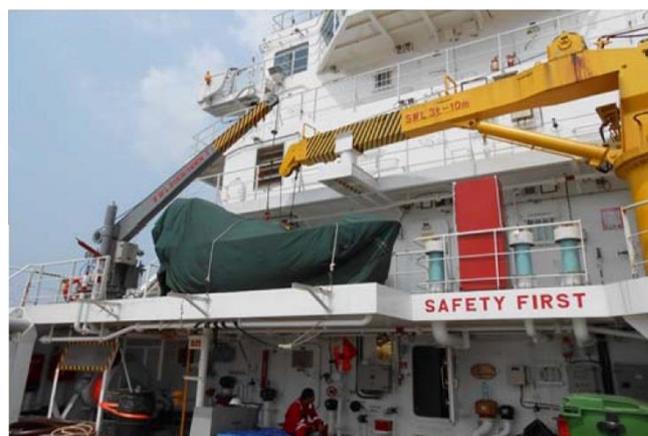
A member has reported a potential near miss incident in which there could have been a fall from height during launch of rescue craft. During annual inspection of the rescue craft on a vessel, it was noticed that to secure and launch the rescue craft a crew member had to go around the rescue boat and stand outboard of it in an exposed place. There was no barrier in place to prevent a crew member carrying out this task falling from height.

Figure: different vessel in fleet without safety chains installed

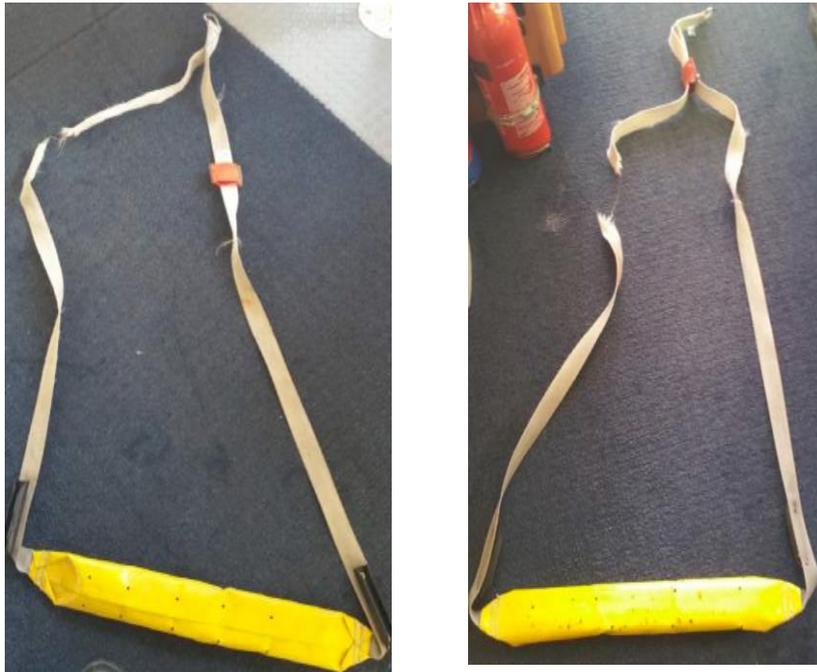
A company has reported an incident in which there was a failure of lifting slings. During a MOB drill in port the dummy was brought to the MOB using a Sula Bedriftsteneste (SB) Rescue Sling, the sling was used with the davit to bring the dummy on board. The sling, under the weight of the dummy, snapped. Two other slings also parted during the exercises within a few hours at the same port.

Figure: showing typical SB rescue slings

- ◆ The slings were being used under 'normal' conditions and parted under the weight of the dummy. A copy of the manufacturer's instructions were obtained from the supplier and it was found that the slings were close to or beyond their replacement date;
- ◆ The slings had been exposed to the elements and were probably near or beyond their replacement date. It is also possible that their integrity had been compromised when being cleaned;
- ◆ Supply dates need to be noted, test and replacement dates adhered to.

A safety alert was circulated with a requirement to check all slings. Replacement slings were ordered to replace any that are near their replacement dates. Requirements for MOB drills were changed, such that it is now required that a proper dummy (to 'load test') is used every other drill.
