## IMCA Safety Flash 05/16

February 2016

## 2 Near Miss: Fouled Diver Umbilical

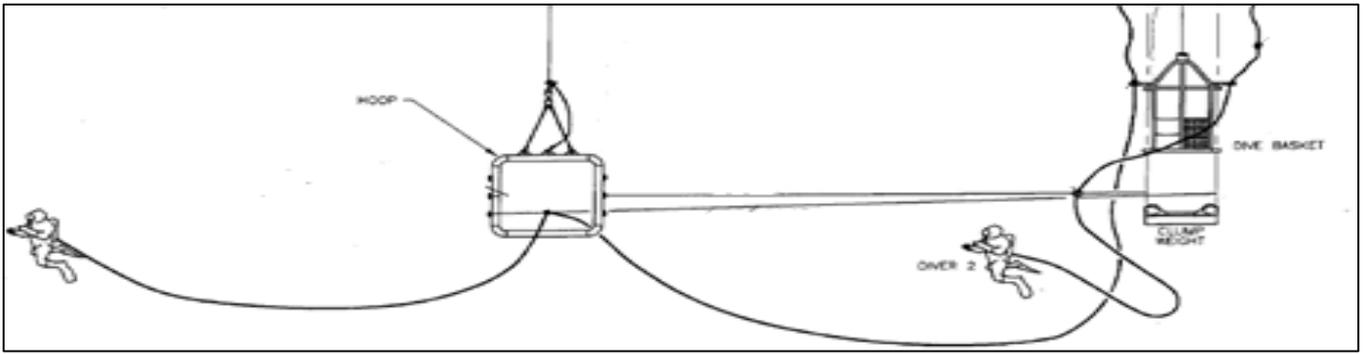
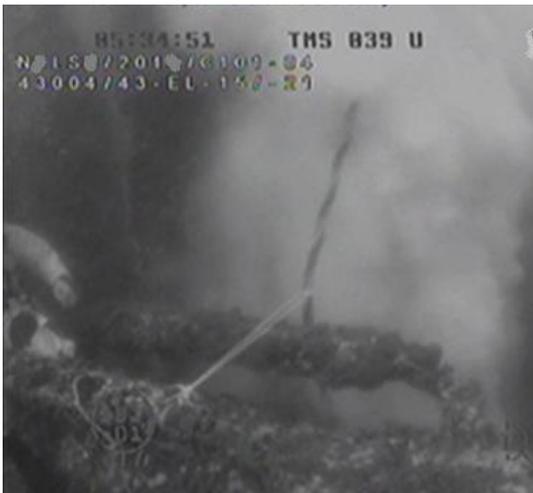
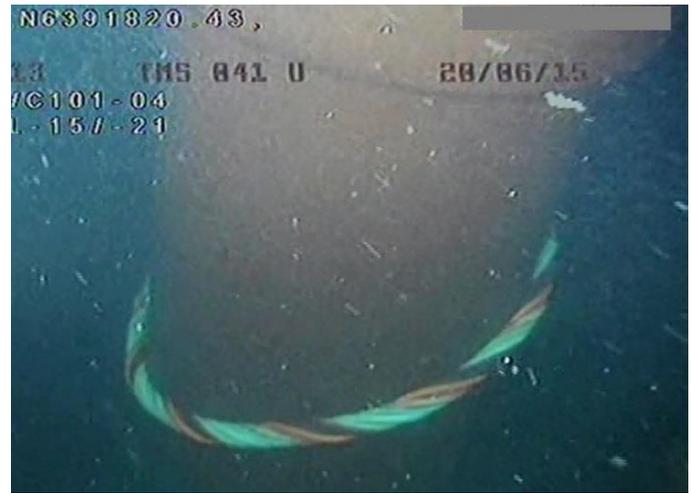
A member has reported an incident in which a diver's umbilical became fouled around a seawater discharge caisson. The incident happened during a shallow water saturation dive (15msw), whilst using extended umbilicals routed through a submerged intermediate hoop to reach the worksite from the diving bell.

The diver had made his way to the structure through the hoop. He was preparing to move into the structure by pulling the required length of slack umbilical through to his location at the edge of the structure, before moving to the work location. This meant the diver had to pull through approximately 23m of working umbilical in order to access the job, which was in the centre of the jacket. The umbilical was slightly negatively buoyant. Whilst the diver was pulling through the 23m of working slack at the jacket, a bight formed below him. The bight was carried by the prevailing current (which was setting towards the aerated discharge), and was drawn into the aerated discharge. As the caisson base was only 2m below the 15m elevation, the aerated water lifted the bight of umbilical upwards and around the caisson resulting in diver 2 being unable to pull through his slack.

*Camera view of fouled umbilical.*

- ◆ The risk assessment identified the caisson as a hazard, but did not identify the aerated nature of the water around the caisson discharge as a hazard;
- ◆ The risk assessment did not identify that 'safe' standoff distances should take into account the maximum length of a diver's 'slack' umbilical that could be deployed in conjunction with tidal direction etc., when establishing safe standoff distances;
- ◆ The aerated nature of the water was considered a nuisance rather than a hazard with regard to the divers' umbilical.

- ◆ Take into account the length and potential route/location of the diver's umbilical in relation to discharges and other hazards (inlet and outlets, snagging points) in addition to the physical location of the diver;
- ◆ Understand that gas entrained discharges can produce significant general upward flow of the surrounding water in their location even if the outflow from the discharge is downward.

- ◆ Ensure all potential hazards are considered during umbilical management – and not just vessel thrusters;
- ◆ Take into account diver routing and access and umbilical management techniques during pre-job engineering;
- ◆ Ensure specific review of the risks of working on extended umbilicals and/or within structures is considered during the risk assessment process.

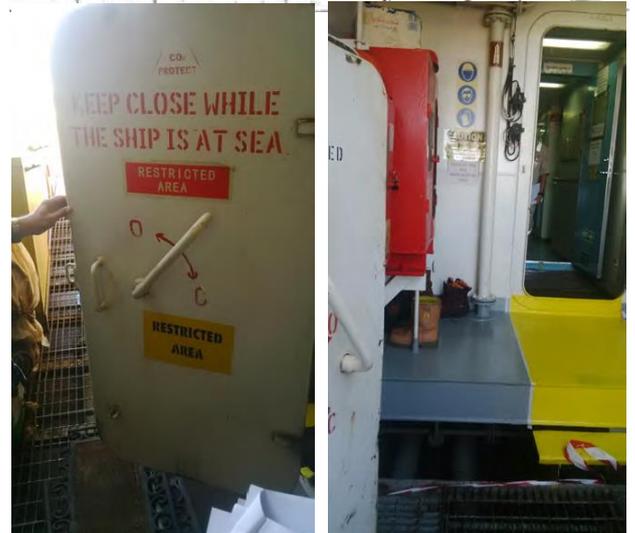
- ◆ Between the accommodation and the winch housing, the internal door was closed but the external, weathertight door remained open (see image, second right);
