IMCA Safety Flash 07/16

March 2016

Focus: Fire Hazards, Mooring, *Hoegh Osaka*

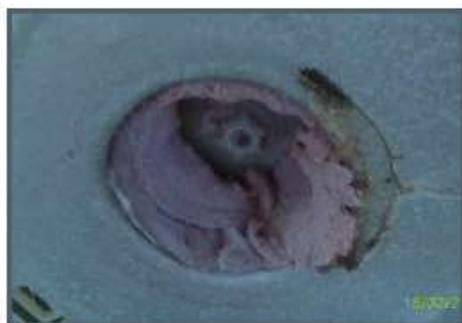
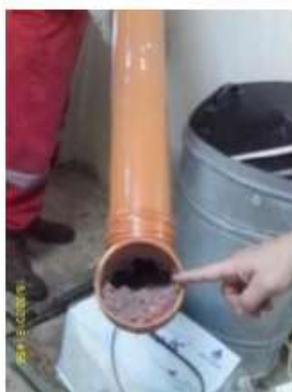
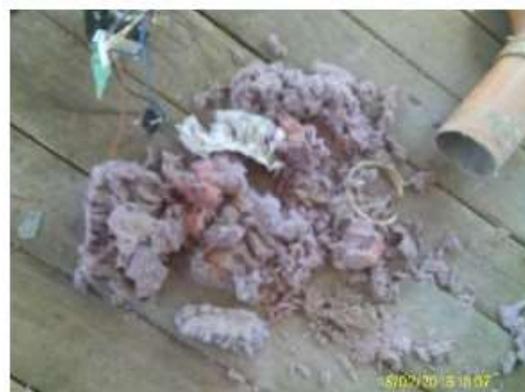
A member has reported a near miss which might have developed into a fire in the laundry room. During a weekly inspection of the laundry room, rags and lint twisted together were discovered in the dryer exhaust fan. Further investigation revealed more accumulated lint within the dryer’s outlet exhaust pipe. When the end of the outlet pipe was removed to check the inside, it was found that it was approximately 85% blocked by lint.

- ◆ Although the dryer's lint filter was in place at the time, the evidence clearly indicates that it hadn't always been in use, or had been used incorrectly – the correct use and installation, and frequent checking of, lint filters is essential to avoid such potentially hazardous situations;
- ◆ Use of ventilation pipes and systems can create traps in which lint accumulates over a period of time, especially if lint traps are not in use or defective – this creates a fire hazard. Such venting systems should be regularly checked to ensure that they are free of obstructions;
- ◆ There was no management of change (MoC), risk assessment or forward planning conducted to fully assess the impact of fitting the venting pipe.

- ◆ Immediately removed the outlet exhaust pipe for thorough cleaning and removal of lint;
- ◆ Subsequently, the dryers were relocated to an external area (winch housing) where they could vent directly to atmosphere.

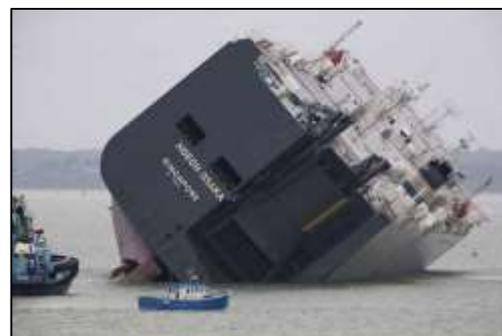
In summary, the report notes that the vessel developed a significant starboard list when turning to port, not long after it was departing Southampton, UK. As the list increased in excess of 40°, the vessel lost steerage and propulsion, and subsequently drifted aground. A cargo shift, as the vessel listed, resulted in a breach of the hull and consequent flooding. All crew were safely evacuated from the ship and surrounding waters. There was no resulting pollution, and the vessel was later successfully salvaged.

It was shown through subsequent stability modelling and analysis that the vessel listed heavily to starboard while turning as a result of having inadequate stability, which had not been identified prior to departure.
