IMCA Safety Flash 08/16

April 2016

Summary

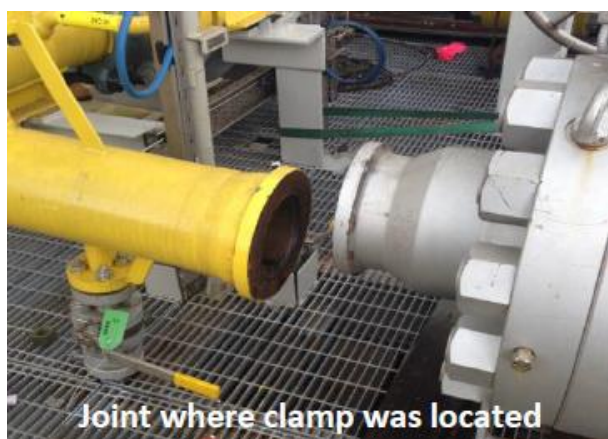
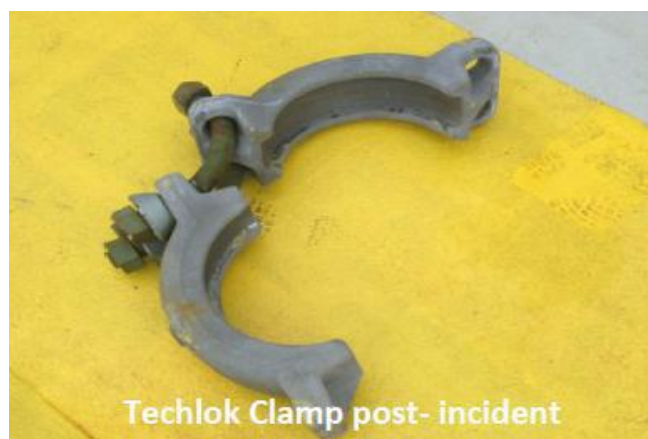
An incident has been brought to IMCA's attention in which a crewman died as a result of a stored pressure release. The incident occurred when a two man team was removing a Techlok (clamp hub connector) to conduct repair work on a leak found during testing. The leak was identified at the hub connector upstream of the manual valve on the top deck of the module. The clamp released under high pressure and struck one of the crewman, causing fatal injuries.

- ◆ The Techlok clamp removal was done using an incorrect method;
- ◆ The Permit to Work was issued with conflicting isolation requirements – there was substandard identification of conflicting work scopes;
- ◆ The compressor isolation certificate number was not included in the test log sheet within the procedure;
- ◆ The Permit to Work recognized the need for electrical Isolations but not mechanical Isolations;
- ◆ Permits to Work for leak testing and leak rectification covered multiple systems. They become generic by nature and reduced the ability to identify task specific hazards;
- ◆ No bleed point was identified between primary and secondary isolation valves;

- ◆ The team did not adequately follow existing Leak Test procedures. Valve line-out was not confirmed during second leak test;
- ◆ Some members of the crew were inexperienced in the task and were unaware of their individual roles and responsibilities;
- ◆ There was inadequate shift handover; electronic handovers were used rather than face to face or written handovers;
- ◆ The agreed procedure and Permit to Work were deviated from. The Project Manager was not aware of change and there was no Management of Change undertaken;
- ◆ Actions implemented following a previous incident were not enforced for any significant period;
- ◆ There was a poor incident reporting and investigation culture.

- ◆ Ensure that toolbox talks take place when appropriate;
- ◆ Ensure that all crew are fully familiar with Permits to Work and Isolations and Barriers;
- ◆ Ensure there is complete understanding of the job and all the risks involved before starting work;
- ◆ Stop The Job and inform a supervisor if conditions change;
- ◆ Always intervene when you see an unsafe act or condition;
- ◆ Never remove safety isolation/equipment/barriers;
- ◆ Never perform tasks for which you are not trained and competent.

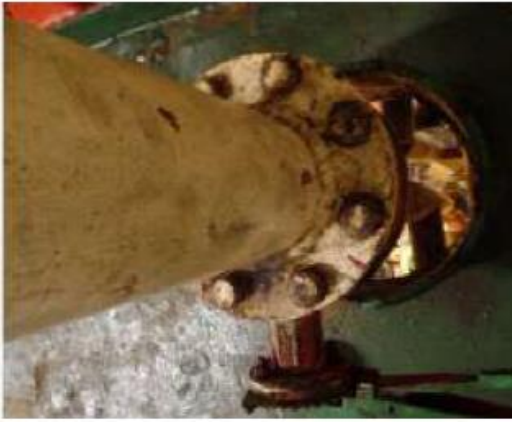
The pipe and the opening through which it had to be lowered. Two helpers were at this location. This was one deck above the fitter's location

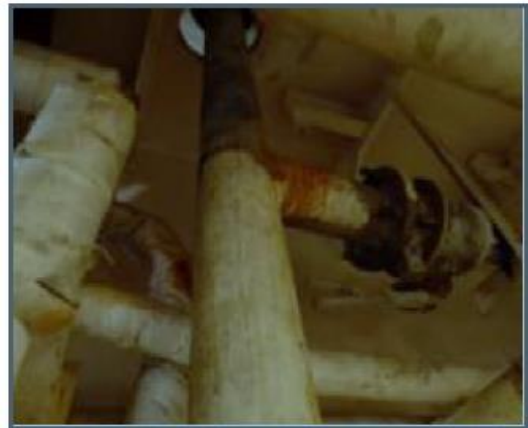
The pipe seen from the lower deck – where the fitter was working

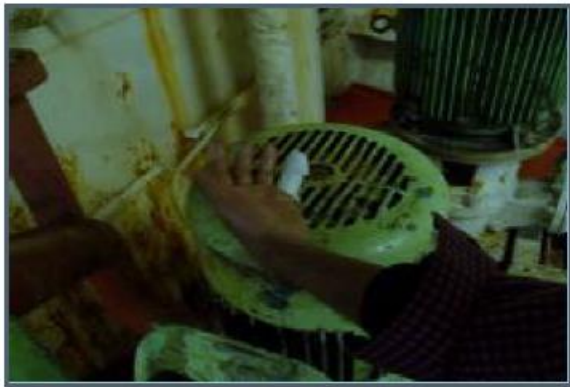
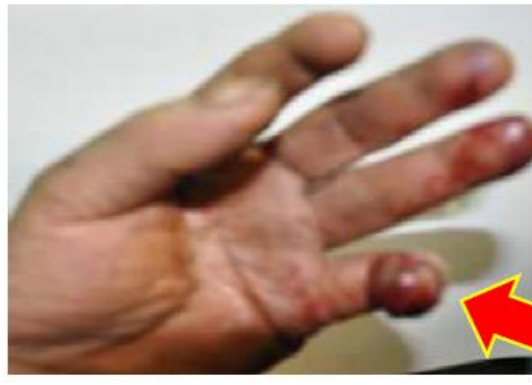
The finger got crushed between the lower end of the pipe and the motor

- ◆ Immediate cause:
 - improper use of equipment – safety rope not suitable for the purpose;
- ◆ Causal factor (management, competence or individual factor):
 - inadequate resources – additional resources not stationed in place
 - inadequate tools/equipment
 - ineffective toolbox meeting
 - inadequate supervision
- ◆ ROOT CAUSE (Inadequate system, standard or compliance):
 - Risk was considered to be tolerable – the work party considered the work to be safe. There was inadequate understanding of the risks involved.

- ◆ Ensure more effective toolbox meetings and proper understanding of risks and take actions to prevent injuries/incidents;
- ◆ A more thorough risk assessment is required for such tasks;
- ◆ Improve existing work methods – increase awareness of the problems that can occur when working in close proximity of parts being lifted or moved;
- ◆ Supervisory personnel should take extra precautions and ensure they supervise the area and job well to include everything that can possibly go wrong;

- ◆ Ensure good communication such as use of ultra-high frequency (UHF) radio, particularly when inter-dependent teams are working in different locations and are not visible to one another or cannot hear each other properly due to background noise;
- ◆ Use of correct tools/equipment for the job;
- ◆ Ensure adequate resources stationed where required.

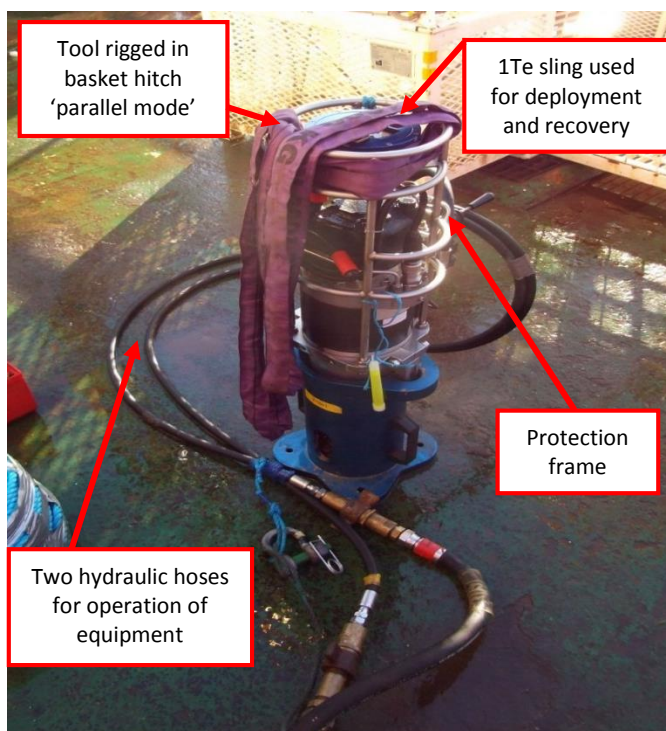
The lift was incorrectly categorised as 'straightforward'. It was covered under the generic toolbox talk and no lift plan was created. The rigging arrangement decided upon was a 'basket hitch lift' using a 1Te webbing sling which was 'snaked' through the uncertified protection frame. This rigging arrangement was not communicated to the diver, who assumed the webbing sling was choked on itself. He re-applied the sling using a single lifting eye only.

On recovery, as the torque tool cleared the 'splash zone', the webbing sling released and the tool fell back into the water. A 'freefall' of the tool was only prevented by the attached hydraulic hoses, through which the tool was successfully recovered to deck.

Showing rigging arrangement

- ◆ A review of operations to identify similar circumstances where equipment is being lifting using uncertified lifting points or where there is a failure to comply with existing lifting procedures;
- ◆ Ensuring that suitable lifting points and lift plans are available;
- ◆ Ensuring that appropriate guidelines, procedures and information are communicated to all personnel involved.

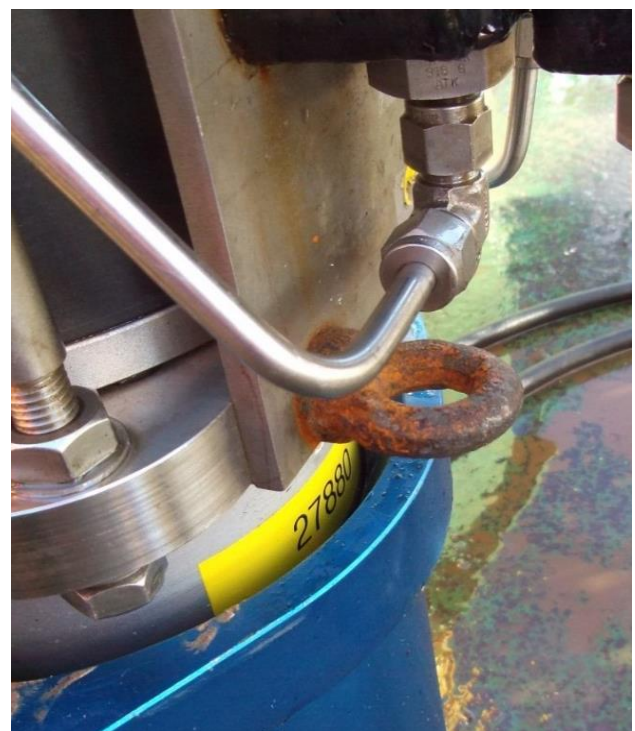
The torque tool had various items retrofitted to it by the supplier, including a protection frame and two 25mm lifting eyebolts. The eyebolts were poorly located, impacting heavily on the component parts and only one was certified for lifting. The tool was provided to the vessel without rigging or guidance as to how it should be lifted.

Showing poor positioning of eyebolts

- ◆ The torque tool was deficient in suitable and certified lifting points, but was accepted and presented for use on board the vessel. These deficiencies were sufficient for the tool to have been rejected at the time of inspection;
- ◆ A diver and unprotected subsea assets were present within the potential DROPS cone radius of 36m. Safe distances and locations for divers should be identified and complied with before lifting operations start;
- ◆ Rigging and lifting certification is not currently a core requirement for divers at this company. A review of diver related lifting operations training is being conducted to establish the rigging and lifting competency of those involved in this process.
