IMCA Safety Flash 12/16

May 2016

Summary

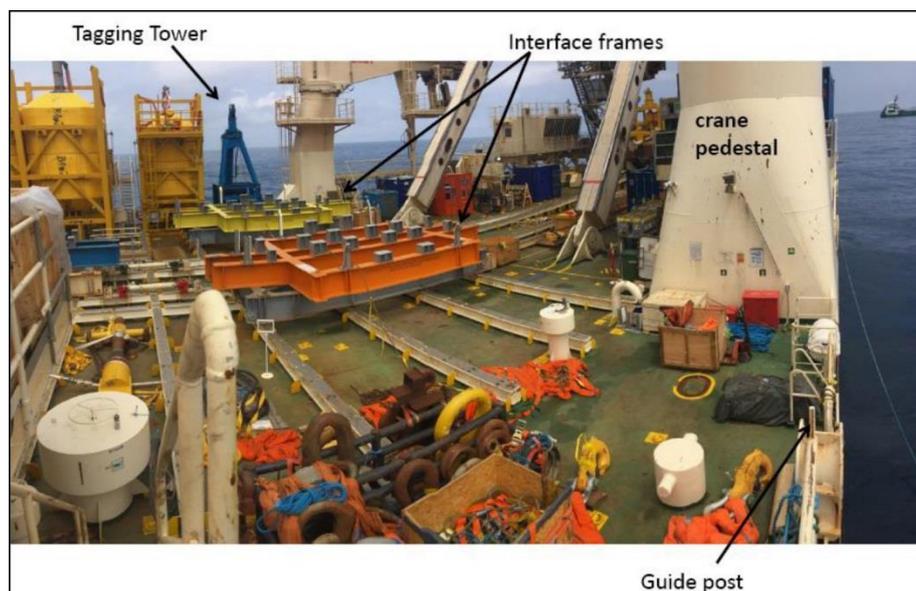
Figure: Showing worksite after incident

- ◆ Direct causes:
 - uncontrolled movement of wire when it became taut
 - injured person 'in the line of fire';
- ◆ Possible underlying causes:
 - lack of concentration or failure to pay attention to the slack of the wire at the critical moment

- the winch was at constant tension – but the tension settings and/or pressure indication were unknown until the wire went into tension
 - poor design of the winch panel: the winch hydraulic power unit (HPU) and emergency stop were initially next to the operator but had been relocated to make more space. The emergency stop was on the HPU, which was a 10m walk (not in a straight line) away from the control panel in a remote location

- the winch operator used unknown pressure to pay in, then moved the stick to neutral when he received the all stop, which applied the brake and locked the tension in the wire

- ◆ technical inspection of all the potentially impacted areas
- ◆ function test of the winch;
- ◆ review and update risk assessment;
- ◆ further appropriate training for these particular types of winches to raise awareness;
- ◆ ensure sufficient personnel are available to make any given operation safe;
- ◆ relocate emergency stop to appropriate location;
- ◆ ensure personnel:
 - ALWAYS intervene when they see an unsafe act or condition
 - ALWAYS perform a UK Health & Safety Executive (HSE) toolbox talk and work with a permit or safe system of work
 - NEVER perform tasks for which they are not trained and competent.

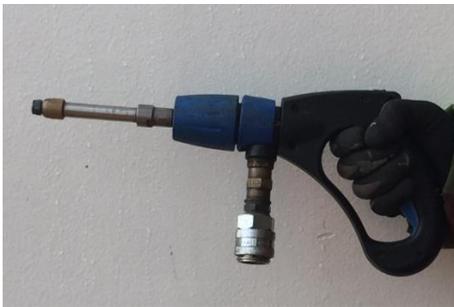
Short Lance (used for enclosed spaces)

- ◆ The AB had been holding the water jet short lance with one hand only;
- ◆ The glove chosen for the job was a simple nitrile glove with no mechanical barrier towards cut resistance;
- ◆ The manufacturer of the short lance recommended two-handed use in their own safety precautions.

- ◆ Incorrect use of high pressure washer with a short lance;
- ◆ Inadequate personal protective equipment (PPE);
- ◆ Risk assessment was insufficient and did not capture the direct risks of using this type of lance;
- ◆ There were no clear written instructions available for using high pressure washer systems.

- ◆ This incident could have been avoided with simple measures such as correct use of the tool, adequate PPE and appropriate training – as a result our member will implement formal training in the use of high pressure washers.

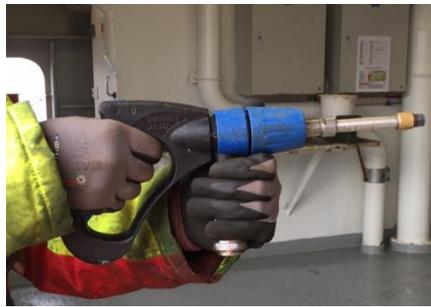
Two hand grip (as recommended by manufacturers)

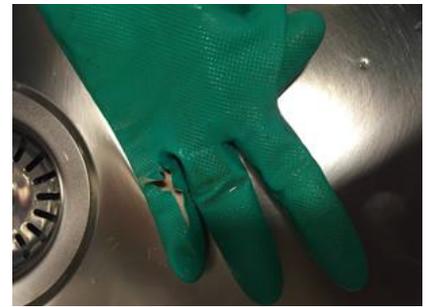
Actual glove used

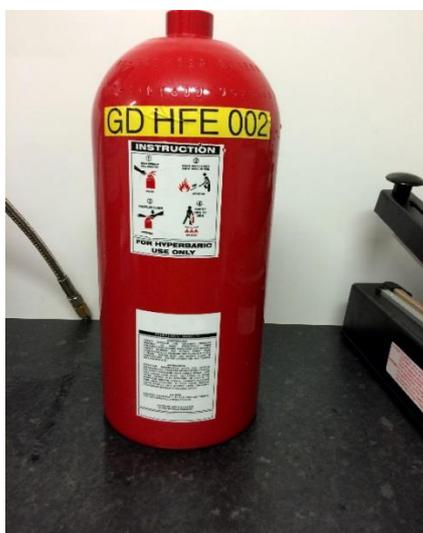
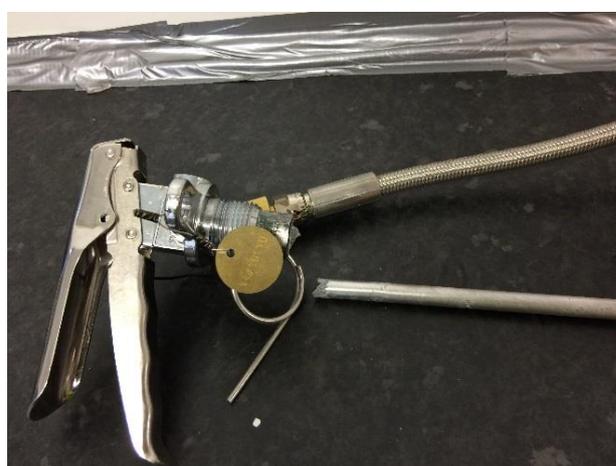
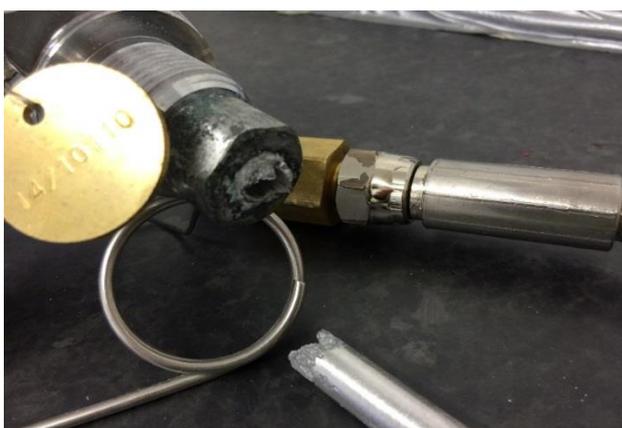
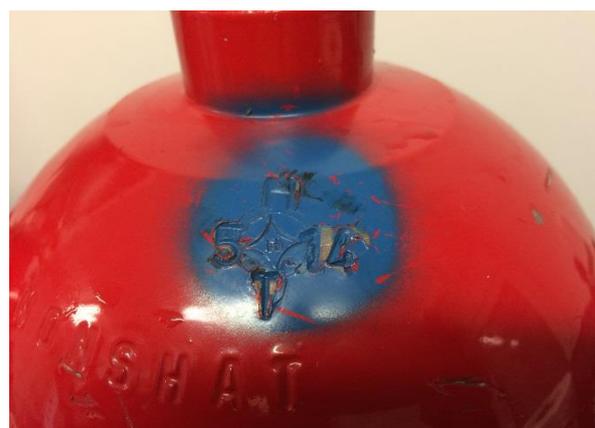
A member has reported a near miss incident in which a fire extinguisher failed due to corrosion of the internal stem. The failure was discovered during inspections of fire extinguishers during a mobilisation. Corrosion had taken place where the brass fitting connected to the aluminium stem. The extinguisher was relatively new and this was its first inspection. On removal of the pillar valve, the technician noticed an unusual amount of corrosion around the internal female brass fitting connecting the aluminium stem to the internal male thread of the pillar valve. The technician touched the stem and it fell apart at the corroded area. The internal inspection of the cylinder found that it was in good condition with no signs of corrosion.

Members are reminded of the corrosion potential with dissimilar metals, particularly in the case of pressure vessels. Our member notes that had the fire extinguisher been required for use in a hyperbaric chamber all that would have happened would have been a release of gas when operated. Our member is in direct contact with the supplier to try and resolve the issue.
