IMCA DP Station Keeping Event Bulletin 03/16

September 2016

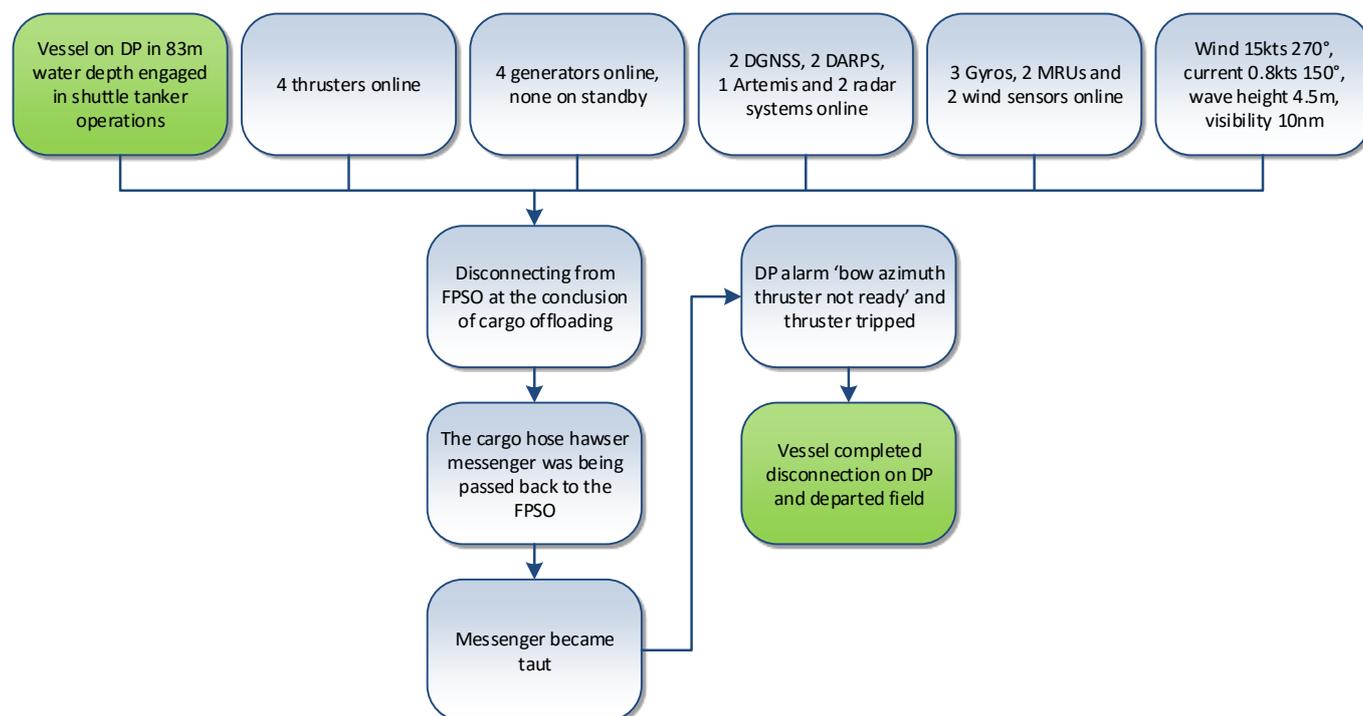
Thruster Entanglement During Shuttle Tanker Operations – DP Undesired Event

Operations were conducted according to procedures. It was concluded that the procedures for this operation needed to be modified to limit the amount of rope in the water to prevent bow thruster entanglement.

- ◆ Operations were being conducted within limits that allowed for disconnection to be completed in a controlled manner using the redundancy of thrusters.
- ◆ All vessel types are reminded to review procedures that might affect DP operations, particularly those covering downlines, hoses, ropes, etc.

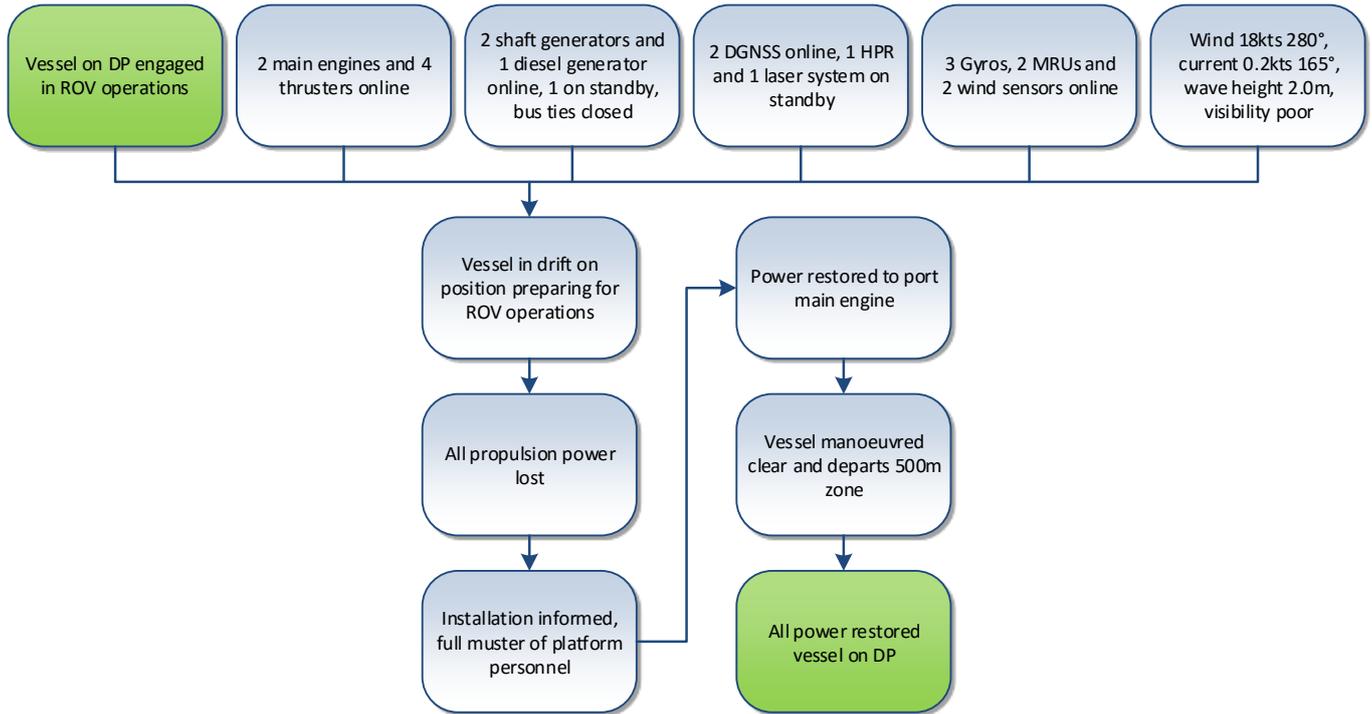
Incorrect Wiring Causes Loss of all Propulsion – DP Incident

- ◆ **What went wrong?** Through extensive evaluation by numerous technicians, the main cause of the incident was found to be the improper wiring of the main and backup power supplies. Three engines were electrically connected through the DC40 main power supply. This enabled an erroneous shut down signal to be sent to three engines simultaneously.

- ◆ **What were the causes of the incident?** There was a fault in the wiring configuration of the vessel's main engine 24VDC supply. The wiring for the main power supply and the backup power supply was reversed which tied the two main engines to the same main power supply, thereby reducing vessel redundancy. Furthermore, a ground fault was identified on the main 24V supply to the main engines. Subsequent testing revealed the diesel control units (DCU) responded differently when subjected to grounding tests; the port main engine would continue running while the starboard main engine would shut down.

- ◆ **What lessons were learnt?** This misconfiguration, and subsequent loss of DP redundancy, was unknown to the crew. The wiring of the vessel's main engine 24VDC supply had been completed prior to the current management company assuming management of the vessel. This incident further stresses the importance of a maintenance programme and complete maintenance records.

Several changes were made to the vessel's systems such as the replacement of the governor, DC40 battery supply and the starboard DCU and all was tested to satisfaction. To ensure the matter has been completely rectified, the vessel was subjected to a full five-year FMEA.

- ◆ This incident stresses the importance for a good initial FMEA, the tracking of modifications and ensuring documentation is up to date, plus the importance of proving redundancy groups on a frequent basis.

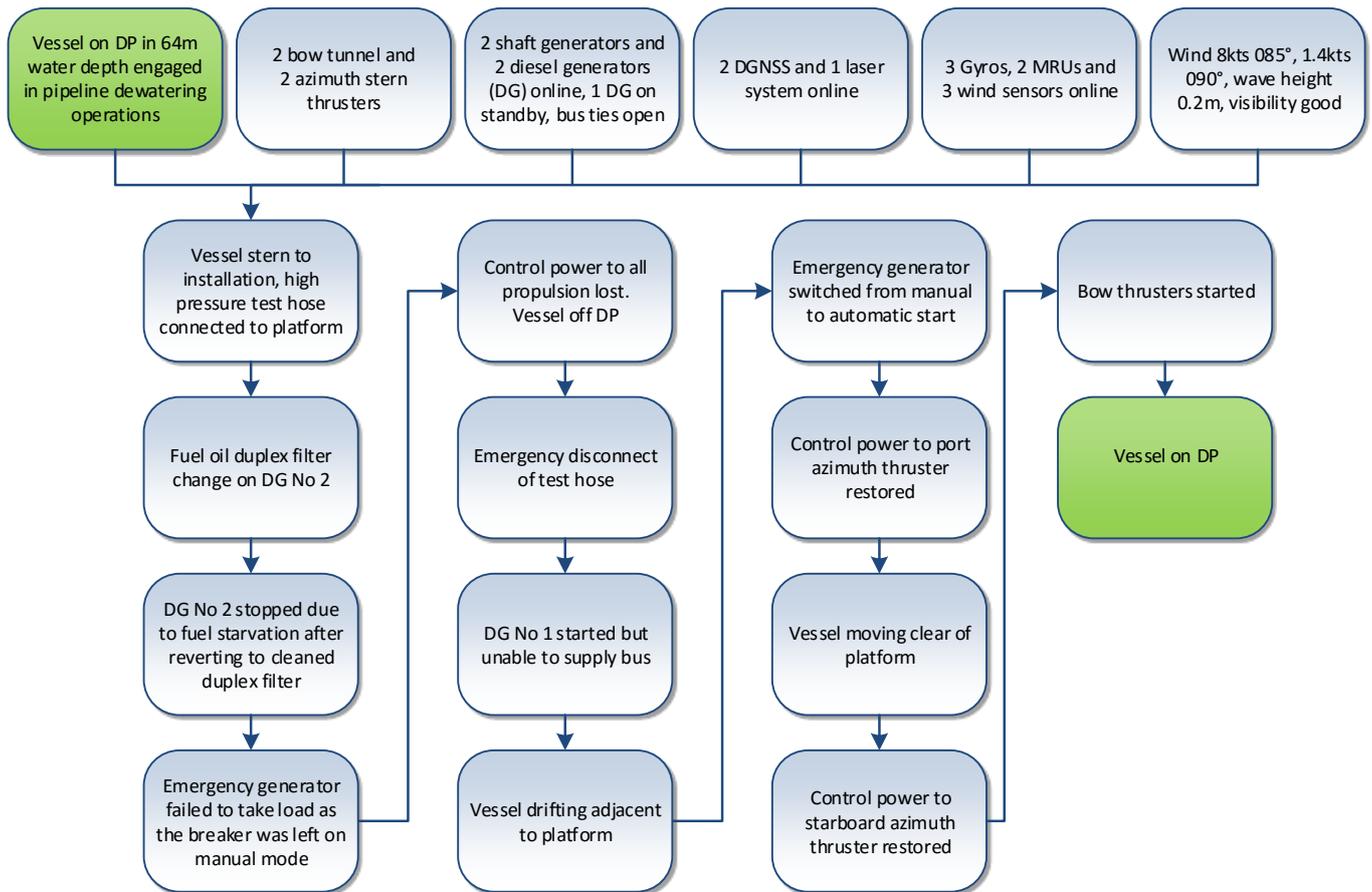
Fuel Oil Filter Change Leads to Generator Failure – DP Incident

During routine rounds the engine room watchkeeper decided to replace the left filter of the duplex fuel oil filter of DG No 2. This generator was part of the port redundant system and supplied power to the 415v and 220v bus A and emergency switchboards. DG No 2 suffered a blackout due to FO starvation after the filter was changed and as a consequence of incorrect operation of the duplex fuel filter. DG No 1, which is also part of the port redundant group, was started, however it was unable to supply power to the bus. The emergency generator did not connect to the bus bar as the breaker was left in manual mode therefore losing power to bus A and the emergency bus bar. At this juncture batteries should take the load for control power of DP essential equipment, however the batteries were drained.

The failure of the port redundant group should not have resulted in the loss of all propulsion control power as there was no failure on the starboard redundant group. However, this was not the case because there was a design fault such that the 220v AC and 24v DC systems providing control power for all propulsion was from the port redundant group only.

The vessel is five years old and this design fault was not captured in the FMEA or annual DP trials. The last annual DP trials was conducted less than three weeks prior to the incident.

- ◆ No maintenance to be undertaken on any active or passive DP component whilst working within the 500m zone of an installation.
- ◆ Switchboard setup was permanently modified so that propulsion control power was supplied from different redundant groups.
- ◆ Switchboard setup to be verified by two separate watchkeepers.
- ◆ Regular DP blackout drills to be instigated.

- ◆ Regular switchboard setup training to be conducted.
- ◆ Battery checks and testing routines improved.
- ◆ Company test and trials programmes reviewed and updated.

- ◆ This incident again stresses the need for a good initial FMEA, tracking of modifications and ensuring documentation is up to date, plus the importance of proving redundancy groups on a frequent basis.
- ◆ Vessels must operate a robust permit to work system.
- ◆ The importance of using correct and concise DP checklists for both engine room and bridge.

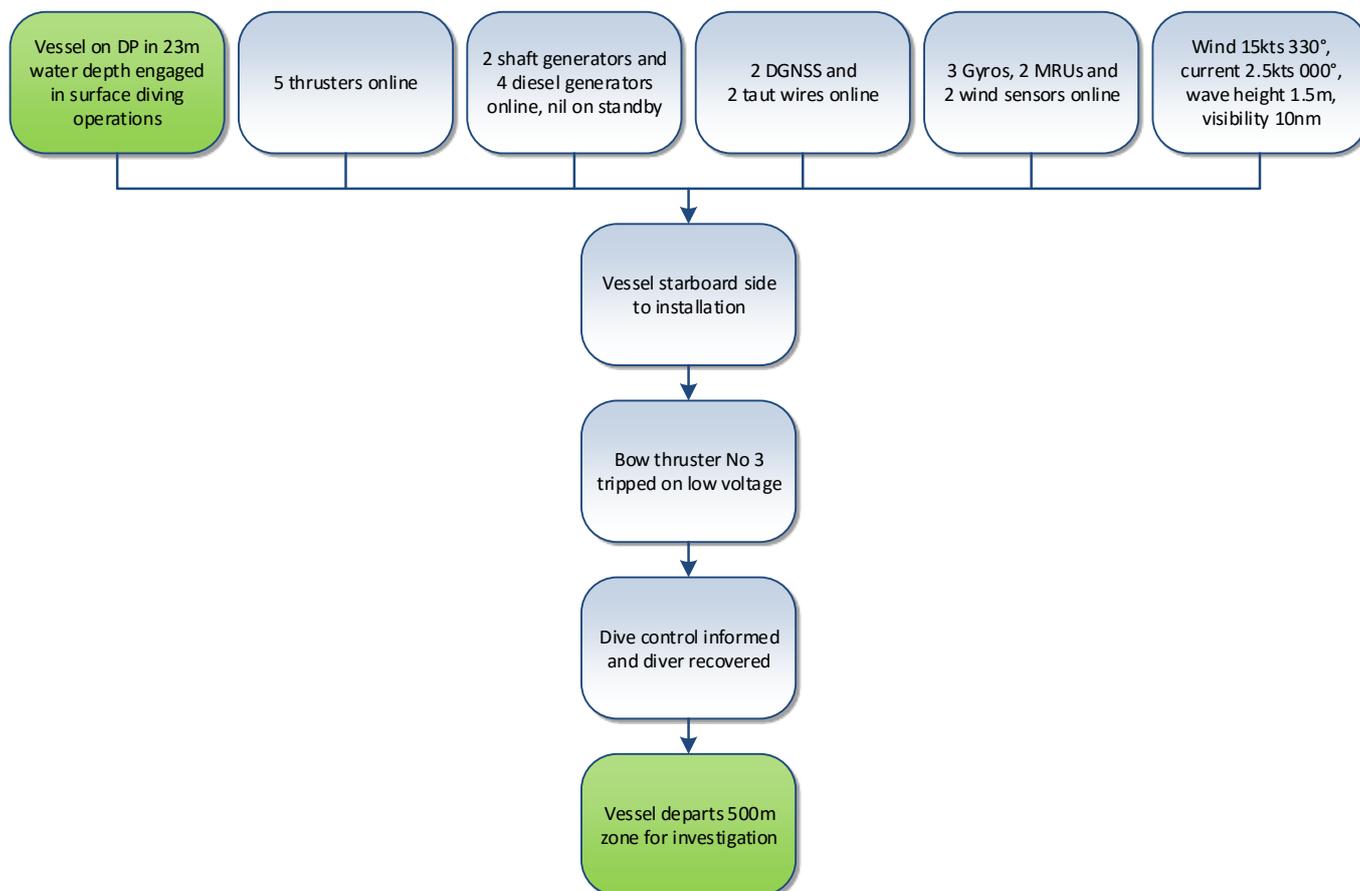
Bow Thruster Tripped Due to Lack of Power – DP Observation

The seat for the stop solenoid on the port main engine was damaged causing a slight air leak past it, this acting on the stop cylinder piston caused a reduction in main engine rpm. The reduction in rpm caused a low voltage alarm followed by breaker trip and low frequency alarm. Power was lost to bow thruster No 3 due to a breaker trip on the switchboard, the port azimuth thruster was not affected as the clutch out rpm was not reached.

- ◆ The vessel did not appear to reach its worst case failure (WCF) and although DP redundancy was effective precautionary measures were initiated.

The vessel has reduced the inspection interval of the stop solenoid valves from annual to six months.

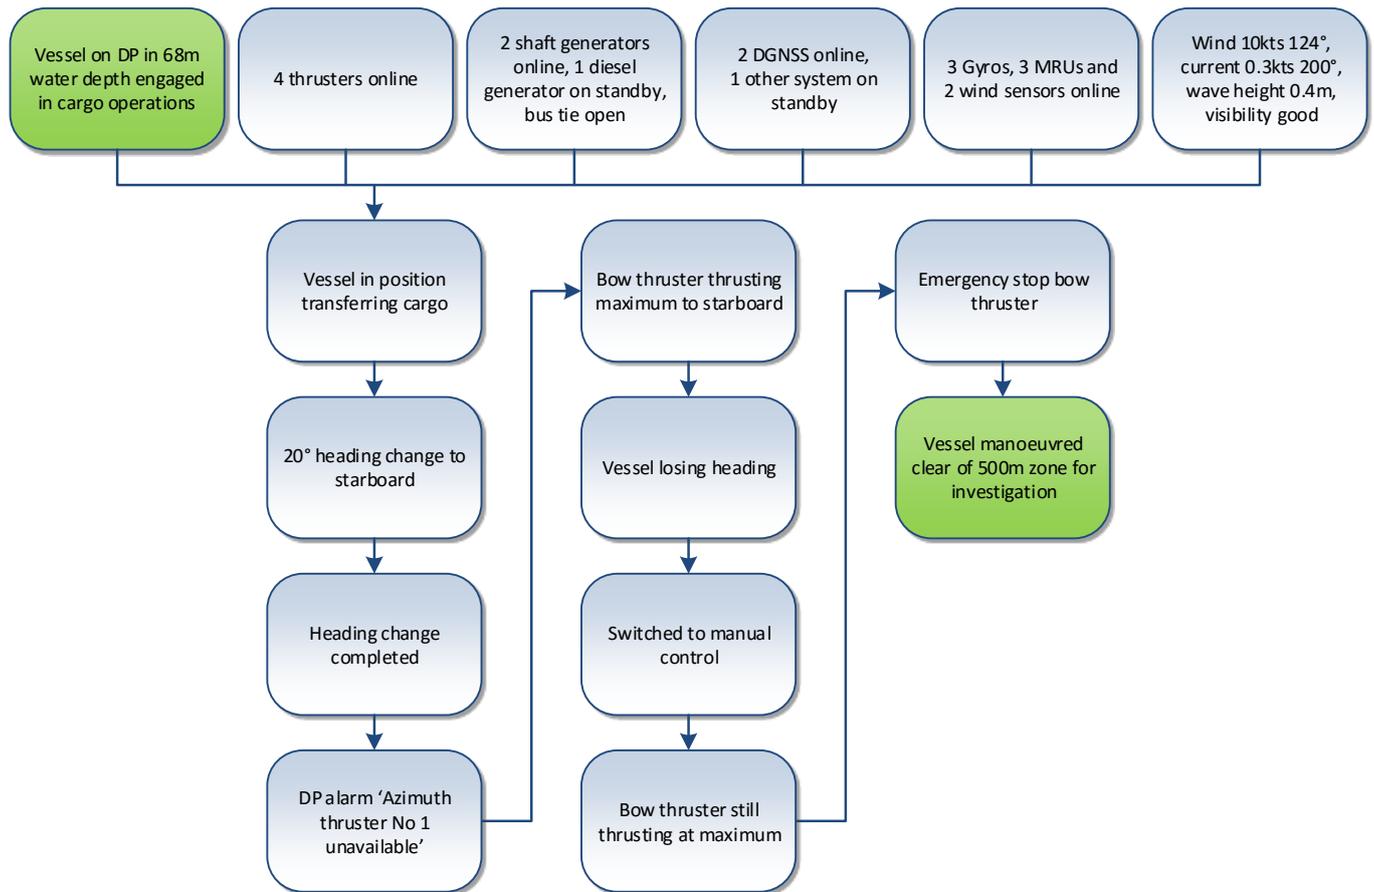
Separate Problem with Two Thrusters Caused Loss of DP – DP incident

The bow thruster gave an alarm that pitch was at maximum showing 114% on DP display. Investigation concluded that the full starboard maximum limit command/set point of the bow thruster proportional valve had been adjusted to 70%. During maximum pitch request the valve had to be permanently opened with constant and continuous hydraulic oil flow through the proportional valve. It was concluded that because the valve direction flow was set at 70% this resulted in the valve's malfunction and pitch stuck at maximum. It was later discovered that the azimuth thruster tripped because of sea water contamination of the gear box oil.

- ◆ Consideration should always be given to making heading changes in incremental steps, a heading change of 20° in one step during critical operations is not recommended.
- ◆ To stop adverse thrust from a rogue thruster it must be shut down and not just deselected from DP control.
