## IMCA Safety Flash 26/16

October 2016

### Focus – Stored Energy/Trapped Pressure

#### 1 Near Miss: Release of Trapped Pressure After ROV Dive

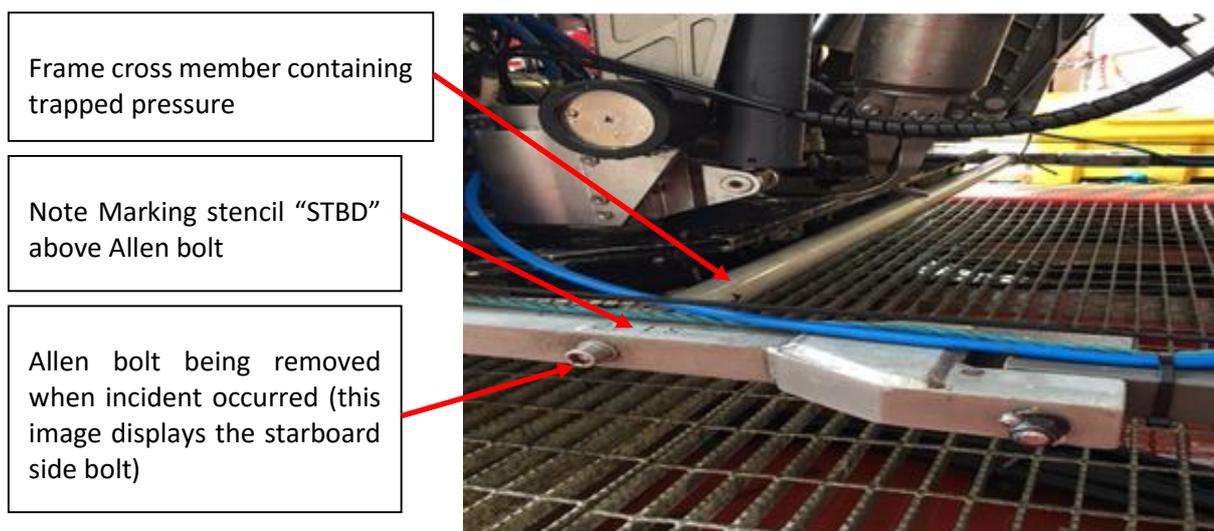
A member has reported an incident in which there was an unplanned release of trapped pressure from part of the tooling frame under an ROV. The incident occurred when it was noted that the frame was not deploying correctly and was slightly twisted. Upon investigation the coil mounting frame had been fitted upside down. The crew began to remove the cross member using an Allen key to separate the frame into two sections for removal and to ease the handling during the turning over portion of the task.

Upon the first quarter turn of the port side Allen bolt, a hissing noise was heard. The supervisor immediately evacuated the area and had it barriered off.

#### Causal factors:

- ◆ The frame was manufactured on the vessel;

- ◆ The potential for trapped pressure had not been identified;
- ◆ The frame had been incorrectly fitted.

The system was left to bleed down naturally. The risks of the job were re-assessed and additional personal protective equipment (PPE) was identified for further work in removing the frame.

The following **actions** were taken:

- ◆ An engineering solution was identified to prevent possibility of trapped pressure – holes drilled in cross member;
- ◆ Safety flash issued;
- ◆ Other similar systems checked and modified as required;
- ◆ Clear markings applied to ensure correct frame orientation.
