IMCA DP Station Keeping Event Bulletin 04/16

November 2016

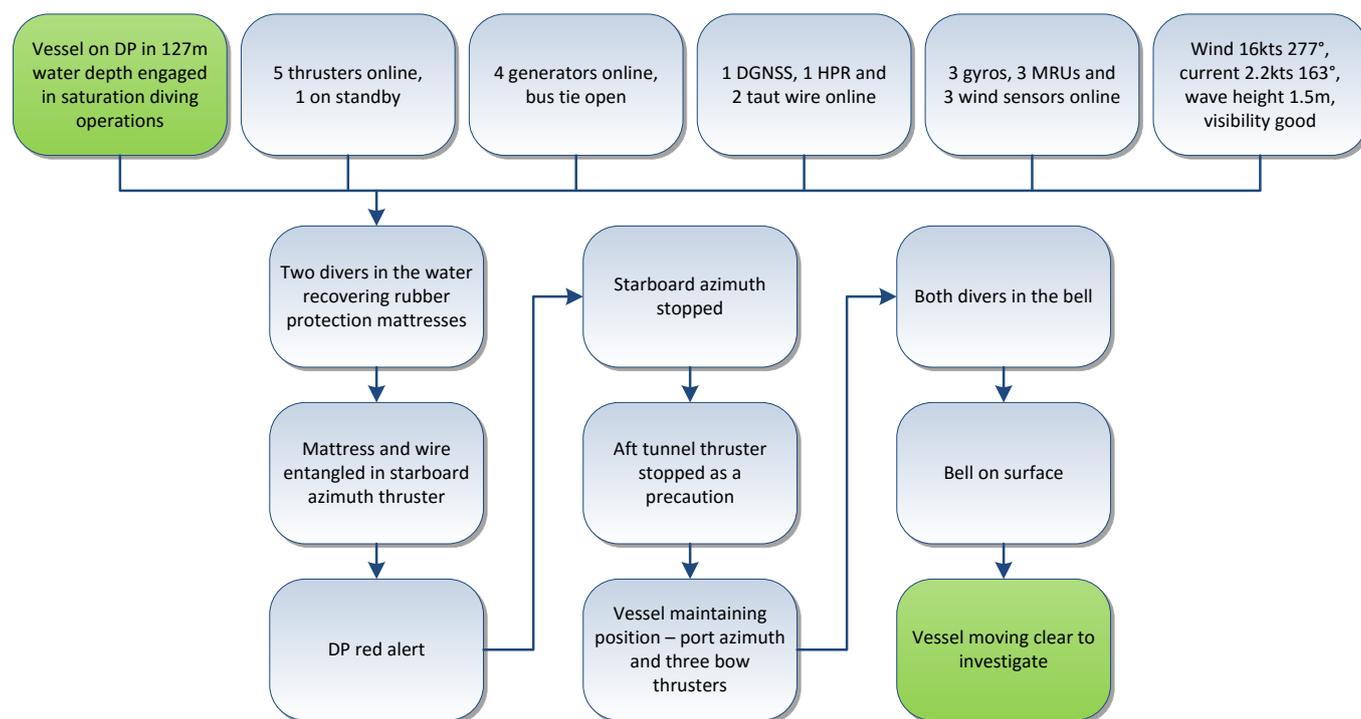
Non-Routine Lift Leads to Thruster Incapacity – DP Undesired Event

The vessel maintained position throughout. The lift had not been properly planned or risk assessed for the object being lifted. There was a failure to recognise that the mattress was not a routine lift. A generic lift plan was used which did not cover this specific lift.

- ◆ Danger of recognising an operation as routine, when it isn't, and therefore using inappropriate standard procedures and risk assessments;
- ◆ A situational awareness of the whole operation, involving all departments, is required;
- ◆ Was there pressure to perform the task on an inappropriate vessel heading?
- ◆ One thruster was on standby – if the lift had been identified as non-standard then possibly all thrusters would have been online;
- ◆ DP red alert was used by the DP operator (DPO), although redundancy had not been compromised. It is unknown whether this was in line with the activity specific operating guidelines (ASOG), however the DPO considered that the event had potential to escalate and therefore decided to initiate red alert.

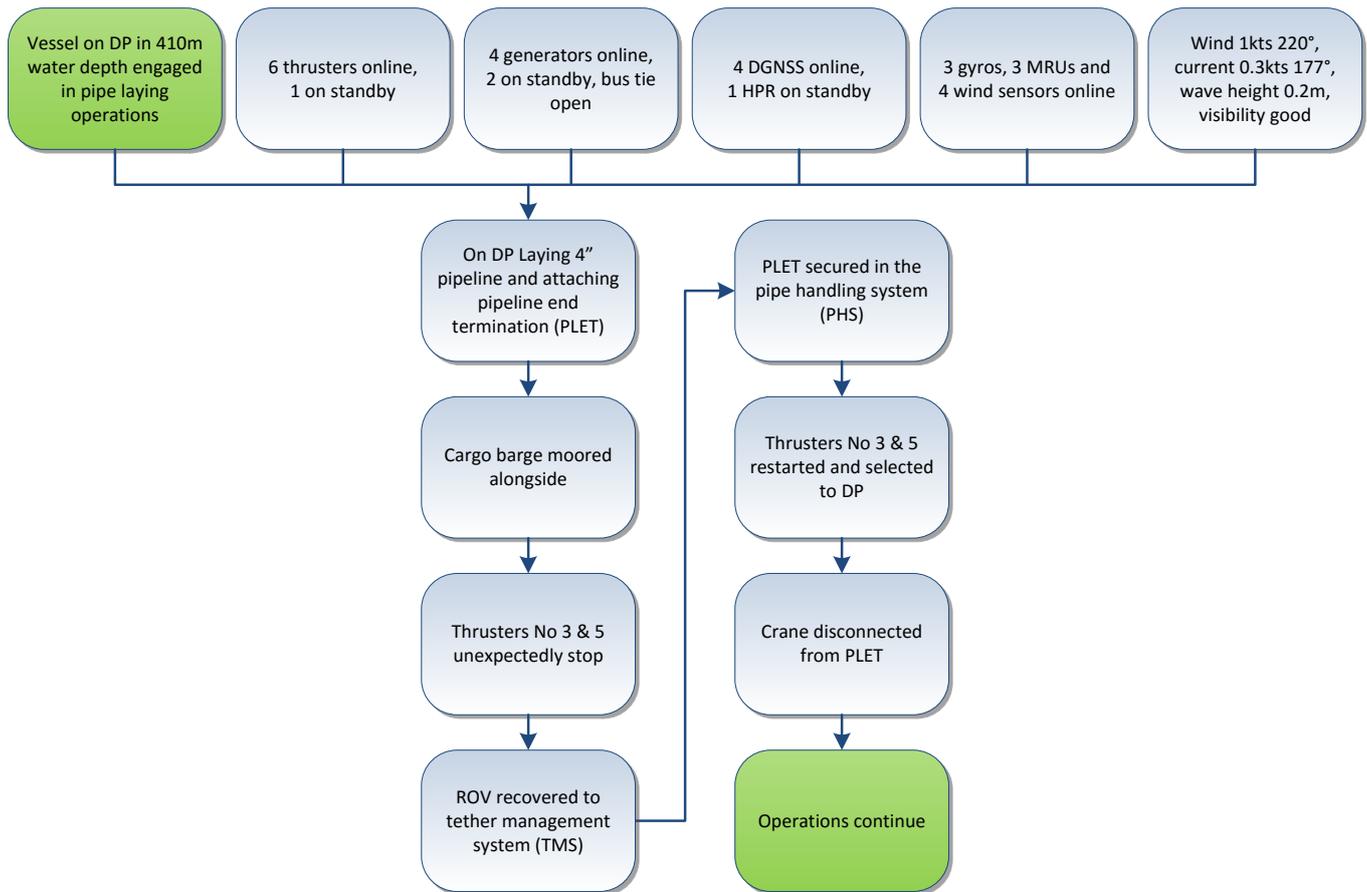
Pipelaying Equipment Short Circuit Causes Thrusters to Trip – DP Undesired Event

The vessel maintained position throughout. The ROV was restricted to the tether management system (TMS) until the vessel was confident of the cause of the thrusters' unexpectedly stopping.

All damaged sections of the 'lay spread' DC bus bars which fed in to the spare drive section of frame A were removed from service and all cabinets cleaned and dried out with air driers. Blown fuses were replaced; the vessel was confident that the fault was localised to the bus bar, and not the connected equipment. The set point of the air conditioning unit was adjusted from 21°C up to 28°C and signage placed on the AC units stating 'Not to be adjusted'. All external doors have been closed and signage placed on the doors stating 'To be kept closed at all times'.

- ◆ The DP system was configured for open bus tie operation;
- ◆ Pipelaying (project) equipment should be on a separate switchboard to critical DP auxiliary equipment;
- ◆ Ideally, main and standby equipment should be fed from separate switchboards;
- ◆ Four DGNSS were online – this is contrary to International Maritime Organization (IMO) DP equipment class 2 requirements of requiring three position reference systems of which at least two should operate on different principles.

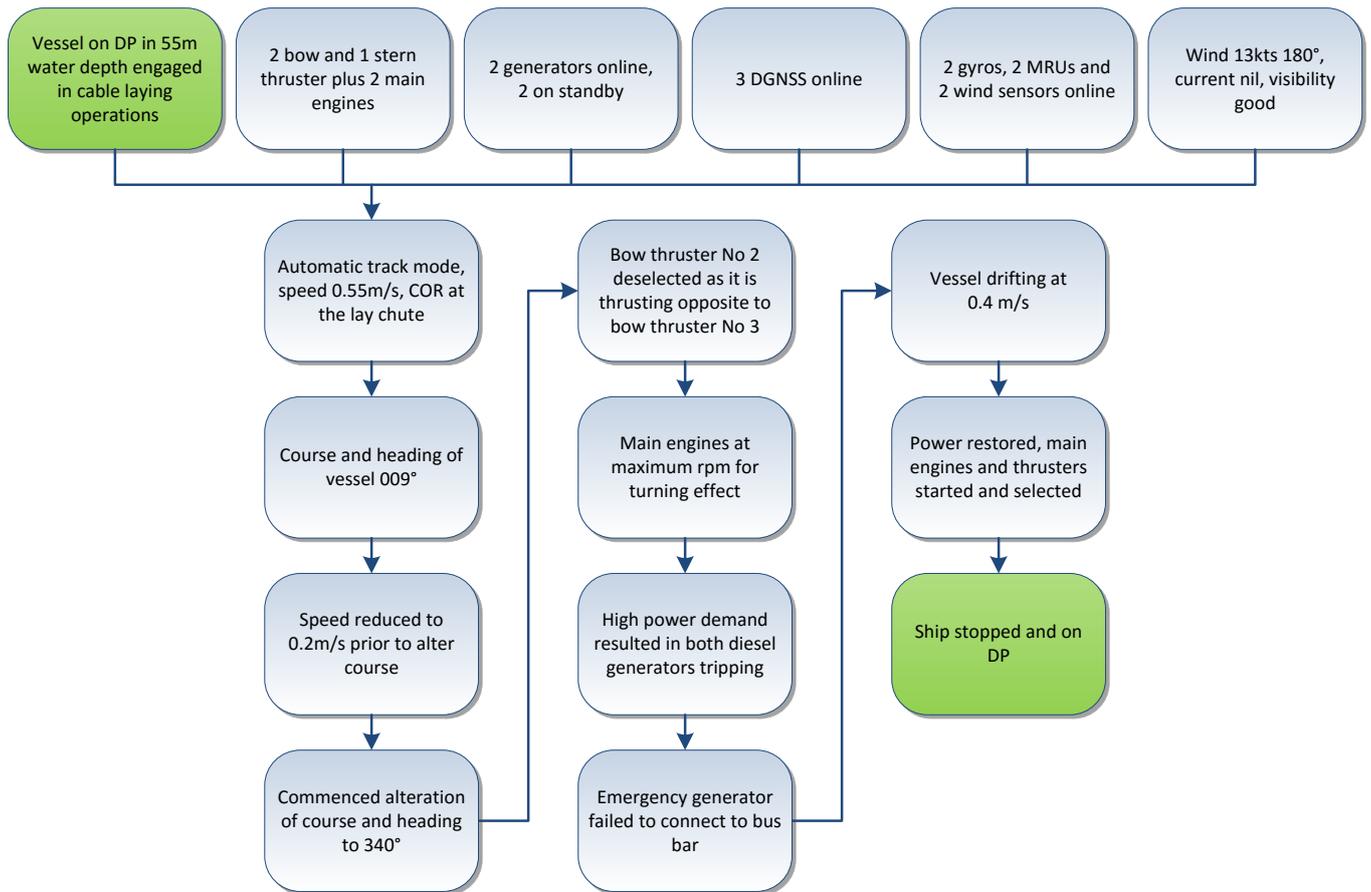
Alteration of Course with COR Offset Causes Loss of Power – DP Incident

The report discussed the set-up and mode selection for the thrusters and main engines during high power manoeuvres such as alteration of course and heading. The vessel standing orders were changed accordingly. Investigation as to why the emergency generator did not connect to the bus bar and therefore aid black out recovery was ongoing.

- ◆ The DPO should be aware of the vessel's DP capability taking into account the environmental conditions and in this case the additional thrust required by the centre of rotation (COR) being set at the lay chute;
- ◆ It was not clear whether the rate of turn could have been adjusted to reduce thruster demand. Considering the COR was set at the stern, it should have been set at a low rate;
- ◆ Was the power management system set up correctly as it should have reduced power demand by activating non-essential tripping as part of black out prevention?
- ◆ It should be questioned whether stopping thruster No 2 contributed to the incident as it may have been reacting as required;
- ◆ What was the problem with the set-up of the emergency generator, was it available for manual start only?
- ◆ Stresses the importance of the technical crew being adequately trained to deal with a black-out event.

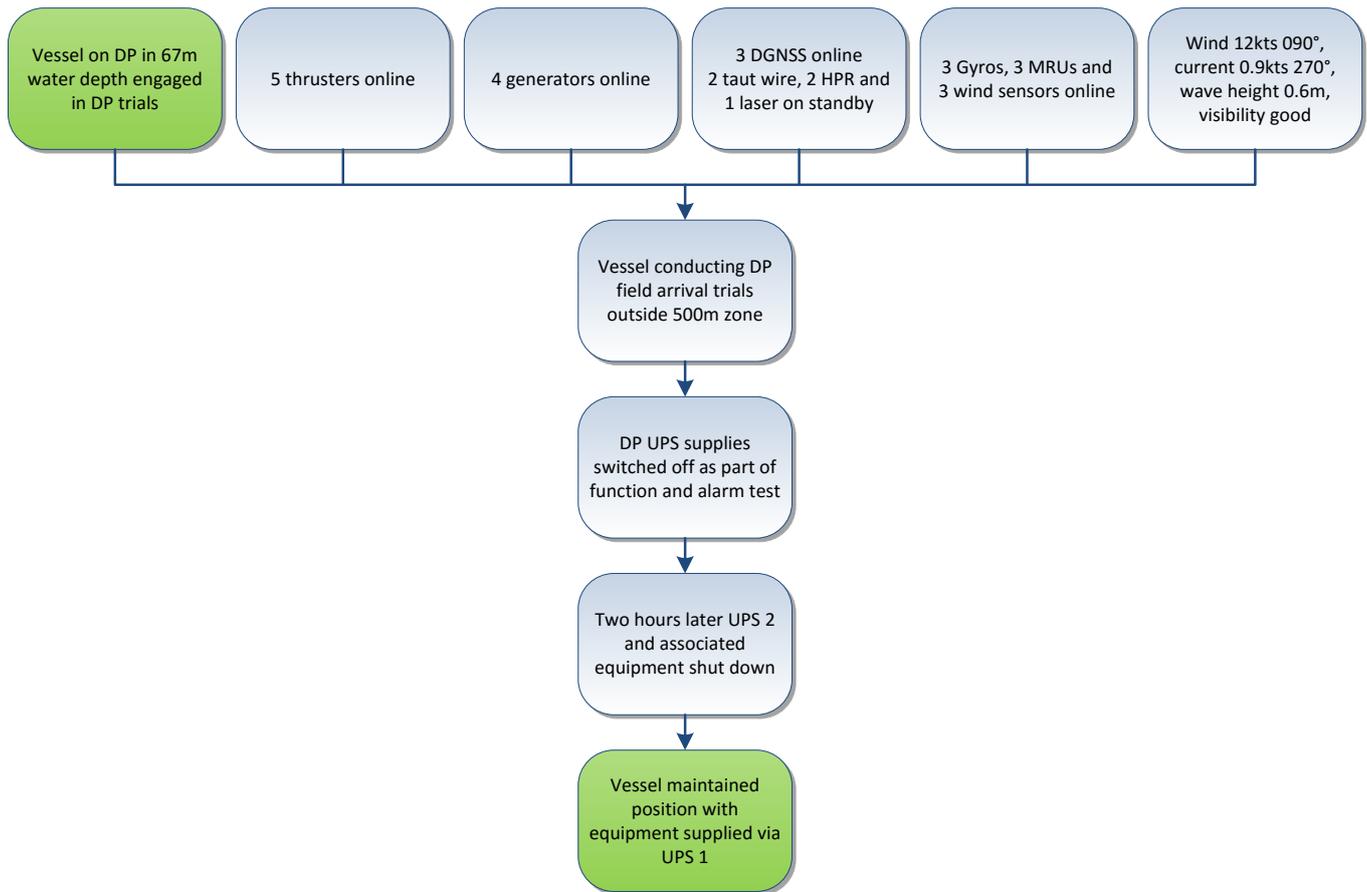
DP Trial Leads to Partial Blackout – DP Undesired Event

It was discovered that the 230v supply breaker was open and the uninterruptible power supply (UPS) 2 batteries completely discharged. Warning alarms generated by the DP system regarding the condition of UPS 2 were overlooked. An additional checklist item was added to the field arrival trials to check UPS 1, 2 and 3 are clear of alarms and operating as normal. Vessel maintained position throughout.

- ◆ The lessons to be learnt from the above are obvious and barriers preventing such errors are essential;
- ◆ Alarms presented to operators must be acknowledged and acted on.

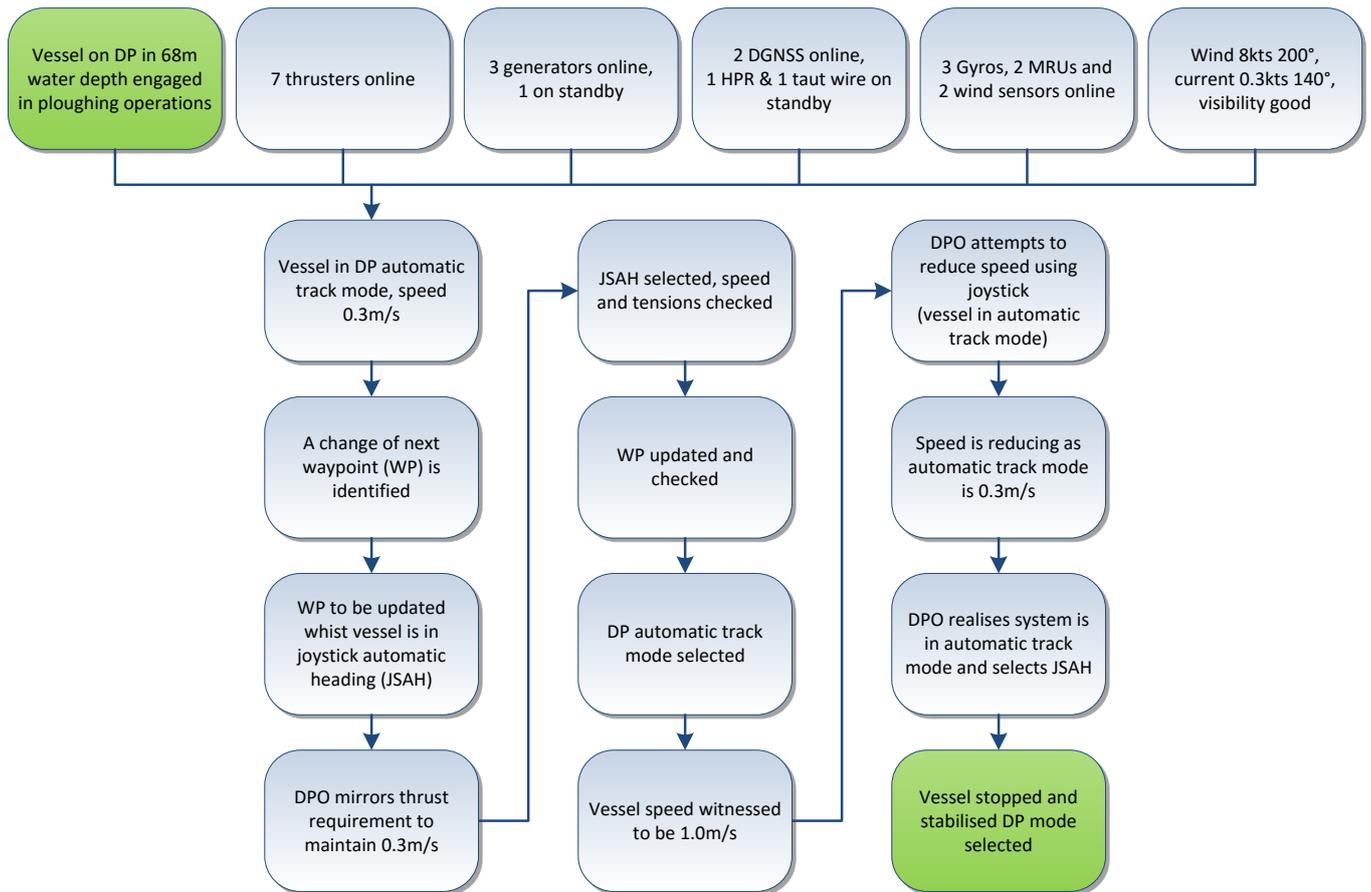
Procedures for Ploughing Using DP Discussed – DP Observation

The report concluded that the DPO was conducting too many concurrent tasks so that he did not sufficiently monitor the vessel speed during the time the vessel was being controlled with JSAH. Further to this, company procedure/standing instruction have been changed so that changing the position of the targeted waypoint can be avoided except in the most necessary of cases. If it is found necessary to change the waypoint position, then the ploughing operation should be temporarily suspended by stopping the vessel and selecting automatic DP.

- ◆ It would be of considerable benefit if plough pulling forces, which can vary greatly, were fully integrated to the DP. It is not clear if this was the case and whether the direction of forces was interfaced;
- ◆ It appears that a proper evaluation of the operation was not made: familiarity of the system is required together with adhering to company procedures;
- ◆ A proper understanding of the relationship between position reference systems and forces is required;
- ◆ Consideration should have been given to reduce speed to the operational minimum, the slower the progress of the plough the less effect it will have on the vessel's positioning capability, as inertia becomes less effective.
