IMCA Safety Flash 09/17

May 2017

Theme: Safety in Diving Operations

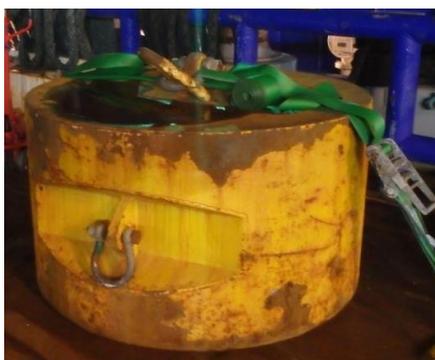
DMA as identified in procedures

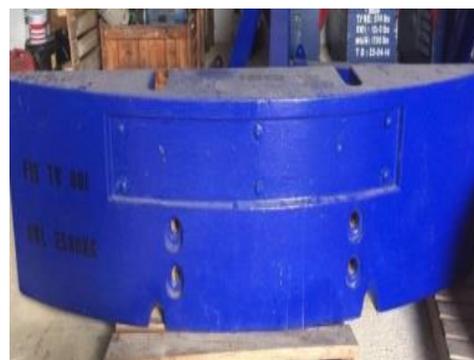
DMA3 that toppled over

- ◆ DMA3 that toppled over (blue DMA, right hand image) was different in weight and design from the one required in company procedures;
- ◆ DMA3 had a very narrow footprint and tall body with a high centre of gravity, making it unstable and unsuitable for rigging under tension and deploying in an upright position;
- ◆ The dive plan identified deployment of a 10te DMA (yellow DMA, left hand image). However, the team decided to use the one deployed by the 3rd party vessel;
- ◆ Whilst this was convenient, no check was made to ascertain whether or not it was fit for purpose;
- ◆ No management of change (MoC) process was initiated, and the risk of this DMA toppling was not identified.

- ◆ DMA3 was procured and sent offshore [by others] for another task. It was identified subsequently that DMA3 was in fact a crane counterweight and was not the most suitable piece of equipment for the task it was being used for;

- ◆ The lifting points on DMA3 were located on the top of the weight and it could only be deployed in the vertical position, offering a small footprint and high centre of gravity;

- ◆ DMA rigging to be altered to allow divers to be outside of the DMA footprint;
- ◆ Appropriate review of company documentation and procedures (to include DMA design specification and diver positioning) and also of the MoC process;
- ◆ Information sharing – video footage and details to be shared for training purposes.

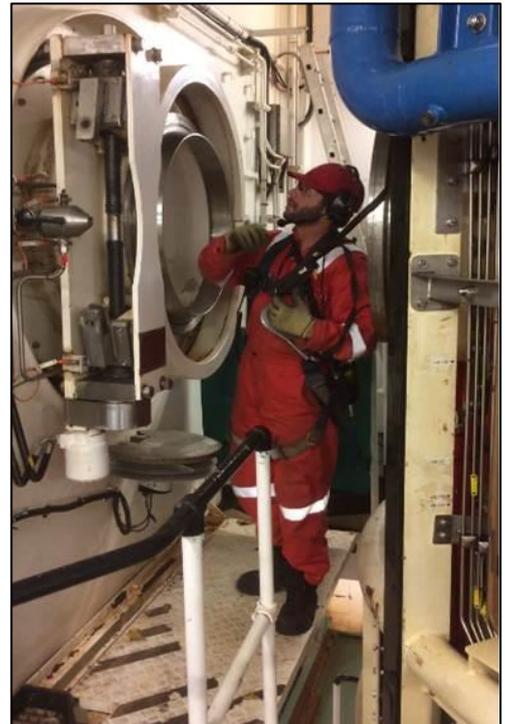
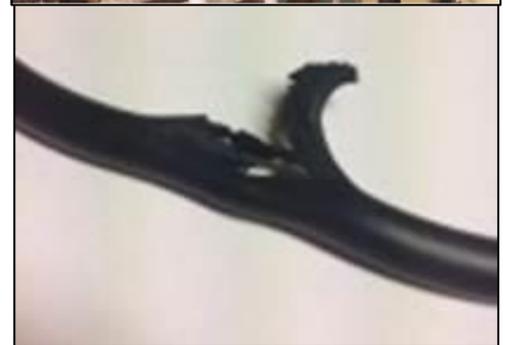
When the bell was trolleyed back and access platforms raised to access the sealing faces, the O ring seal was found to have been damaged. The O ring had become displaced prior to the bell mating, and a section of the O ring had come out of its groove. When the bell was mated, the O ring prevented the two faces from coming into correct alignment and the clamp would not close fully to allow the interlock to engage. During repeated clamp closures, the O ring was damaged but pushed back into the groove and until the clamp closed fully and the interlock engaged. The subsequent pressurisation procedure proved there was a leak past the O ring and the bell mating was ceased and the leak investigated.

The incident was caused by the damage to an O ring which had become misplaced. The O ring seal had not been fully inspected either by sight or touch before the bell lock off and reconnection, and this misplacement had not been identified.

- ◆ Lesson: Bell mating flanges and seals should be inspected between every bell run to ensure they are in correct location and in good condition;
- ◆ Actions taken:
 - a process is now in place requiring the inspection and recording of the bell mating flange faces and seals;
 - access has been improved to carry out this task without the need for specialist work methods and associated personal protective equipment (PPE).

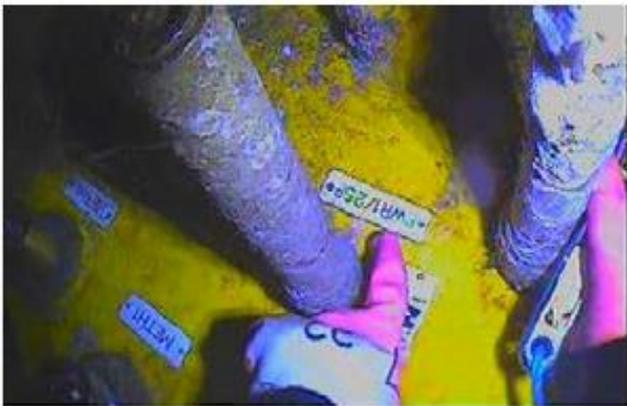
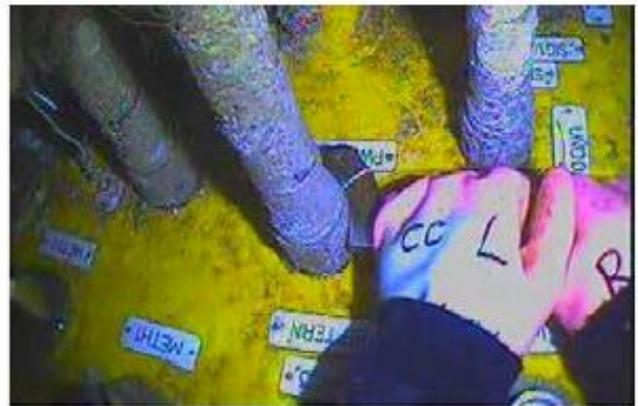
Initial attempt to remove correct Tronic unsuccessful

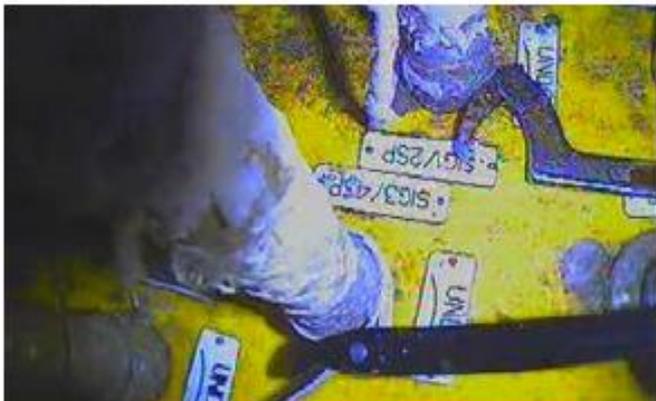
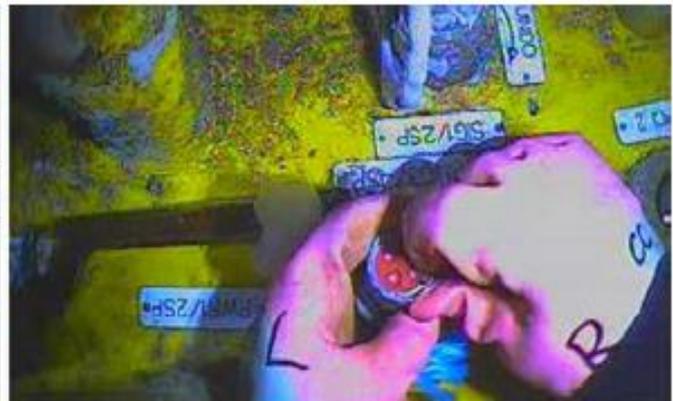
Incorrect Tronic removed and cleaned

The mistake was noticed while preparing to connect the jumper to the wrong port as the colours did not match. The job was immediately stopped and a "Time Out For Safety" held, before retracing the steps and continuing with the correct Tronic connector.

- ◆ Increase focus/attention in setting up for worksite identification;
- ◆ Procedures and task plans should include steps to positively identify and mark the specific item to be worked on;
- ◆ Dive Supervisors should ensure the specific item to be worked on is positively identified and appropriately marked for intervention;
- ◆ Should the worksite be left, even momentarily, the item to be worked on should be reacquired and again positively identified before work resumes.

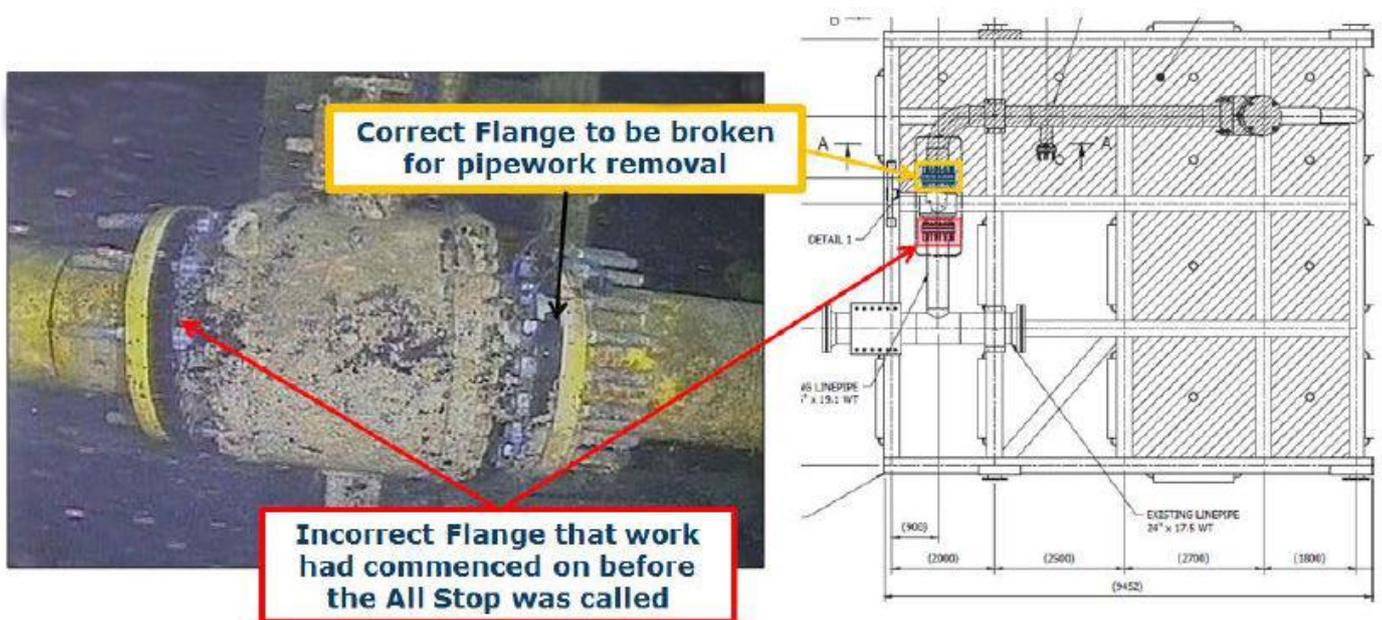
Planned operations for removal of a section of pipework from a flange took two dives. The section to be removed was correctly identified during Dive number 1, but after bell turnaround and the meal break, during Dive 2, the incorrect flange was identified and the wrong bolts were removed.

After several bolts had been removed, the Dive Supervisor called an “All Stop”, as it was identified that work was being conducted on the wrong flange. A “Time Out for Safety” was called to discuss actions already taken and to agree the further actions needed. At no time were the divers or equipment at risk as the Pipeline End Manifold was shut down.

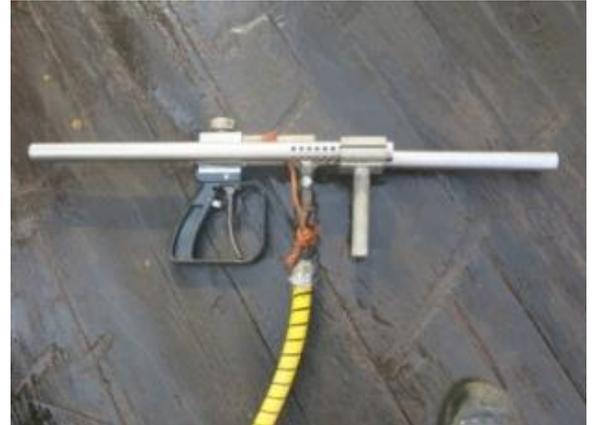
During diving operations to clean a riser with a HP water jet type *Cavitek*, a diver cut his leg (thigh) with the water jet.

The incident occurred whilst the diver was not properly secured during the cleaning operation. The diver should always be comfortably and securely positioned during HP water jetting operations. It is especially important to ensure that this is so during mid-water work, otherwise there is a greater likelihood that the diver may lose control of the trajectory of the jet stream during jetting operations. The likelihood of such an event will also be increased if the retro jet and forward jet on the gun is strongly unbalanced.

Our member notes that there was an incorrect calculation of the HP hose length needed for this job. The minimum length of hose required per jetting gun unit is normally considered to be 1.5 times the maximum anticipated working depth. The length of the hose should not impact upon the comfort and security of the diver during HP water jetting operations.

The length of the waterjet lance may not have been appropriate (too short). The inherent potential for accidental self-injury during use of high pressure jetting guns increases as the length of lance (barrel) decreases.

- ◆ Before water jetting operations:
 - ensure proper and dedicated tool box talks are held
 - ensure there is a full assessment of risks and needs at the work area
 - check the required length of hose;
- ◆ When cleaning vertical parts of structures in mid-water divers should be rigged to be stable and comfortable for jetting operations;
- ◆ Check that the gun is appropriately designed, properly balanced, well-maintained and fit for purpose;
- ◆ Ensure the diver holds the gun with two (2) hands;
- ◆ Stop/release the trigger before each movement.
- ◆ Ensure regular communication from the diver to the dive supervisor about the situation at depth;
- ◆ Remind the dive team of the importance of good communications and **consistent observance of safe working practices**.

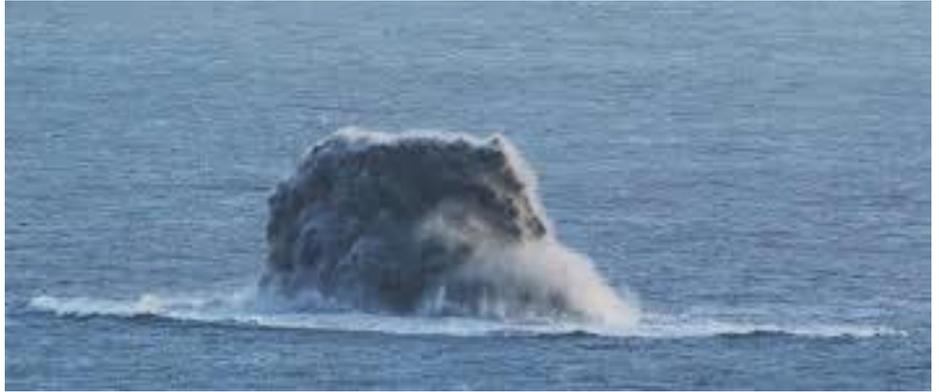
A member has reported a near miss incident in which there was an unplanned release of gas from a subsea pipeline, when divers were working nearby. A vessel was engaged in connecting a 32" (81cm) spool to the pipeline with the vessel crane connected to the spool. Divers were in the bell for changeover of shift. Suddenly there was a release of gas near to the vessel. The Master took immediate action and moved the vessel 150m out of the area; the clearing crane wire was slacked off, and at a safe distance when no bubbles were observed in the water, the ROV was launched. The ROV went to the crane hook location, and the crane hook was released safely. ROV and crane wire was recovered without any damage to any property. The divers were unharmed.

- ◆ An energy isolation permit was in place which was issued by the refinery and platform;
- ◆ The refinery failed to inform the vessel about the valve opening and expected gas flow down the pipeline.

- ◆ There should be proper communication established between the refinery and the vessel before opening any valves and permitting gas flow down the pipeline;
- ◆ The vessel should be ready always to face any H₂S emergency at site;
- ◆ Drills for H₂S emergency, general muster, abandon ship and LARS bell recovery should be carried out regularly;
- ◆ H₂S detectors and appropriate PPE should be tested periodically.
