IMCA Safety Flash 10/17

May 2017

This safety flash consists of incidents having a number of unrelated themes.

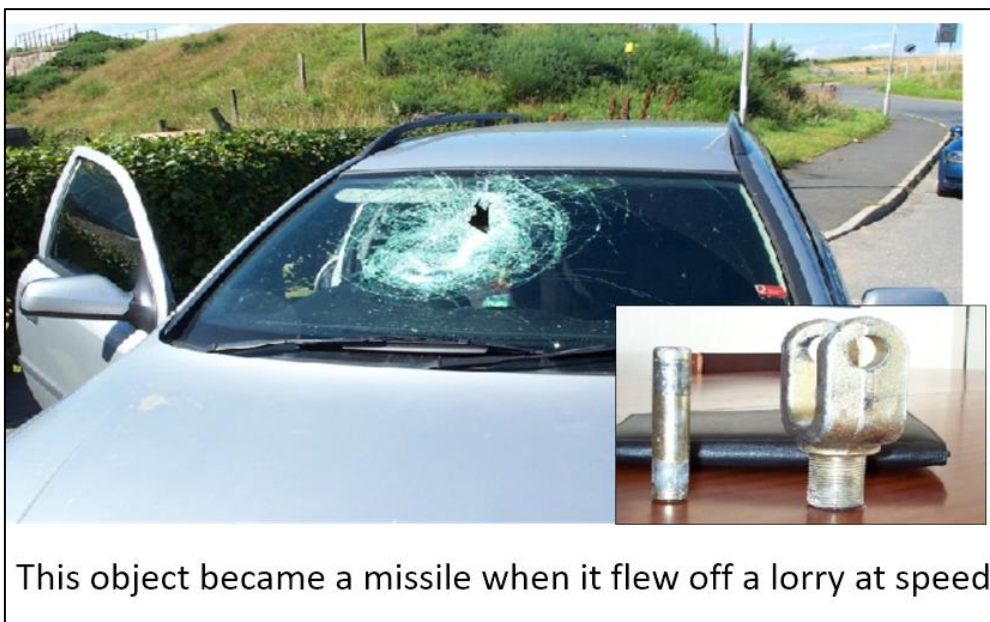
UK Step Change in Safety has published a ‘Safety Moment’ describing an incident in which a car travelling along a road near a port was struck by an object. It is thought that the object was left on top of a container that came back from offshore and was being transported on a lorry travelling in the opposite direction.

The object weighed 15kg and came through the windscreen of the car, narrowly missing the driver - a mother - and her child. This incident could easily have been very much more serious.

- ◆ Pre-transportation checks must be undertaken and given high importance;
- ◆ People responsible for loading and transportation must be observant and ensure loads are secure;

- ◆ Everyone must remain in a safe area, clear of lifts until the cargo is landed;
- ◆ All dropped and potential dropped objects must be reported to the installation and vessel owner.

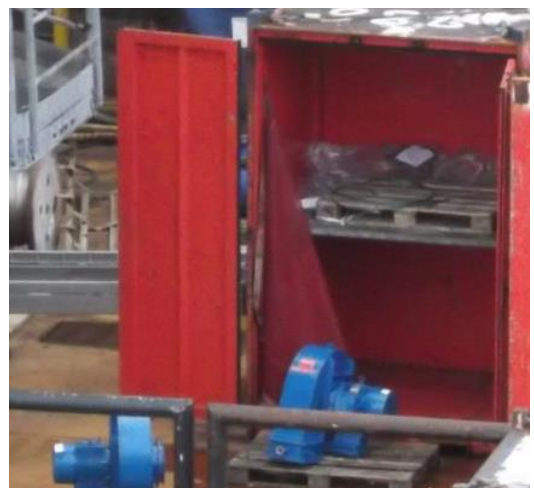
Step Change UK reports an incident in which an unsecured motor in a cargo carrying unit (CCU) fell to deck as it was being secured. No-one was harmed but the motor, which weighed 95kg, was extensively damaged.

When opened, a CCU was found to be a shelved unit containing two palletised blower motors each weighing 95kg – one on the lower level and the other on the shelf. It was intended to remove only the lower motor and send the second (upper) motor back onshore for reloading. The upper motor was not secure and moves were made to secure it before back loading. As crew climbed onto the shelf in attempts to secure the motor, its pallet shifted and tipped forward. The motor fell from height onto the deck, causing extensive damage to the motor. No one was injured during the incident, but had there been crew in the way, this could have resulted in serious personal injury. See the full alert [here](#).

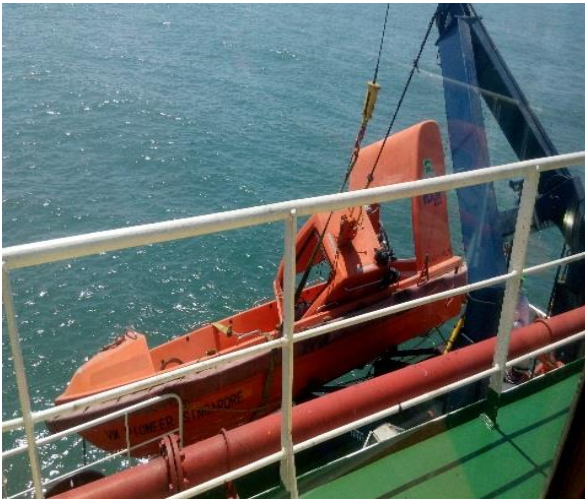
A member has reported an incident in which a rescue boat (FRC) was damaged as a result of it being lowered in its davit during a scheduled drill. During the process of being swung out, the FRC experienced a load imbalance causing it to list heavily on its starboard side. This resulted in the starboard load bearing rod being dislodged from the boat foundation, which in turn meant that the boat could not be lifted back up using its single arm davit. No personnel were in the boat so there were no injuries – but the FRC was damaged.

FRC listed to starboard, showing canopy parted

- ◆ More effective command and control should be exercised by vessel management during small boat operations, particularly launch and recovery;
- ◆ Careful checks should be carried out by designated personnel before lowering the boat, to ensure that everything is properly prepared and ready;
- ◆ The vessel management and crew resourcefully managed to recover the damaged boat using the provisions crane, but there was no proper Management of Change (MoC) procedure initiated, leading to the potential for a second, possibly more serious incident;
- ◆ Thorough review to take place of company procedures and training for small boat operations, including preparation of video and photographic training material.

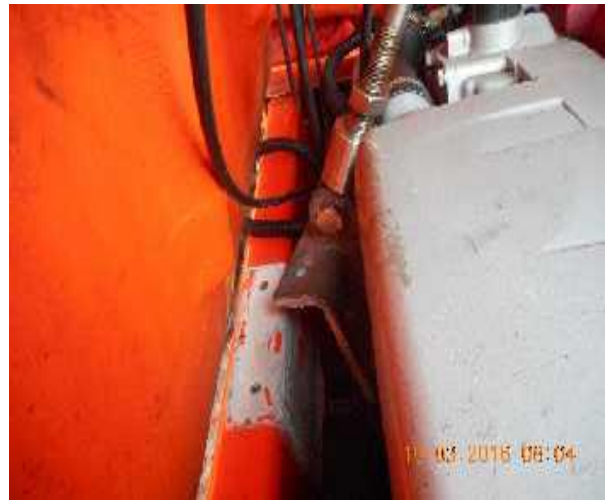
Showing failed starboard load bearing member

- ◆ Following the Masters instructions, crew proceeded to lower the boat up to water level;
- ◆ The boat was swung out on the davit without removing the shipside securing chain before launching;
- ◆ The crew continued to hoist the boat with the help of motor; the boat started tilting to port side, until the whole load of the boat came onto the starboard side supporting rod;
- ◆ Structural integrity of the boat: pictures taken during drill reveal that the engine door was not in place on the canopy before lowering. It is important to ensure the structural integrity of the boat before launch;
- ◆ Due to more load on the base of the starboard side supporting rod, the boat top canopy sheared off from the foundation. At that point, the Master suspended the operation.

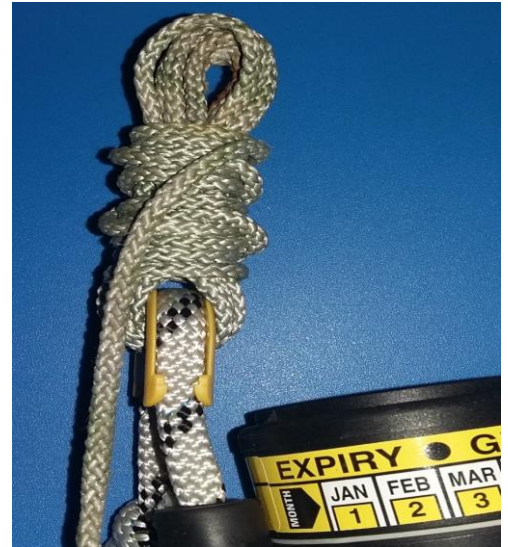
IMCA's attention has been drawn to a near miss in which it was found that the hydrostatic release on a life raft was not correctly rigged. This was discovered following the replacement of a life raft. It was noticed that if the collar on the Senhouse slip was lifted for life raft launch, it would not release the strap as the lashing that connected it to the hydrostatic release unit was tied too tightly, so the arm would not easily slip through and release. This was due to the hitches in the lashing being carried on too far up towards the slip, not leaving enough room for the arm of the slip to move sufficiently.

Lashing tied too tight where usually connected to Senhouse slip

- ♦ The Senhouse slip should not be attached through a lashing and should be directly attached to the hydrostatic release unit;
- ♦ Hydrostatic release units are fitted with a yellow plastic that aids the release of the Senhouse slip when released. If fitted through a lashing, this can create friction making the operator unable to launch the life raft safely;
- ♦ The lashing can still be used in the securing of the life raft, but in a different position. Care should be taken to ensure that the painter line is tied through the red ring on the Hydrostatic release unit.

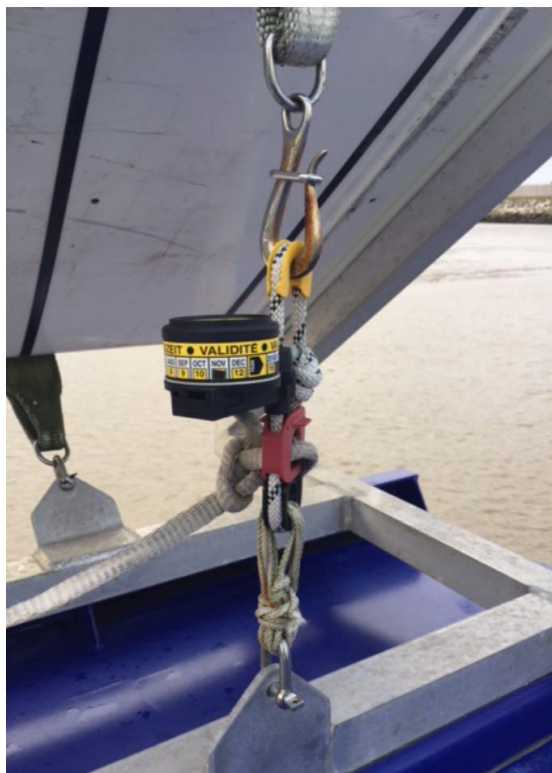
Correctly stowed HRU on life raft

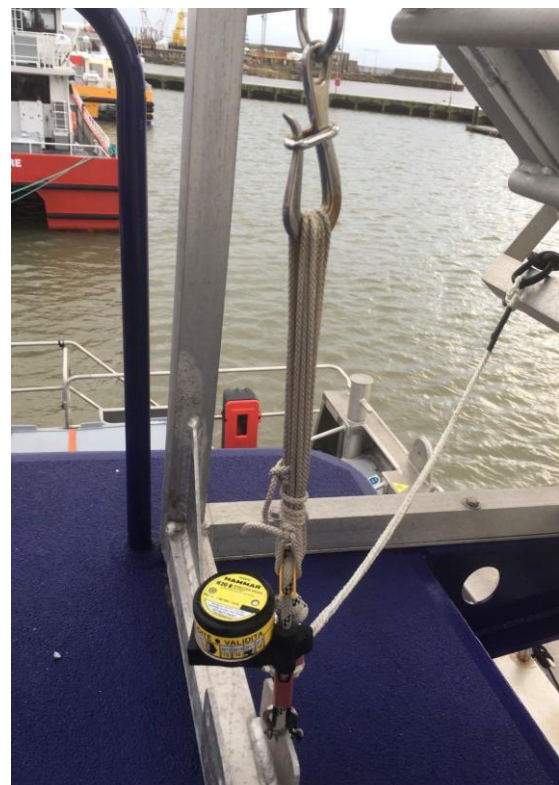
Incorrectly rigged HRU.

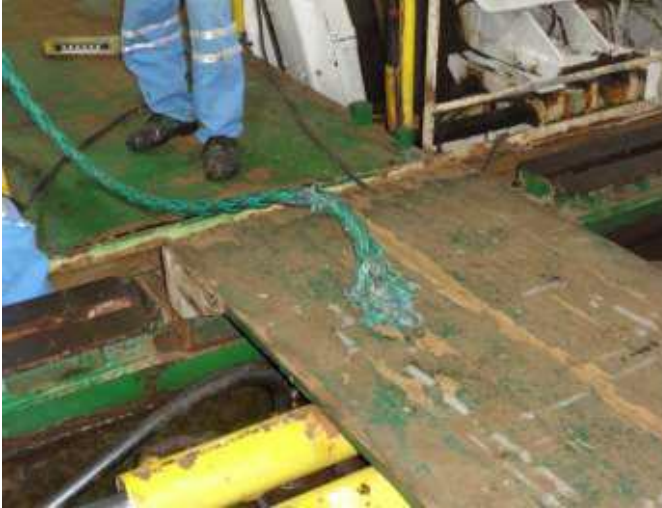
The end of the rope pulled out of its socket, releasing the rope down the aft deck and overboard. A bar at the stern was damaged and a camera and floodlight were carried overboard.

Parted rope on deck

- ◆ The rope failed at less than the minimum breaking load (MBL) of the rope, which was 25.0 tonnes:
 - tensions of up to 200kN (app. 20 tonnes) had been experienced during the recovery

- ◆ **It is possible that the rope socket had gradually degraded over the previous 10 grapnel drives, but with no obvious visual signs of having done so.**

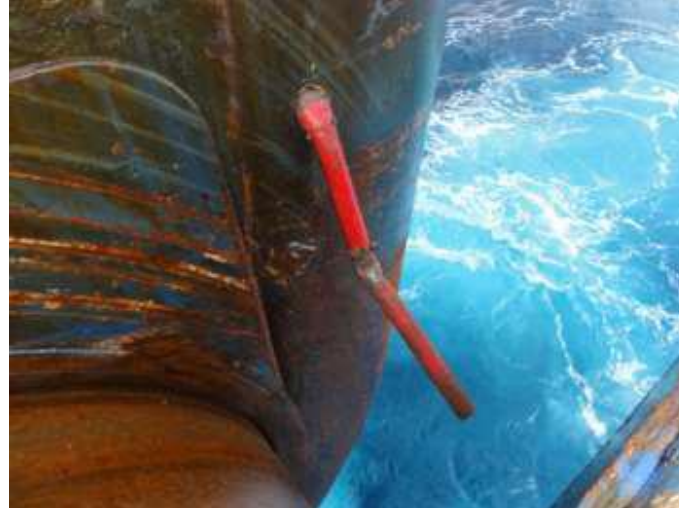
Resulting damage to Atlantic bar

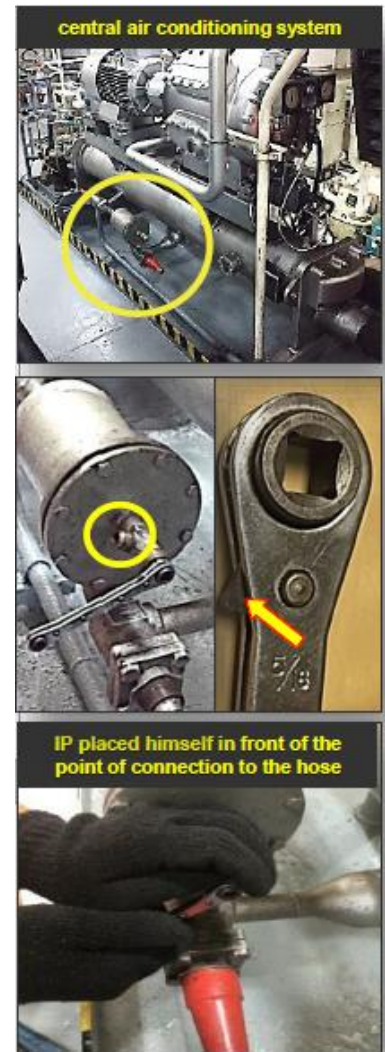
But the engineer decided – with the AC compressor running – to give one last torque to the valve to once more ensure it was properly torqued. He crouched and placed himself in front of the point of connection to the hose – “in the line of fire”. Unfortunately, he inadvertently opened the valve instead of tightening it further. It is considered likely that the pin of the ratchet wrench had moved to the opposite position and the engineer did not check the direction of the torque.

There was an immediate refrigerant gas leak towards him. He put his left hand on the leak and tried unsuccessfully to close the valve with the ratchet wrench with his right hand. At that moment, a colleague pushed the engineer out of danger and was able to close the valve in a safe manner.

The engineer's gloves were initially frozen on; once they were off, his hands were placed in running water. He suffered severe second degree freezing burns to both hands. He was treated on board with the telephone guidance of a doctor, and subsequently transferred ashore for hospital treatment.

- ◆ Proper training in job risk analysis, risk assessment and “line of fire” for crews;
- ◆ Permit to work (PTW) to become mandatory for work on high pressure equipment;
- ◆ Rotate the position of the discharge point of the compressor so as not to point towards workers, and addition of safety/retention valve (Schrader type valves) on compressor discharge lines;
- ◆ Provision of proper and specific thermal protection gloves;
- ◆ Reassessment of chemicals used on board and their MSDS;
- ◆ Ensure that client/operator is informed of any and all injuries on board contractor vessels on hire as soon as possible.
