IMCA DP Station Keeping Event Bulletin 02/17

June 2017

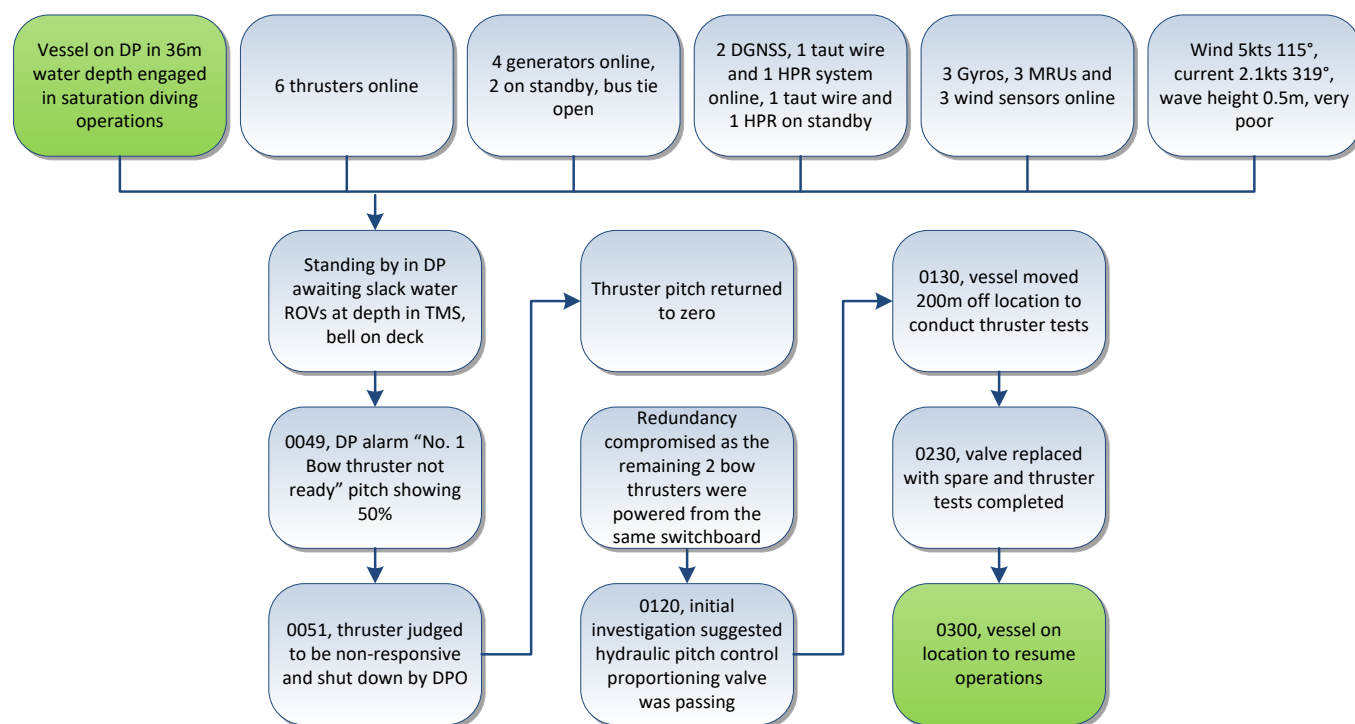
Bow Thruster Fault Compromises Redundancy – DP Undesired Event

The vessel was working in an open water situation and there was no loss of position.

- ◆ Useful reporting of an undesired event that did not result in a loss of position.
- ◆ After an event such as this, planned maintenance routines should be checked to ensure they are adequate.
- ◆ Particulars of the vessel are unknown however it might have been possible to power the two remaining bow thrusters from either side of the switchboard and therefore maintain redundancy with just two bow thrusters.
- ◆ This was a well executed operation that ensured full thruster redundancy options were made available prior to operations resuming.

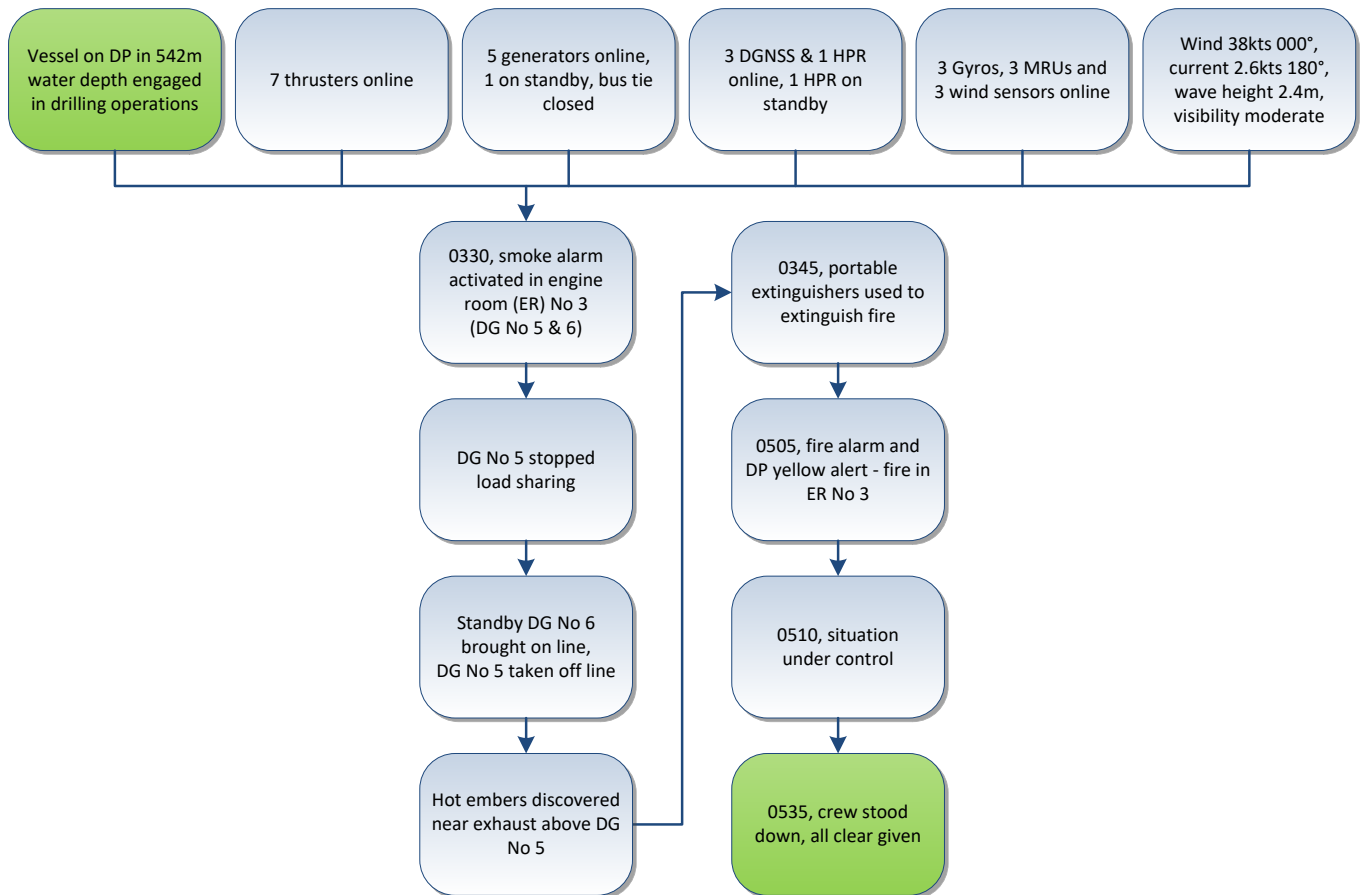
Fire in the Engine Room – DP Undesired Event

Investigation found that the turbo charger on engine No 5 was damaged. DP position was maintained throughout.

- ◆ A fire on any vessel is serious and in the engine room of a DP vessel engaged in operations it should be considered very serious.
- ◆ The first signs of a fire in the engine room should warrant a DP yellow alert.
- ◆ Full details of the vessel power distribution are not known but consideration should be given to electrically isolate the affected engine room.
- ◆ The above two points should be covered by the vessel activity specific operating guidelines (ASOG) or well specific operating guidelines (WSOG) so that the crew is in no doubt what action to take.
- ◆ Vessel emergency drills should consist of scenarios such as this so that all crew know what to do and what will happen in similar circumstances.
- ◆ It is essential the crew know what conditions would cause an automatic activation of the fire deluge system.

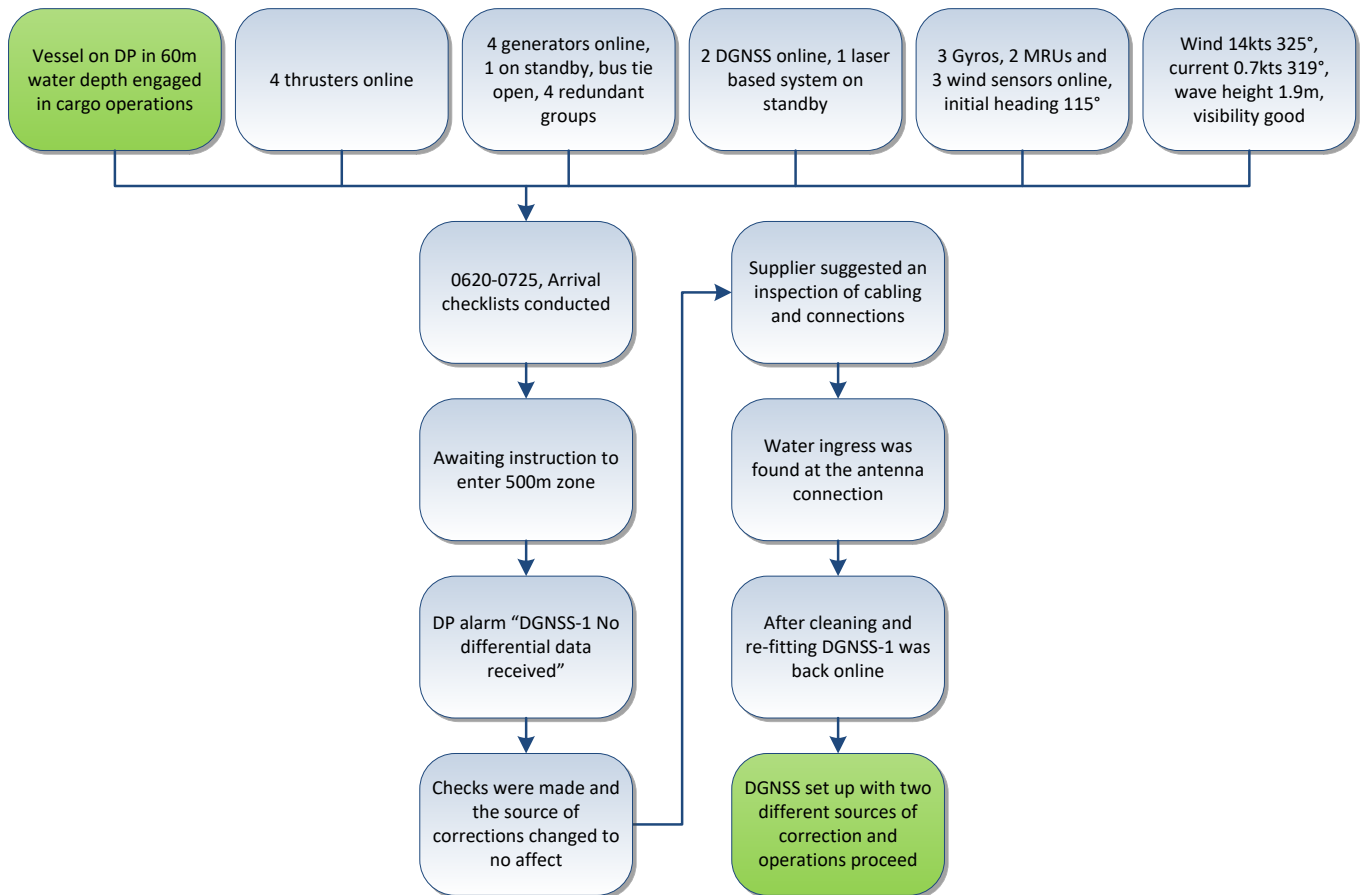
Bad Connection Causes Loss of DGNSS – DP Observation

After all the checking, it was found that there was water ingress at the L-Band connector to the antenna on the mast. This was dried and cleaned. The connectors were properly sealed with self-bonding electrical tape and cable ties.

- ◆ This observation reinforces the need for good practice conducting field entry/arrival DP checks making sure all DP systems are operational and healthy.
- ◆ It is unclear why the laser-based reference system was not in use but it is assumed the system was not immediately available due to distance or shadowing.
- ◆ Several recent reports indicate the use of only two enabled position reference systems (PRS), these are often both DGNSS. It cannot be stressed enough that a mixture of PRS should be used.
- ◆ Regular checks of connections which are exposed to the environment need to be carried out and included in planned maintenance systems.

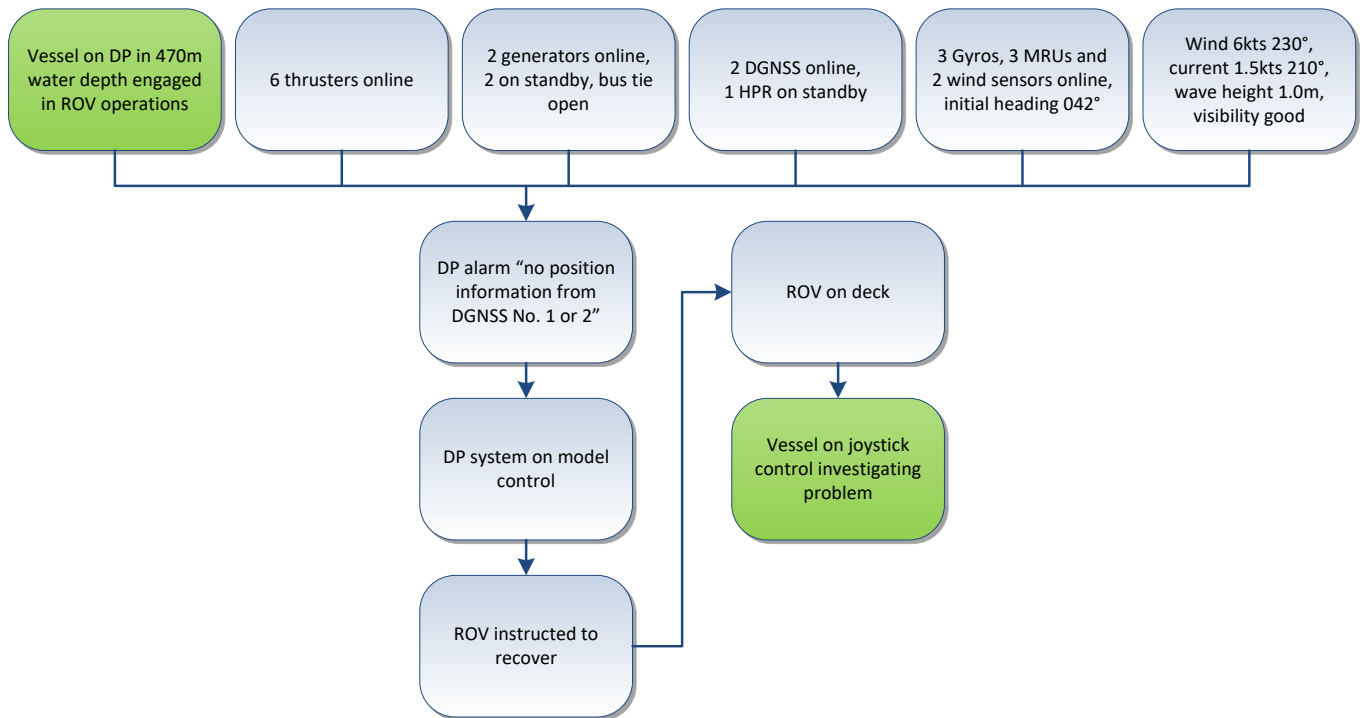
Loss of DGNSS Resulted in ROV Being Recovered – DP Incident

Both the satellite positioning systems in use were from the same provider.

The report recognised this and recommended that the systems were changed so that position information was provided by different service providers. The service provider informed the operator after the event that its services experienced periods of increased latencies for just over twenty minutes on the day and time of the incident.

- ◆ It would appear from the information available that the standby hydroacoustic position reference (HPR) system did not have an acoustic transponder on the seabed. In any event it was not utilised.
- ◆ Proper consideration should always be made of the required PRS based on the specific operation and the DP equipment class of the vessel.
- ◆ When considering redundancy of satellite systems do not just consider equipment manufacturer and software versions; the correction type and transmission method should also be different.
- ◆ It is noted that two separate vendors could use correction details from the same source, therefore users should compare what correction type is being used.
- ◆ In similar situations users could consider switching to raw global navigation satellite system (GNSS) data, therefore staying on DP but with a larger footprint.

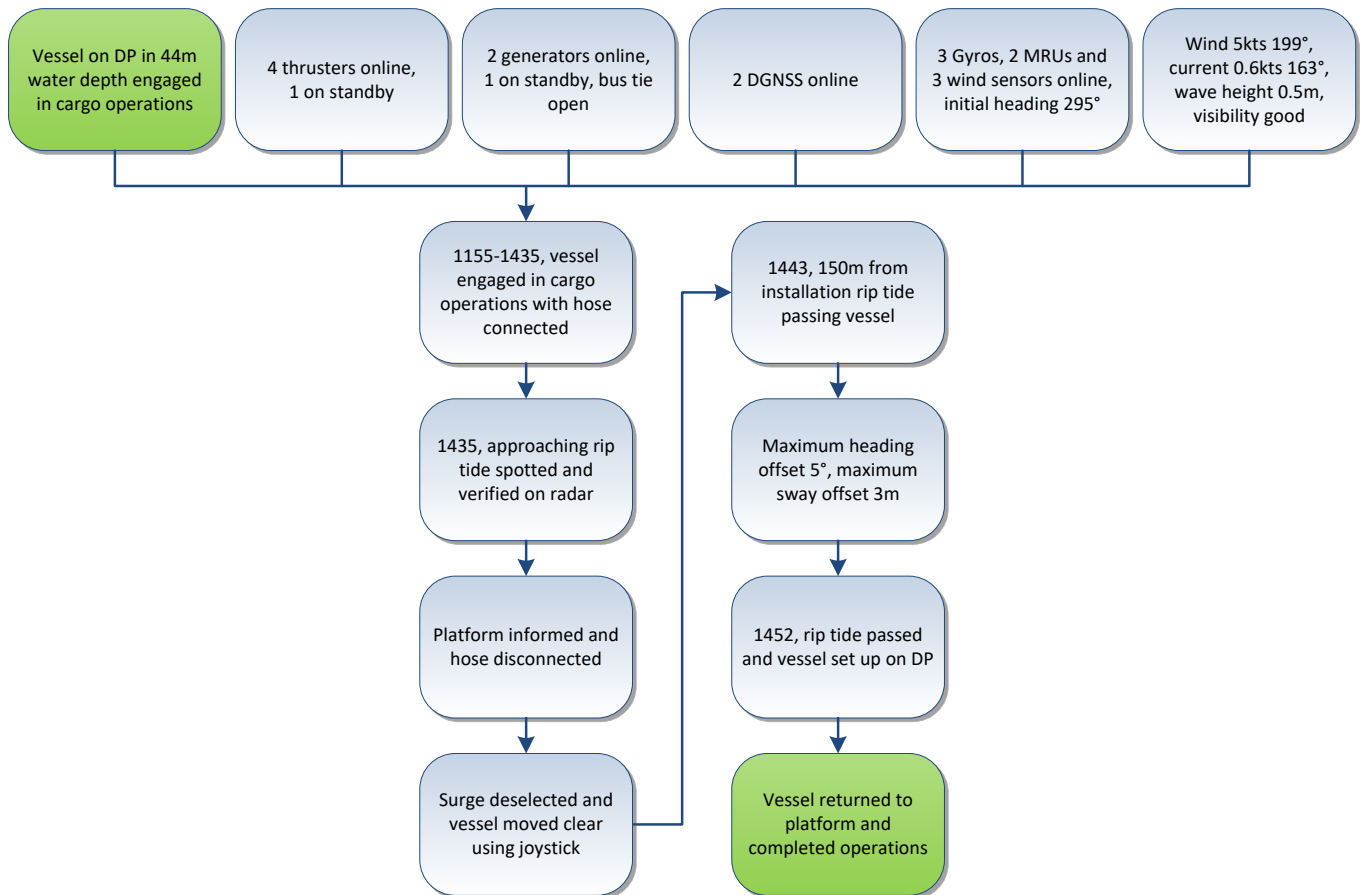
Rip Tide Presents Problems – DP Observation

It was a single rip tide and when it had passed the vessel was set up back in automatic position mode. There was clear evidence that a degraded performance was caused by the rip tide. A risk assessment was made, all DP set-up checks were carried out and the DP system performance was monitored for 20 minutes. Other rip tides were not observed and the vessel approached the installation to resume operations.

- ◆ The observation demonstrates a positive attitude to observing environmental conditions with respect to vessel capability and taking the correct actions to avoid potential dangerous loss of position.
- ◆ It is unreasonable to expect any DP system to cope with the sudden change in forces that can be introduced by rip tides which can have a catastrophic effect on the ability of a DP system to maintain position and heading.
- ◆ If this was a DP equipment class 2 operation then the report indicates that there was inadequate redundancy with regards to position reference systems.
