IMCA Safety Flash 22/17

August 2017

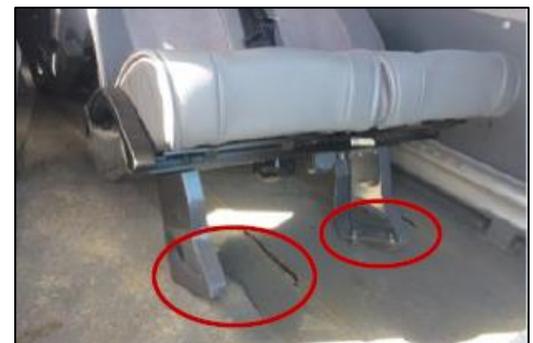
Figure 1: Inadequate seat anchorage bolts with welded square plate

Where the seat anchoring is inadequate, there is a potential risk that in the event of a collision, the seats could pull from the floor.

- ◆ Verify through inspection the type of seat anchorage bolts used. Seat anchorage bolts where “square plates” (Figure 1) are welded to the bolts might be inadequate in holding the seat in its position in the event of lateral force being applied (e.g. during collision). Only use appropriate, fit for purpose, bolts (e.g. made out of one piece) to robustly secure the seat.
- ◆ Verify through inspection the anchoring of the supporting rails and rail supporting beams. These might be inadequately anchored to the vehicle when retrofitted (Figure 2). These rails and beams must be adequately anchored to the chassis (e.g. bolted).

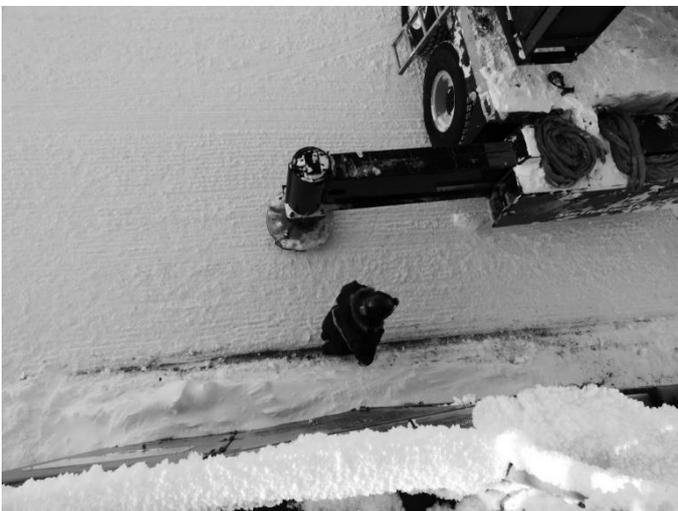
An IOGP safety alert recounts how, at a land-based seismic survey camp, a worker was trapped and injured when a reversing vehicle did not stop. Someone was working as a spotter helping a crane operator reverse a mobile crane into position. As the crane reversed to approximately 1.5m from the desired position, the spotter reached for his radio to give the **STOP** command, but lost his balance in snowy conditions. While he regained his balance, the crane continued to reverse. As a result, the spotter was caught between the outrigger and the well house, causing an injury to his right wrist.

Aerial view of spotter and crane position

- ◆ The spotter lost his balance placing him in the line of fire;
- ◆ The crane operator continued to reverse after losing visual contact with the spotter. The spotter and the crane operator had previously agreed that if visual contact was lost that they would rely on verbal communication but did not agree that the verbal communication would be constant;
- ◆ This method of positioning the crane was considered normal by the two employees;
- ◆ While moving, the crane outrigger was left extended to prevent potential hydraulic oil leaks;

- ◆ Users of mobile equipment or vehicles (cranes, fork lift trucks etc.) should establish clear communication protocols before starting work;
- ◆ Persons on the ground or on deck near moving vehicles should never allow themselves to be “in the line of fire”;
- ◆ When operating mobile equipment or vehicles, if visual or verbal contact is lost with people nearby on the ground, **STOP** immediately until contact is re-established and safe operation can continue.

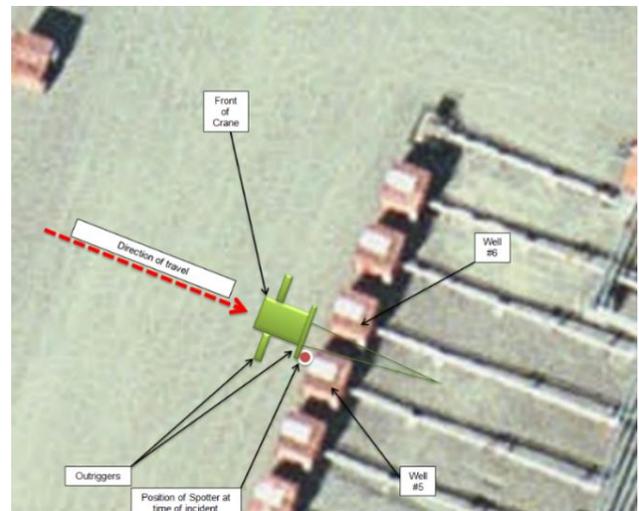
Aerial/plan view of scene of incident
