IMCA DP Station Keeping Event Bulletin 04/17

October 2017

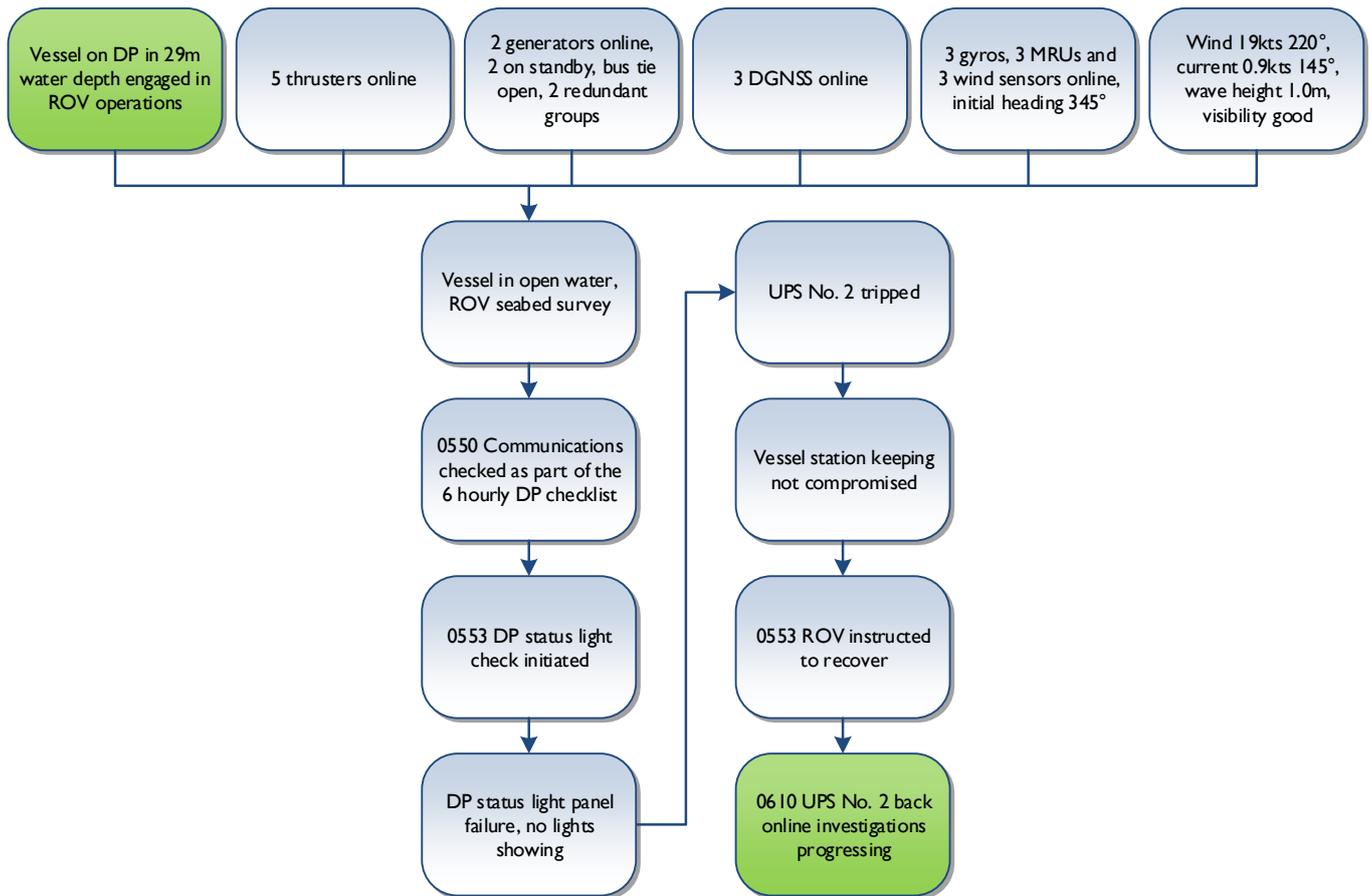
Temporary Connection to DP System Caused Short Circuit – DP Undesired Event

Various DP equipment, including the DP status lights, were connected via UPS No. 2. Investigation found that the UPS tripped because of a break in the portable cable supplying the DP status lights to ROV control.

- ◆ The vessel does not have a permanent ROV system, when an ROV system is mobilised it is a requirement that the ROV control has DP status lights. This is achieved by installing a portable set of lights that are connected to the vessel's DP system by a cable.
- ◆ The same cable had been in use for several years whenever an ROV system was mobilised.
- ◆ Inspection procedures have been modified to include portable wiring and a bend preventer/limiter used for future connections.

- ◆ Connection of ANY temporary system to a DP system should be as part of a formal management of change and properly risk assessed.
- ◆ The connection of ANY temporary system should be designed to tolerate a short circuit or any other failure.
- ◆ Additional systems that are connected to a DP system should be approved by manufacturer and class and should be extensively tested.
- ◆ The vessel is recorded as operating within DP equipment class 2, however only satellite derived position reference systems were recorded as being in use.

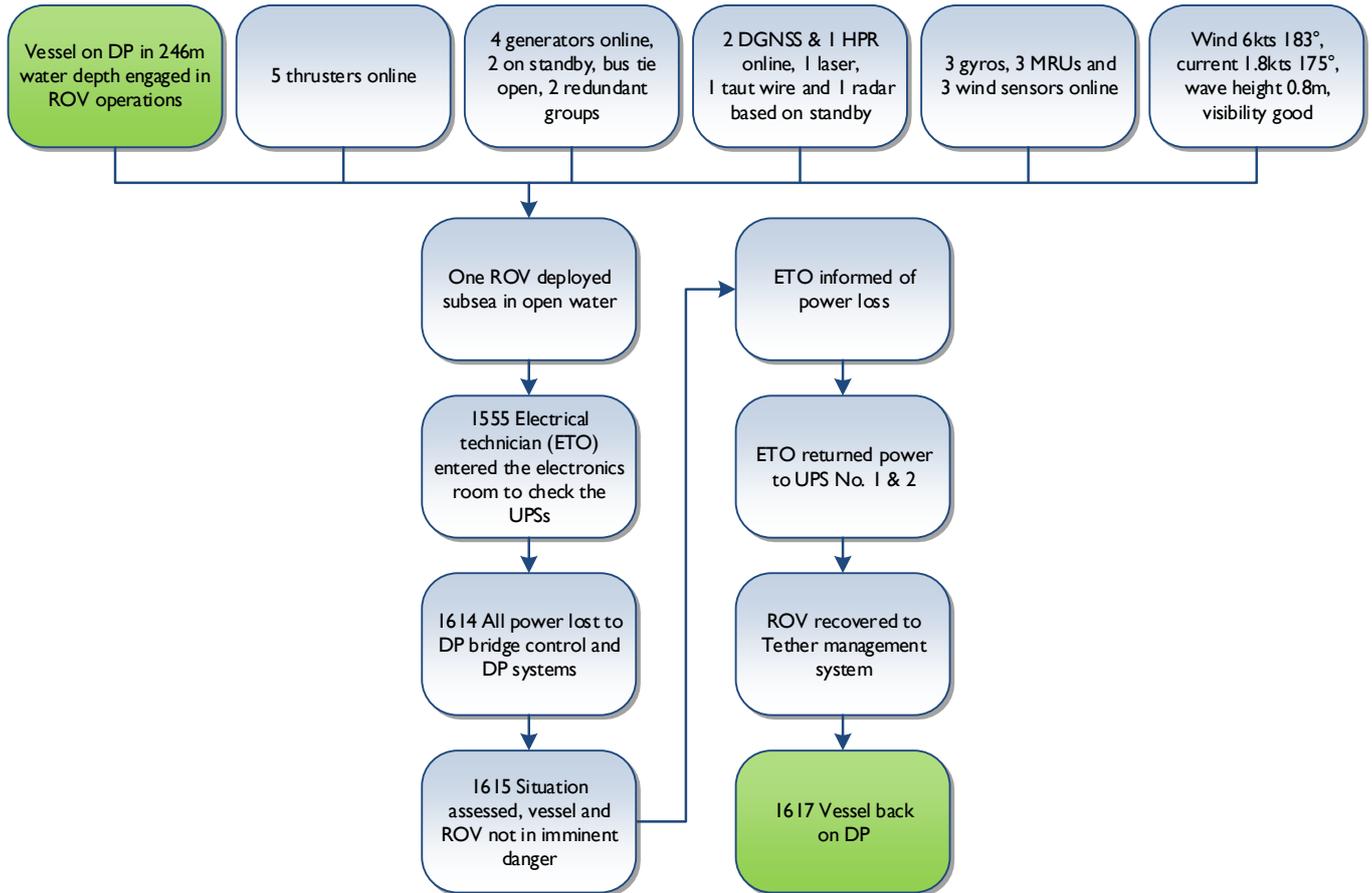
Check of the UPS led to Loss of Power – DP Incident

At approximately 1555 the ETO came to the bridge and asked the Senior DPO permission to enter the electronics room to check the UPS batteries. The SDPO gave permission, not knowing the detailed work scope of the ETO.

- ◆ Both planned and unplanned work on DP equipment should be subject to a permit to work system.
- ◆ Maintenance routines need to be carefully managed during DP operations and planned maintenance of any DP equipment should be avoided whilst the vessel is operating on DP.

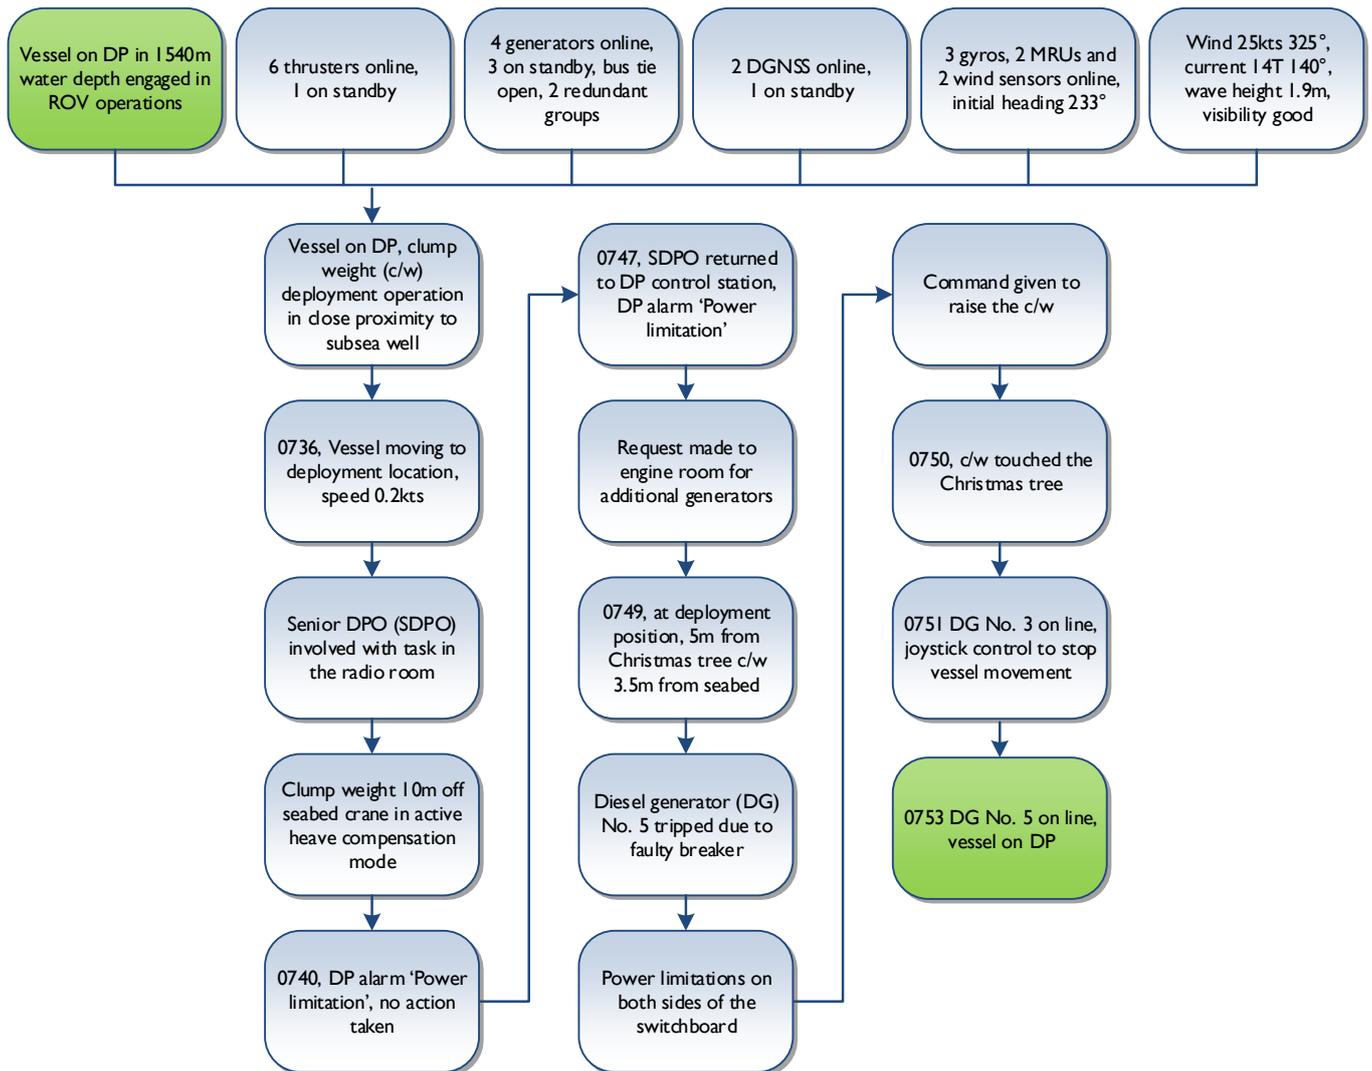
Lack of Planning and Situational Awareness Causes – DP Incident

The event was investigated by the vessel operator, findings are summarised here:

- ◆ The DPO was left alone at the DP console during critical subsea operations. In such critical subsea operations, subsea lifting in vicinity of Christmas tree, both DPOs should have been 100% focused on current operations.
- ◆ Following the power limitation alarms, the DPO didn't inform the SDPO, or request to start additional generators. Despite having wind and current pushing the vessel in the direction of the Christmas tree, he didn't realize that the situation was becoming critical.

- ◆ The activity specific operating guidelines (ASOG) was built up considering only vessel operations criticality and location (inside or outside the 500m zone), it failed to take into consideration the power consumption of ROV and cranes during these operations.
- ◆ The ASOG required only 2 DG on each bus bar. That means that YELLOW status (load >50%) would be reached earlier than with 3 DG per bus bar. The DPO and engineer on watch didn't respect the ASOG as they didn't react when YELLOW status was reached.

- ◆ The purpose of a micrologic breaker is to protect the electrical circuit from damage caused by excess current. In this situation, the breaker interrupted current due to misreading of the amperage. Preventive maintenance routines had been followed and increasing maintenance frequency would not prevent the kind of failure that affected DG No. 5.

- ◆ The power limitation alarm was active for 11 minutes, the power management system did not instigate an automatic start, therefore the FMEA and DP trials should be questioned.
- ◆ Neither the DPO nor engineer reacted to the situation and one DPO was left alone at the DP control station during a critical phase.
- ◆ Lack of preplanning and development of a separate ASOG for the task directly contributed to the event.
- ◆ The vessel is recorded as operating within DP equipment class 2, however only satellite derived position reference systems were recorded as being in use.

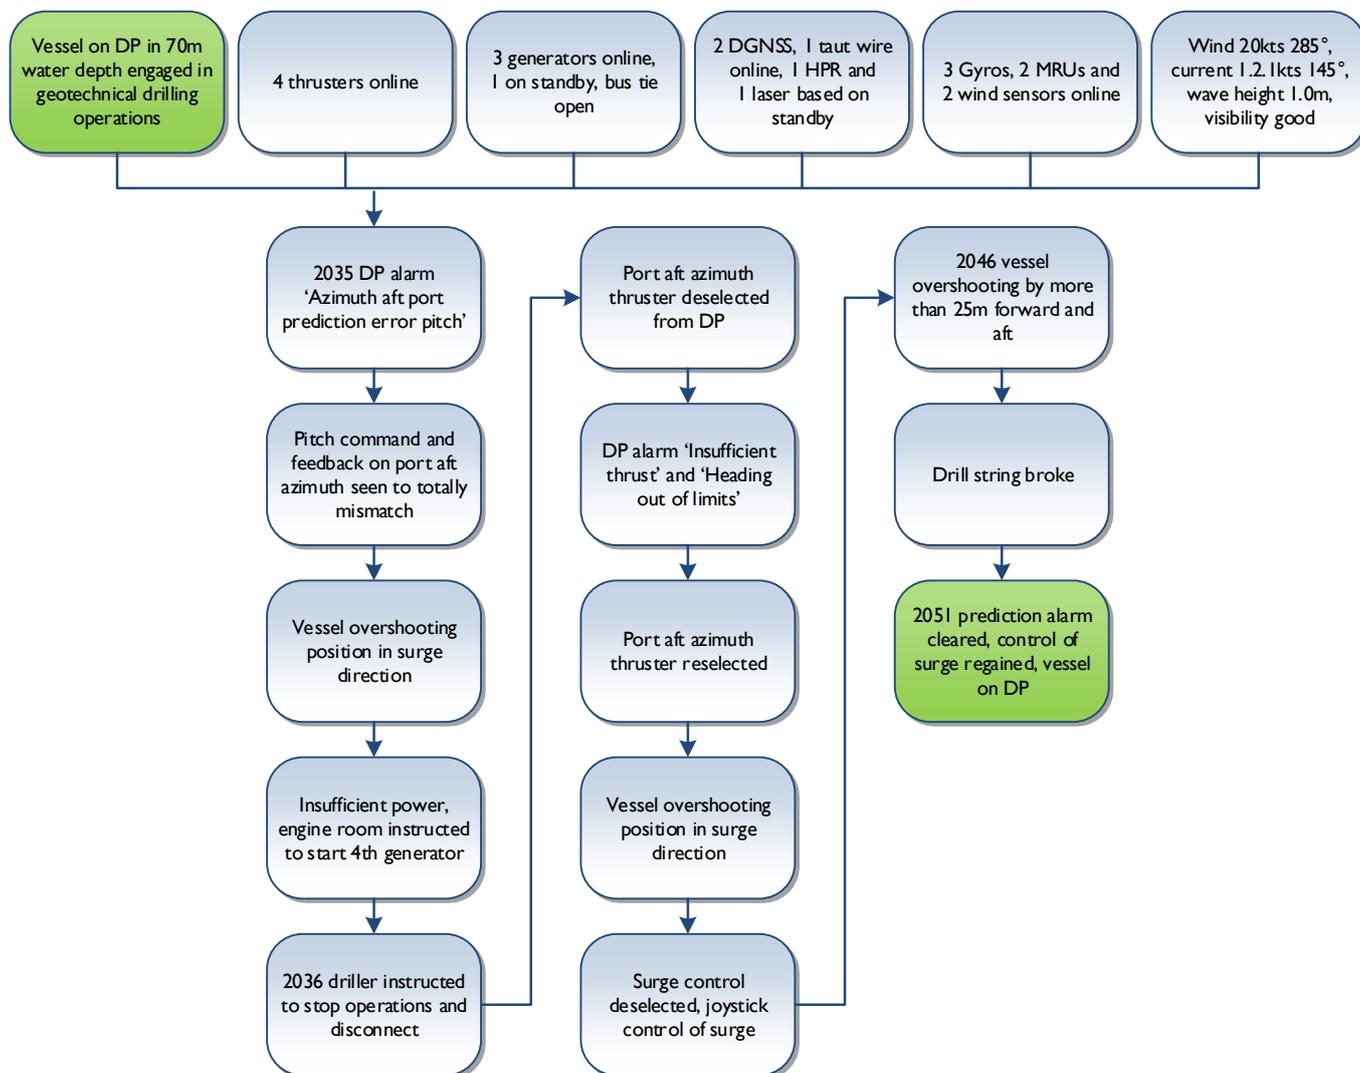
Thruster Command and Feedback Differences Leads to – DP Incident

The DP system reported a thruster pitch prediction error when a large difference between the command and feedback was detected at 20:35:34. The description for a thruster prediction alarm states that the operator must take action to determine if the alarm is caused by a faulty feedback signal (DP performance nearly unaffected) or a faulty command signal (DP performance affected).

The port azimuth thruster was not stopped and only momentarily deselected from DP. The thruster gave thrust in the wrong direction while it was running and the DP system was unable to maintain position.

The prediction alarm went to normal again at 20:51:04 and the DP system was able to maintain position. No problems were reported after this.

Since the command output from the DP control system was correct, it was concluded that the fault had to be in the output control loop. It was decided to replace items in the command loop with spare parts held on board.

Trials and DP tests were carried out to verify system after replacement of parts. No problems or findings to report.

- ◆ The reason for reselecting the errant thruster must be questioned.
- ◆ In this situation stopping the errant thruster should have allowed the DP system to regain control.
- ◆ Event box No. 2 (pitch command and feedback mismatch indication) provides the trigger to stop the thruster because it indicates there is a problem with thruster commands.

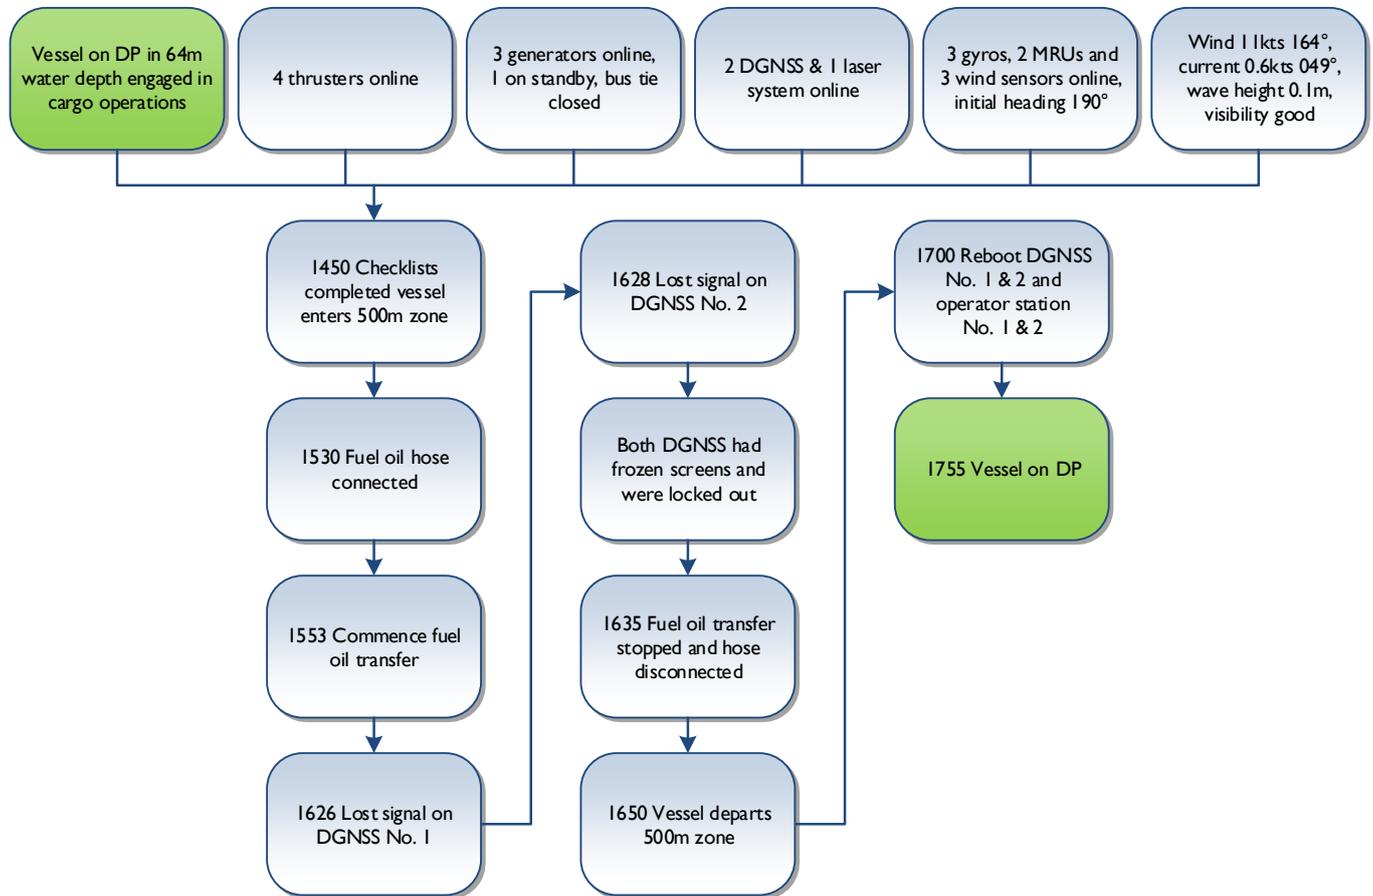
Common Mode Failure of DGNSS – DP Undesired Event

Both DGNSS systems had locked up, the touch screen was not responding and the NMEA signal was no longer being received, the DP system alarm displayed 'Telegram timeout'. The GNSS manufacturer concluded that with both systems suffering issues at the exact same time it pointed towards a common factor, the likely root cause was signal interference.

- ◆ The DP system worked as designed, the vessel departed the 500m zone, for investigation, on DP using the laser system as reference.
- ◆ The root cause of the problem was not found however it was believed to be a common mode failure.
- ◆ Most DGNSS suppliers have a function available to check for shadow of satellites, users would be wise to make proper use of this tool.
- ◆ Improvement measure would be to use two different DGNSS suppliers and different differential position services.

1. Ensure the antenna, cables and connectors are in a good condition and no damage to them.
2. Tune the MF module on each set to different MF stations.
3. Check if both systems are utilising the same Precise Point Positioning service; if so, consider changing one of them.
4. Copy the configuration files for reference.
5. If a further crash occurs take pictures of the system screens as there may be additional windows error messages.
