IMCA Safety Flash 32/17

December 2017

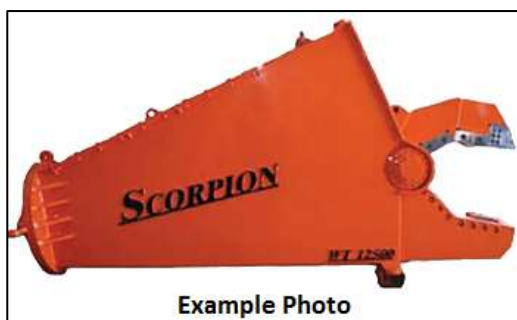
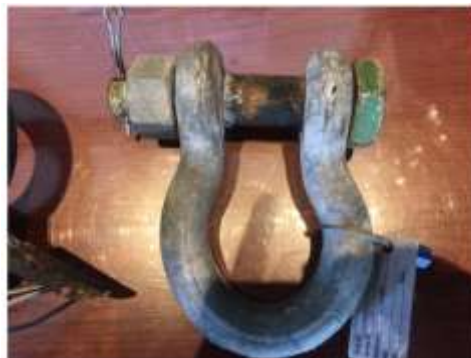
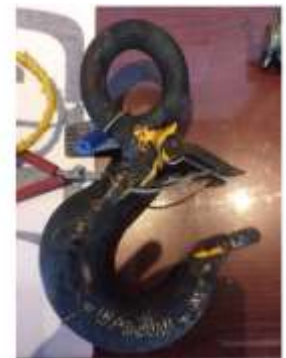
During a recent decommissioning operation, shears were used to cut a pipeline. The shear tool was rigged to the crane in a vertical fashion. The shear tool was placed on the pipeline at the cut location and when the shear jaws closed around the pipe to make the cut, the shear tool was pulled downward due to the 'bird's beak' design of the jaws.

As a result, the load quickly increased the tension on the rigging over the safe working limit (SWL) of the rigging resulting in damage (deformation) to the rigging. The crane operator was instructed to immediately reduce load to an acceptable level.

This incident resulted in damage to property (hook and shackle) but could easily have been a good deal more serious, having the potential to have harmed the diver who was working close to the shear tool.

- ◆ Failure to recognize the hazard of the shear tool pulling downward during cutting operations;
- ◆ Inadequate preparation/planning.

- ◆ Lack of knowledge;
- ◆ Inadequate communication.

- ◆ Placement of the shear tool and the amount of 'slack' available to make a cut will have an impact on the outcome;
- ◆ Ensure SWL of rigging arrangement is communicated to crane operator prior to lifting operations;
- ◆ Ensure rigging drawings are available. If not, a hand sketch should be prepared locally and reviewed/approved prior to lifting operations.

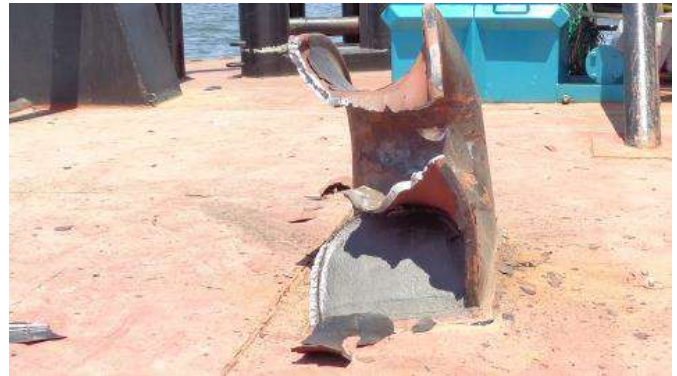
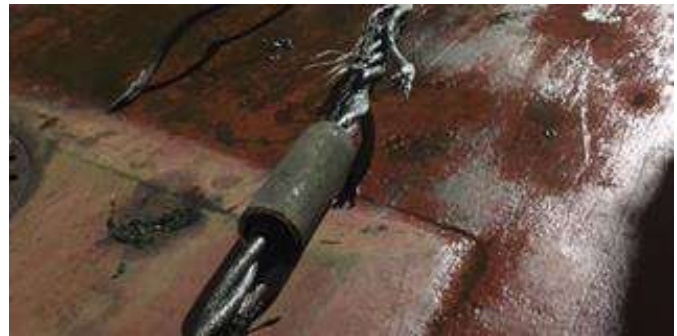
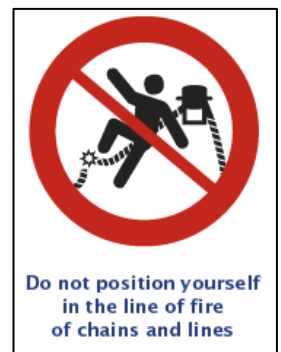
During offshore wind farm construction, pull wires were being laid. One small vessel was acting as a winch vessel, and another as an anchor. These vessels were connected with a steel wire rope sling. During wire pull operations, the steel wire rope sling failed. When the wire failed the energy stored in the steel wire rope sling and the rigging arrangement was released, causing damage to the rigging arrangement, load cell, Panama chock and the deck of the winch vessel. There were no injuries, as a 'clear deck' instruction was in place.

The wire failed at the splice inside the ferrule following an increase in tension. It was concluded that the mechanism of failure was a low-cycle fatigue fracture.

Further detailed investigation showed that dynamic forces on the hold-back or anchor arrangements were higher than anticipated, leading to the overstressing and therefore the failure of the wire. These peak forces were not picked up during manual logging.

Similar failures have occurred due to the splice failing under higher than anticipated dynamic loading causing the splice to pull from the ferrule.

- ◆ Because the 'clear deck' instruction was followed, ensuring that no personnel were in the 'line of fire', there were no injuries;
- ◆ One of the investigation findings was that an incorrect calculated sling breaking load (CSBL) was assumed. Hence the working load limit (WLL) of the steel wire sling was also incorrect. When a steel wire sling is assembled, a reduction in WLL for the assembly is applicable depending on the end termination and the factor of safety. In this case, the termination efficiency (K_T) for a 'super splice' or 'super loop' is 90%. For example, if the steel wire had a CSBL of 100 Tonnes, a factor of safety of 3:1 and a termination efficiency of 0.9, then the assembled wire sling should have a WLL of 30 Tonnes – i.e. $CSBL = WLL \times S_F \times K_T$. This reduction was not included on the certificate's WLL that came with the assembled wire rope sling. Clear marking, certification and utilisation of equipment must be checked thoroughly when new equipment is delivered;

- ◆ The forces on the wires were measured via a load cell. These readings of the load cell were logged manually. Data logging should be automated allowing continuous (digital) logging of the load cell data. This data can then be used to check which forces are being exerted on wires and if workability limits are reached.

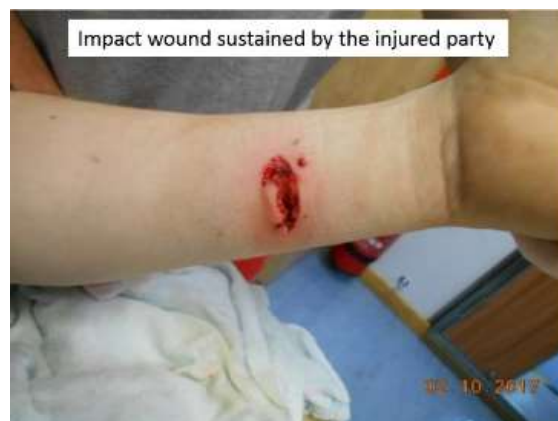
The Marine Safety Forum (MSF) reports another incident wherein a crew person was injured following misuse of a pillar drill. Crew were in the process of using a piece of 2mm metal plate to manufacture a metal blank for a pipe on the vessel's hot water system. It was necessary to drill a small hole (6mm) at one end of the plate. For this operation, it was decided to use the workshop pillar drill. Whilst drilling the metal plate the drill bit became stuck. This then forced the metal plate out of the drill vice. When the operator reached up to stop the machine the metal plate that was stuck to the drill bit dislodged, flew off the drill bit and hit his left arm.

- ◆ The task had not been properly risk assessed;
- ◆ The wrong tool had been selected for the job;
- ◆ The vice holding the job had not been sufficiently tightened;
- ◆ The speed of the drill had not been adjusted for drilling metal;
- ◆ The injured person was *“not wearing his personal protective equipment (PPE) correctly”*.

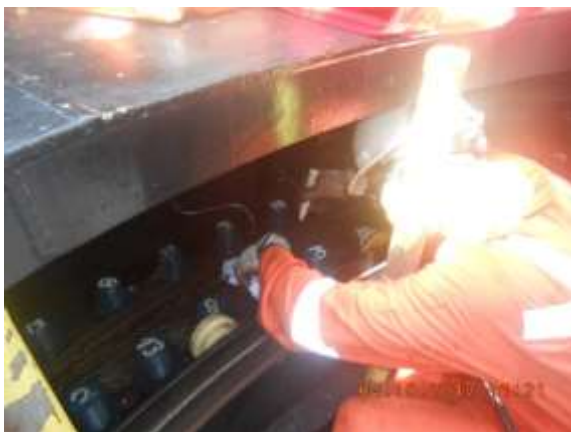
Turret working location

A four-yearly task was in progress, to check the tension of bolts on the bearing of a floating storage and offloading (FSO) unit turret. During moving the bolt tensioner, a part (the puller, weighing 13kg) fell between the bearing stud bolts of the inner (static) and outer (rotating) bearing races. Before it could be removed the FSO weathervaned, trapping and compressing the tensioner part between the two rings of bolts. A crew member went to investigate further. As he crouched over the tensioner part, it suddenly came free and struck him in the head causing serious injury. He was promptly medevaced to hospital onshore.

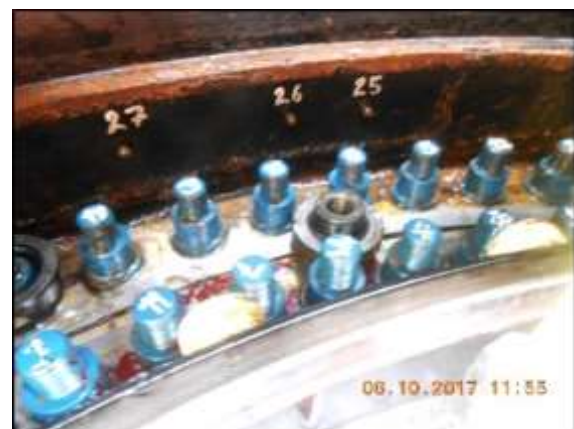
Tensioner part trapped between bearing race stud bolts

- ◆ The risk of a tensioner part falling and becoming trapped between the stud bolts was not recognised in the job safety analysis (JSA), work procedure or turret vendor documentation;
- ◆ This risk was not recognised by the crew member, who placed himself 'in the line of fire';
- ◆ No **stop work authority** was applied when the task deviated from the expected work process;
- ◆ The design of the turret bearing races and stud bolts location allowed the tensioner part to become trapped and compressed when the FSO weathervaned.

- ◆ Provide additional safeguarding tools and equipment to prevent the tensioner puller from dropping in between the inner and outer stud bolt or even this tool and equipment could help to support the re-tensioner while moving along the race;

- ◆ Investigate a manual handling tool that will reduce the risk of accidentally dropping the tensioner parts;
- ◆ Review the JSA and work procedure to include routine and unexpected risks and provide troubleshooting guidance. Include JSA to consider weather limits for the work and use of a tug on the FSO stern;

- ◆ Reinforce use of **stop work authority** if work deviates from normal conditions. Investigate if this task should be performed by a specialist contractor rather than the FSO crew;

- ◆ Develop 'line of fire' awareness training;
- ◆ Share information with other operating assets with a FPSO and future project FSO, to design out the hazard, e.g. put the two bearing races and rings of bolts at different elevations.
