IMCA DP Station Keeping Bulletin 03/18

August 2018

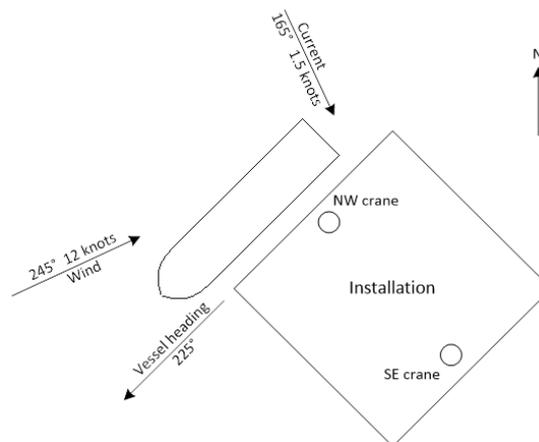
A DP2 platform supply vessel was set up on auto DP engaged in cargo operations inside the 500m zone of a fixed platform. The DP design concept of the vessel was such that there were two redundant groups and the vessel was set up with power generation and thruster supplies equally split across each redundant group with main bus ties open. Weather conditions were acceptable based on the capability of the vessel and the vessel was undertaking cargo offload on the north west side of the platform on a “blow on” position due to unavailability of the south east side platform crane.

The port aft azimuth developed a failure that led to it tripping out of DP control and its main circuit breaker opened. As the vessel was being operated within its environmental envelope and the thruster failure did not exceed the designed worst case failure, the vessel maintained position.

However, as redundancy had been compromised cargo operations were immediately suspended and the instruction was given to leave the 500m zone for thruster investigation. The DPO, in consultation with the master, decided to deselect auto DP control mode and selected manual control mode, at which point the vessel became unable to maintain its position and light contact was made with the platform before vessel control was regained. The decision was made to return to port for investigation.

Investigation highlighted that when auto DP is deselected, all thruster setpoint references move to zero for the deselected surge, sway and/or yaw axis therefore when the DPO selected the vessel to manual control all thrusters effectively stopped producing force leading to the loss of position.

1. The decision to switch out of auto DP control in order to manoeuvre the vessel out of the 500m zone resulted in the vessel's position loss and contact with the platform. This decision was incorrect and the DPO had a lack of knowledge regarding how the system should perform. Had DP control been maintained, the vessel could have been manoeuvred away from the platform without harm.
2. The DP operations manual did not explicitly state what actions should be taken in the event of a major DP system component failure nor did it explain the consequences on station keeping during DP control mode changes. Guidance: IMCA M 220 – *Guidance on operational activity planning*.

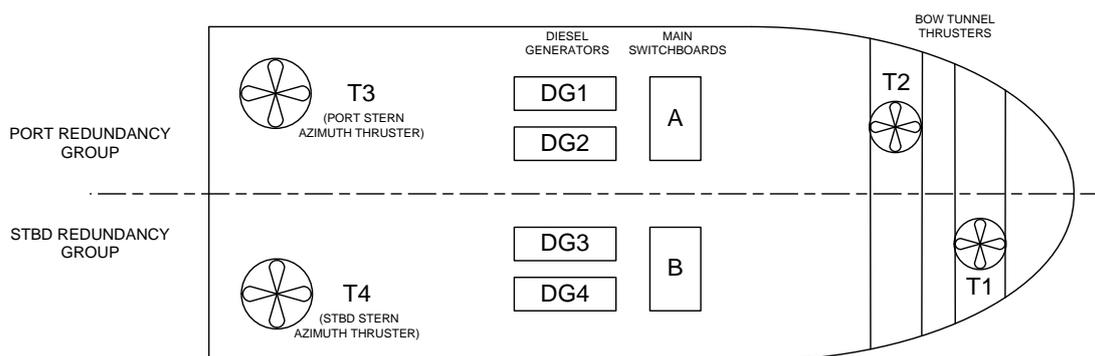
The vessel was set up with power generation and thruster supplies equally distributed across each redundant group as shown in the below example.

The bus ties between the redundant groups were closed creating a common power and propulsion system and DG1, 2 & 3 were online, DG4 on standby. The weather was typical for the area: wind speed 4kts, current 3.0kts and wave height 1.5m.

The engineer on watch noticed a developing load imbalance across the online engines. DG1 and 3 dropped load quite rapidly, leading to them both being tripped on reverse power protection, leaving only DG2 online. The PMS automatically instigated a standby start of DG4. However, before DG4 was up to speed and synchronised, DG2 tripped on overload, leading to a blackout. DG4 connected to the switchboard as part of the blackout recovery process and the engineers worked to bring DG1 & 3 back online.

An investigation found that the DG2 governor had experienced a mechanical failure, leading to excessive fuel supplied to the engine. The engine therefore 'grabbed' load from the otherwise healthy online machines forcing them to trip on reverse power. The generator protection and power management systems had no way of identifying the faulty machine although the PMS did generate load imbalance alarms prior to blackout.

1. The failure modes and effects analysis did not consider all the potential operating modes. In this case the FMEA did not properly analyse the common and hidden failures associated with closed bus operations, nor did it properly identify the vessel's worst-case failure. There was no clear statement regarding the critical activity mode of operation (CAM) for the DP systems configuration. Furthermore, the FMEA had not been revised for many years and therefore there had been no possibility to improve and further the analysis in light of industry lessons learned since original production. Failures of this nature are well understood and have been well documented in IMCA and other industry guidance for many years. Guidance: IMCA M 166 – *Guidance failure modes and effects analysis (FMEA)*; IMCA M 247 – *Identifying DP system components and their failure modes* (due to be published in Q3 2018).

2. There were no specific operating guidelines for the operation. The DP operations manual was lacking in specific operations data. However, it was acknowledged that the poor level of detail maybe because of a poor quality FMEA and the lack of different operational modes analysed within the FMEA. Guidance: IMCA M 220 – *Guidance on operational activity planning*; IMCA M 166 – *Guidance on failure modes and effects analysis*.
