## IMCA DP Station Keeping Bulletin 04/18

November 2018

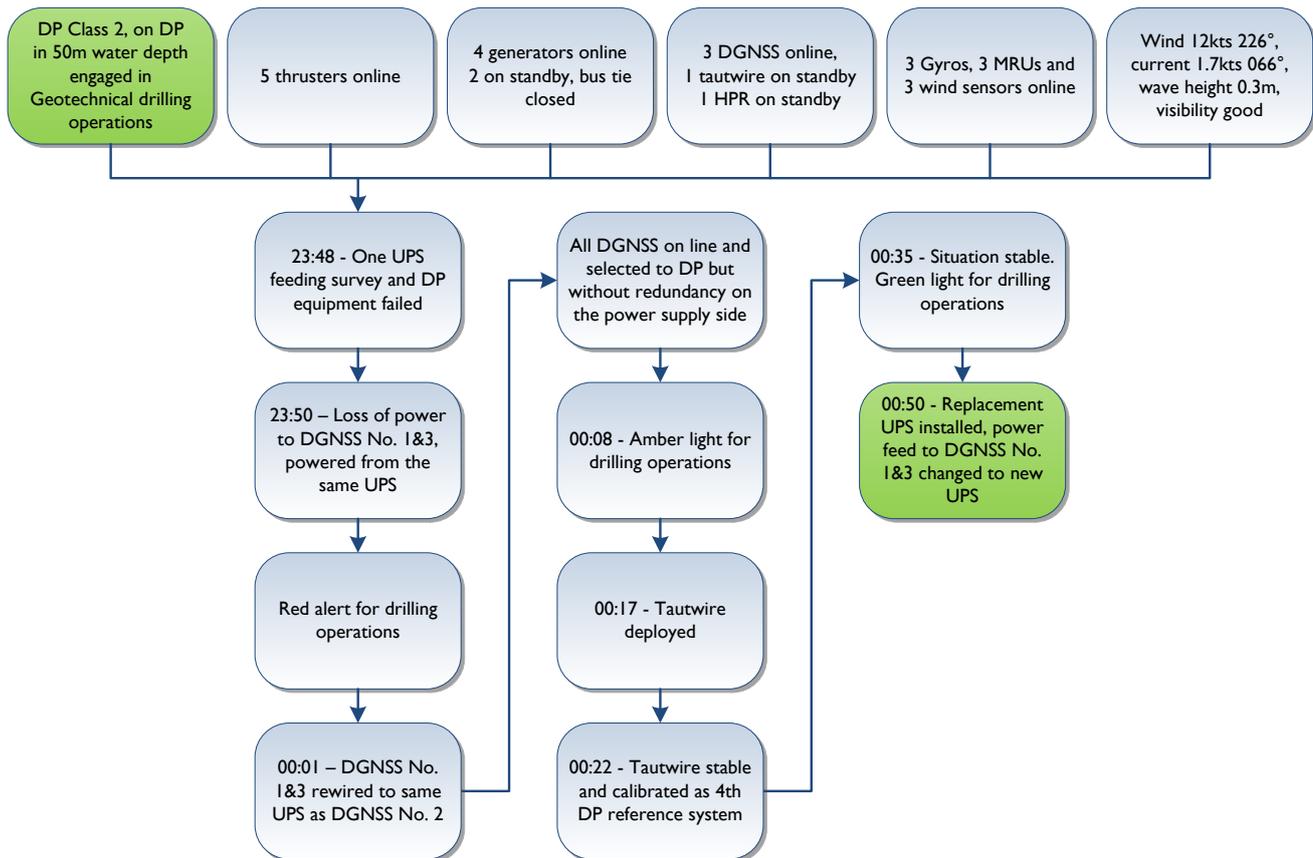
### Event 3: Use of Third-Party Equipment Leads to DP Undesired Event

The UPS and the DGNSS source does not fall under the vessel's planned maintenance system (PMS), as this is owned by the survey company. The equipment is maintained and tested before it is installed on a vessel. While the testing of signal dropout and UPS function is part of the vessel's DP checklists, there is no electrical maintenance or routine testing on the specific UPS while in service onboard; the backup strategy is to keep a spare UPS onboard.

Redundancies worked as designed; no critical situation developed. Drilling operations suspended purely due to loss of redundancy.

An additional checklist to routinely test the capabilities of the UPS was developed and implemented as part of the vessel PMS.

- ◆ The online position reference systems (PRs), 3 x DGNSS, do not provide adequate redundancy according to industry guidance;
- ◆ Considering the time taken to select the taut wire it appears 'stand-by' meant that the depressor weight was still on deck and not deployed;
- ◆ Reference should be made [Guidance on operational activity planning](#) (IMCA M 220);
- ◆ The report indicates that two of the PRs were supplied with power from a UPS that was not designated for the DP system;
- ◆ The DP FMEA should be revisited to verify the effects of failures of the DP UPSs and the power distribution supplying the UPSs. It should be verified that the arrangements, the UPS endurance and the PRS set up for the industrial mission are in accordance with the DP Class 2 requirements;
- ◆ DP equipment should not be repaired and brought online after repair without being suitably tested;

- ◆ A proper assessment should be made, and MoC procedure followed when connecting third party equipment to the DP system;
- ◆ Reference should be made to [Guidelines on the shared use of sensors for survey and positioning purposes \(IMCA M 235\)](#).
