IMCA Safety Flash 27/18

December 2018

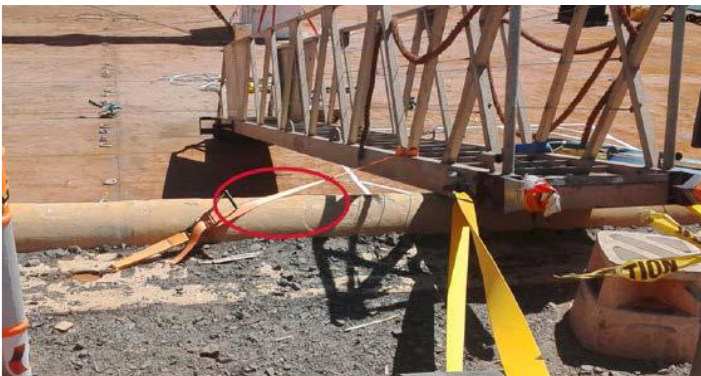
Gangway secured at the high end on the quayside using a cargo strap (cargo strap in direct contact with abrasion point).

- ◆ The method used to secure the gangway securing took no account of a tidal range of 7.5m;
- ◆ The position of the cargo straps securing the gangway on the quayside meant that the straps were in direct contact with the quayside edge, an abrasion point, at low tide;
- ◆ The task was perceived as 'routine'; the personnel involved did not identify the potential for the cargo straps being exposed to an abrasion point and thus failing;
- ◆ The gangway was designed with a roller on its lower end to enable free movement, but this was incorrectly secured, producing tension and failure of the upper securing method;
- ◆ Inspections of the gangway were conducted; however, they failed to identify the potential for the quayside cargo straps to be exposed to abrasion, or that the gangway had been secured at both ends.

- ◆ A task risk assessment should consider and assess the following:

- identification and communication to all stakeholders to establish who is responsible for setting up, monitoring and inspecting gangways
- expected tidal changes and potential vessel movements (due to sea state/weather/vessel traffic in the vicinity) when setting up and securing gangways
- appropriate rigging of gangways (gangways which are designed to be free moving are not to be secured at the roller end and should have sufficient space to travel and accommodate the tidal range and any barge movements)
- regular inspection of the gangway to include free movement of any rollers, checking that the securing method is free from obstructions and abrasion points.

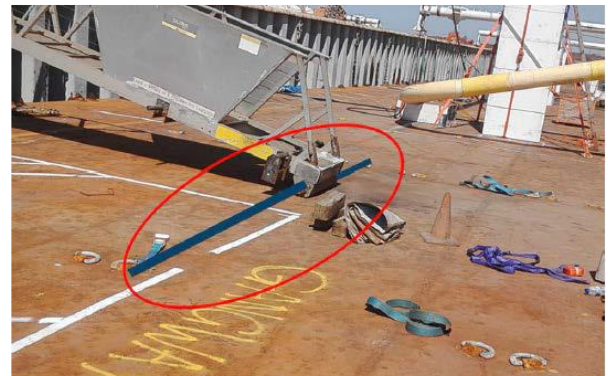
Gangway secured at low end (roller end) using a cargo strap.

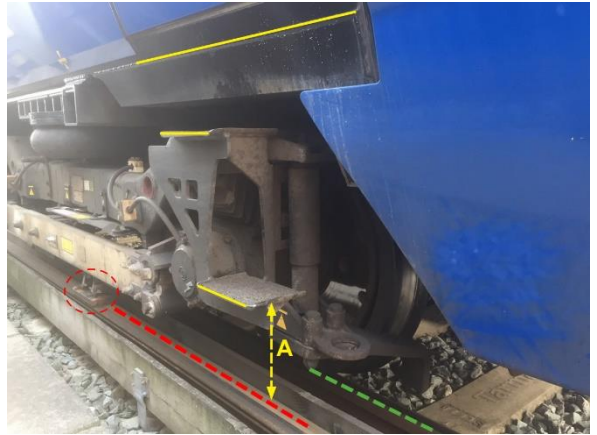
A train with 450 passengers on board failed just outside a railway station during the evening rush hour. The fault on the train had caused the brakes to apply and the driver was unable to release them. The driver took advice over the radio and, following this, began to evacuate the passengers to track level. This involved passengers climbing down vertical steps to ground level, to within 30 centimetres of the live electric conductor rail (750 V direct current), and walking along the side of the line for about 30 metres to the station.

Although no-one was hurt in the incident, the close proximity of the energised conductor rail to the evacuating passengers posed a significant risk of serious harm.

- ◆ Causes identified by the RAIB:
 - the train driver was given **instructions by control room staff who had misunderstood** the actual location of the stranded train (the control room staff thought the train was actually in the station)

- the train driver and the signaller **did not reach a clear understanding about the actions that were required** to safely detrain the passengers
 - the delay caused unrest among the passengers on the train and contributed to **stress and task overload of the driver, which affected his decision making**

- the driver's experience and skills did not enable him to cope with these demands, and **those responsible for the track did not effectively implement their own procedures** for managing an incident involving a stranded train;

- ◆ The importance of following the correct procedures when preparing for incidents and/or emergencies;
- ◆ Ensuring that communications are properly understood;
- ◆ Ensuring that details of incidents are promptly and effectively communicated.

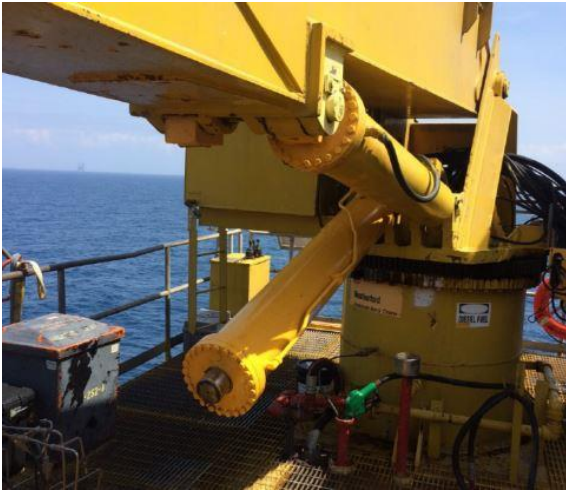
Incident 1

In the first incident, a hydraulic boom cylinder recently installed was compromised when the cylinder rod separated from the cylinder rod eye. This caused the cylinder to drop to the deck below. As there were two cylinders on the crane, the failure did not cause the boom to collapse.

- ◆ In the cylinders that failed, the pin-to-pin lengths were different – this was due to different rod lengths;
- ◆ The difference in rod lengths meant that when the cylinders were working in tandem, the shorter length cylinders experienced stress at the rod pin coupling;
- ◆ The stress, alongside an inferior weld, resulted on a failure of the rod pin coupling and rod connection. This failure led the rod to separate from the rod pin coupling, causing the cylinder to fail.

- ◆ Ensure equivalent eye-to-eye rod length of hydraulic boom cylinders, when repair of one is necessary;
- ◆ Review crane cylinder configurations;
- ◆ Make the original equipment manufacturer aware of the failures (regardless of the manufacturer) – BSEE recommends that operators obtain any replacement hydraulic boom cylinders from the original equipment manufacturer, or a certified manufacturer.

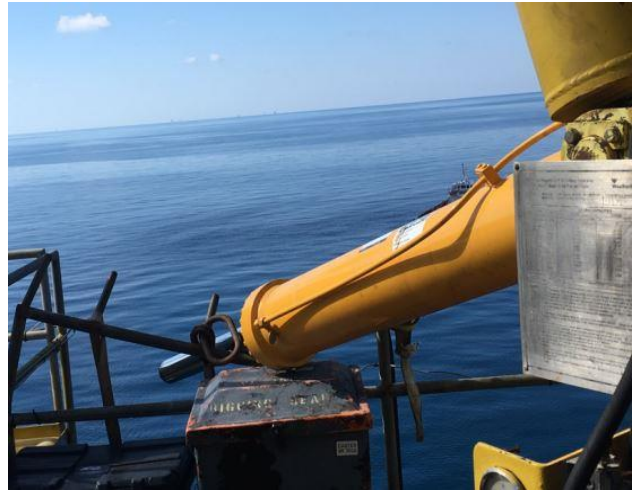
Incident 2

In the second incident, a replacement for the above-mentioned failed cylinder suffered the exact same failure. In this second instance, the replacement cylinder fell and hit a handrail.

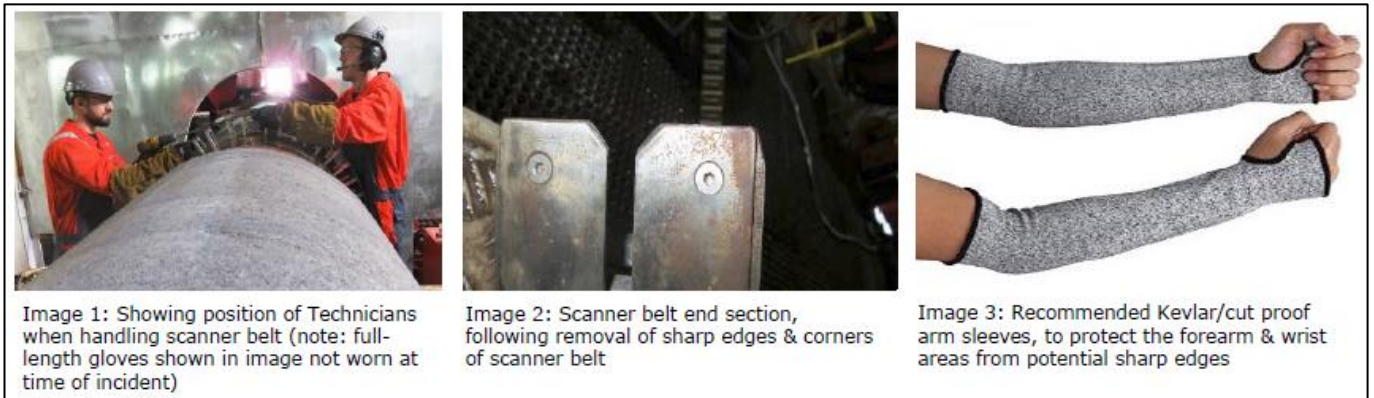
During pipelay operations, two non-destructive testing (NDT) technicians were handling a 'scanner belt', which is used to connect the automated ultrasonic testing (AUT) scanner to the pipe for testing pipeline welds. On completion of weld testing, the scanner belt (approx. 10kg) was released by one of the technicians, and it 'slipped

off' the pipe and made contact with the other technician's wrist. This resulted in a laceration which required 8 stitches. The injured person was wearing full personal protective equipment (PPE). However, the scanner belt made contact with his wrist which was exposed through the gap between the coverall-sleeve and glove.

- ◆ The equipment design did not account for sharp edges and potential risks during manual handling;
- ◆ Personnel involved in the task did not identify the potential for exposure to sharp edges on equipment, and had perceived the task as 'routine';
- ◆ The injured person did not have clear communication or eye contact with the other technician who released the scanner belt. It was also found that language barriers between the technicians contributed to poor communication;
- ◆ The injured person's coverall sleeve had 'crept up' when his arms were reached out, exposing his wrist to contact with equipment.

- ◆ Review of tasks that involve repetitive manual handling of equipment, to ensure that potential sharp-edge hazards are identified and appropriately controlled;
- ◆ Communicate safe manual handling techniques for tasks that involve more than one person dealing with equipment at the same time. This should include focus on good communications to prevent loss of control;
- ◆ Review of similar tasks and associated PPE controls, to identify potential exposure to forearms or wrists, when arms extending outwards or upwards. Consider use of cut proof arm protection, as shown in images above;
- ◆ Reinforce the need for the continual review of controls associated with 'routine' tasks, during toolbox talks (TBT) and hazard inspections.
