IMCA Safety Flash 01/19

January 2019

1 Confined Space Entry: Person Overcome by Fumes and Rendered Unconscious

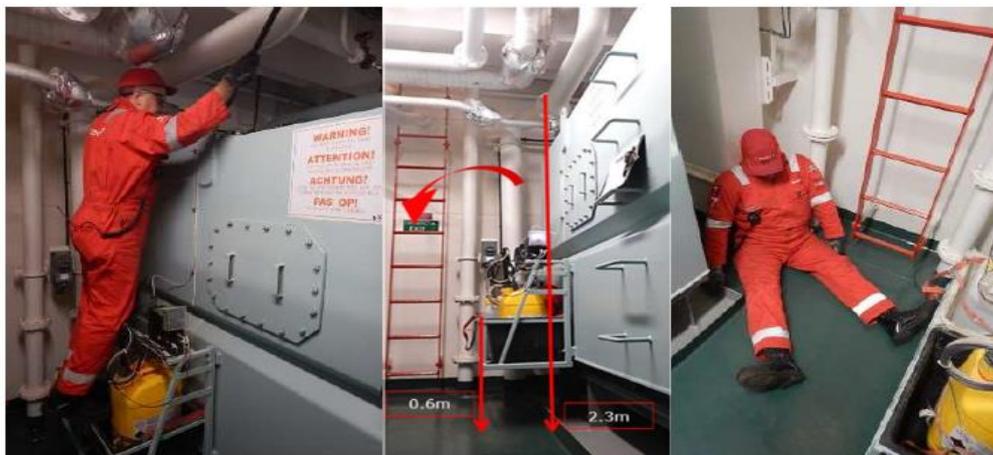
Three crew members on a vessel were tasked with opening a sewage tank inspection hatch to check the condition of a faulty sensor. The hatch was subsequently removed to facilitate cleaning of the sensor, with one individual standing on a fixed rack to gain access. During the task, that individual was overcome by a concentrated plume of Hydrogen Sulphide (H₂S) from the tank, causing him to become unconscious and fall to the deck. He was unconscious for around 90 seconds and suffered minor cuts and bruises to his right hand.

Re-enactment of the incident

- ◆ Safe systems of work were not followed:
 - there was a failure to identify potential hazardous gases as part of the risk assessment
 - there was non-adherence to the permit to work (PTW) procedure
 - there were inadequate working at height controls
 - there was an inadequate tool box talk;
- ◆ The manufacturer’s instructions for opening the inspection tank were not followed. In particular, there was no check for potentially hazardous gases;
- ◆ The sewage treatment plant had not been operated and maintained in line with manufacturer’s instructions, which led to the build-up of Hydrogen Sulphide.

- ◆ Ensure safe systems of work are followed for all maintenance activities including adherence to the PTW, task risk assessment, toolbox talk (TBT), working at height and associated procedures where applicable;

- ◆ Before using or maintaining equipment, ensure that all relevant personnel are familiar with the operation, required maintenance activities, associated risks and required safety controls as defined by the manufacturer's instructions;

- ◆ Ensure that workers tasked with the operation and maintenance of sewage treatment plant are made aware of the potential for H₂S, the risks associated, the required control measures including the requirement for breathing apparatus if there is potential for H₂S release;

- ◆ Re-iterate to all workers that they have a responsibility to **stop the job** if during the work:
 - circumstances change and present new additional risks

- they feel uncomfortable or unsafe or are unsure of the planned task.

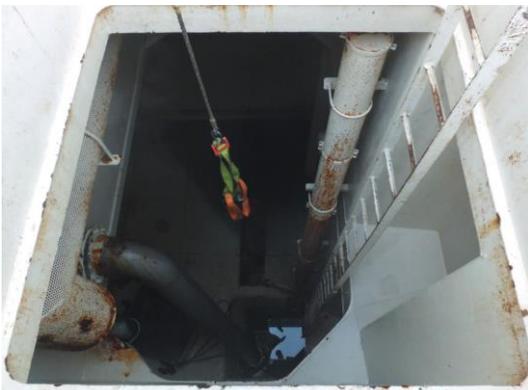
The second engineer entered a refrigerated saltwater tank (RSW) (which was being prepared for cleaning) and collapsed. He was seen lying unconscious at the aft end of the tank by a crewmate, who immediately raised the alarm. Three of the vessels' crew entered the tank and tried to resuscitate the second engineer, but they soon became dizzy, confused and short of breath. One of the crew managed to climb out of the tank unaided, the other two crewmen and the second engineer were recovered onto the open deck by two crewmen wearing breathing apparatus. The two crewmen made a full recovery, but the second engineer could not be resuscitated and died.

RSW tank

It was unclear when and why the second engineer entered the tank. However, evidence indicated that his intention was to sweep the residual seawater that had settled at the aft end of the tank forward in to the tank's bilge well.

No safety procedures for entering or working in RSW tanks had been completed before he entered the tank.

- ♦ Working in enclosed or confined spaces is potentially hazardous; procedures for entering and working in them should be robust, understood and utilised;
- ♦ Enclosed space rescue plans need to be in place on all vessels, risks must be understood, and rescue plans practised;
- ♦ All crew members have a responsibility for their own safety; this is particularly important in respect of lone working.
