# IMCA DP Station Keeping Bulletin 01/19

February 2019

The following case studies and observations have been compiled from information received by IMCA during 2019. To ensure anonymity all vessel, client and operational data has been removed from the narrative.

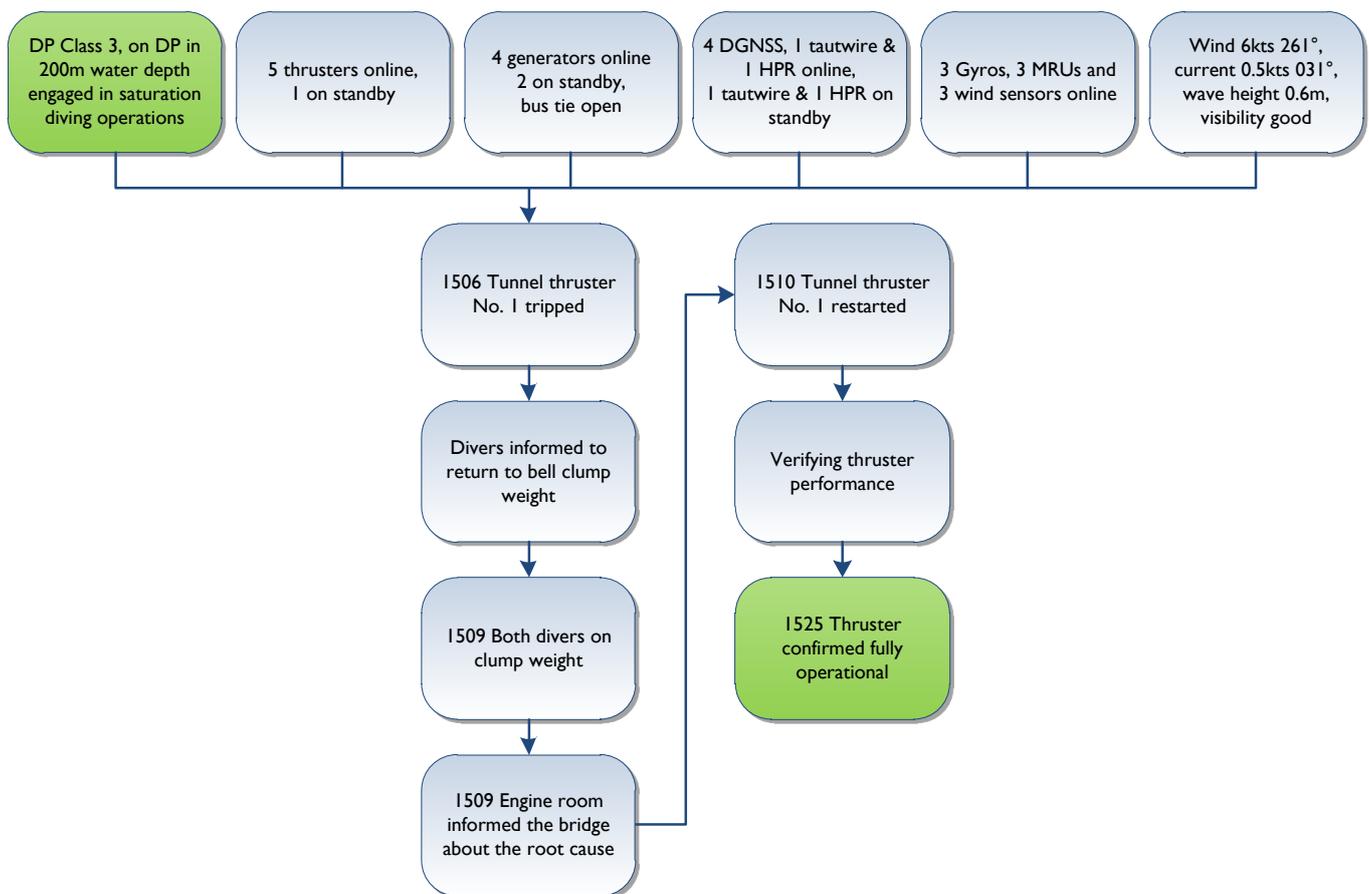
## Event 1: Loss of Tunnel Thruster – DP Undesired Event

During diving operations in open water, tunnel thruster No. 1 tripped offline. Investigation showed that the cause was due to tripping of the thruster hydraulic pump because of voltage instability. The voltage instability was caused by a spike load on an unrelated circuit breaker on the same switchboard which tripped. Because of the voltage drop on starboard 690V switchboard during the event some of the equipment breakers opened on under voltage:

- ◆ Tunnel Thruster No. 1 due to power drop to hydraulic pump and signal command “External Shutdown” from controller to frequency converter drive.
- ◆ Starboard ER fans.

The vessel maintained position throughout the event.

- ◆ This event highlights how unrelated equipment failure can have an effect on DP system equipment and therefore the vessels redundancy concept and needs to be considered during failure analysis.
- ◆ It is assumed that redundancy was not compromised by the tripping of the tunnel thruster and therefore it was not necessary to initiate a DP amber alert.
- ◆ It is not good practice to have 4 DGNSS selected to the DP controller, this could result in rejecting other selected systems if the DGNSS were to drift due to a common satellite problem.
- ◆ The root cause should have been identified and isolated from the 690v switchboard before the thruster was re-enabled.

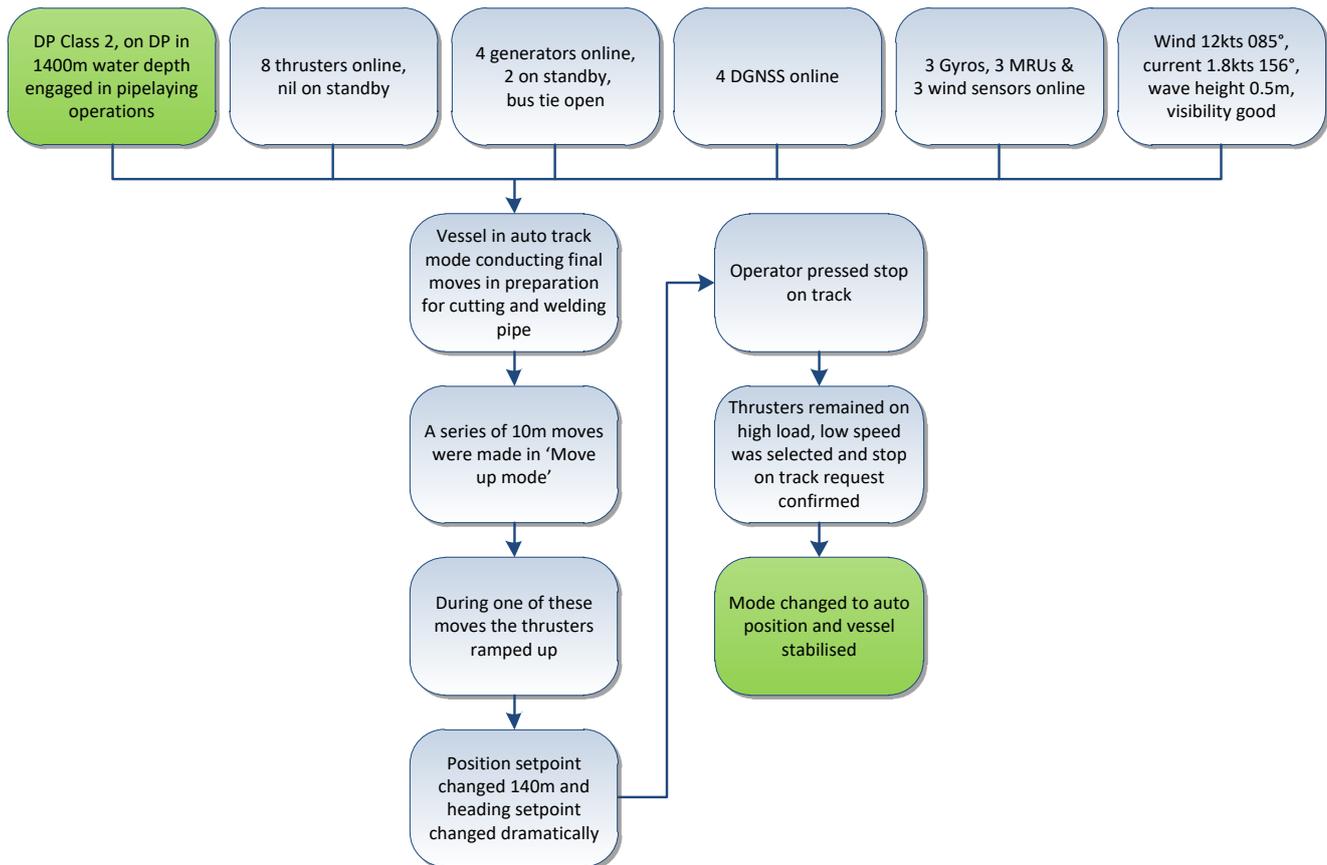
## Event 2: Specialised Pipe Laying DP Mode – DP Undesired Event

When the vessel was confirmed stopped and on the setpoint, the operator checked the auto track setting to find the cause of the track change. Upon checking, it was verified that the 'waypoint for radius turn' had changed to 'operator' a pre-set value of 200m; the vessel standard setting is 'waypoint table'. The operator reselected 'waypoint table' and the previous barge track was displayed.

During investigation, the vessel crew were able to recreate the failure. Since the incident occurred the log files have been forwarded to the DP system manufacturer for review. The conclusion is that the issue is specific to move-up mode.

The position setpoint changed dramatically to about 140m, heading setpoint also changed to 14 degrees and thrusters started ramping up. This was due to a dramatic change of barge track

The barge track changed from a waypoint table selected radius of 1828m to 'Operator' selected of 200m.

The selection of "operator specified turn radius" (radio button selection) should be inhibited and "greyed out" when vessel is in a turn while move-up sub mode is active. This inhibit function was not activated when the dialog box was opened again after the "auto – turn – move up" function had been activated. Four conditions have to be aligned for this to happen. The "move-up" mode was introduced in 2002 and this is the first time this was reported to the original equipment manufacturer. So, the MTBF is 15-years but of course the consequence could be damage to the pipe. A software modification has been made, installed and tested on this specific vessel. The global customer support team have a process in place to go through all software releases which have this function and update the vessels that are affected during next service visit.

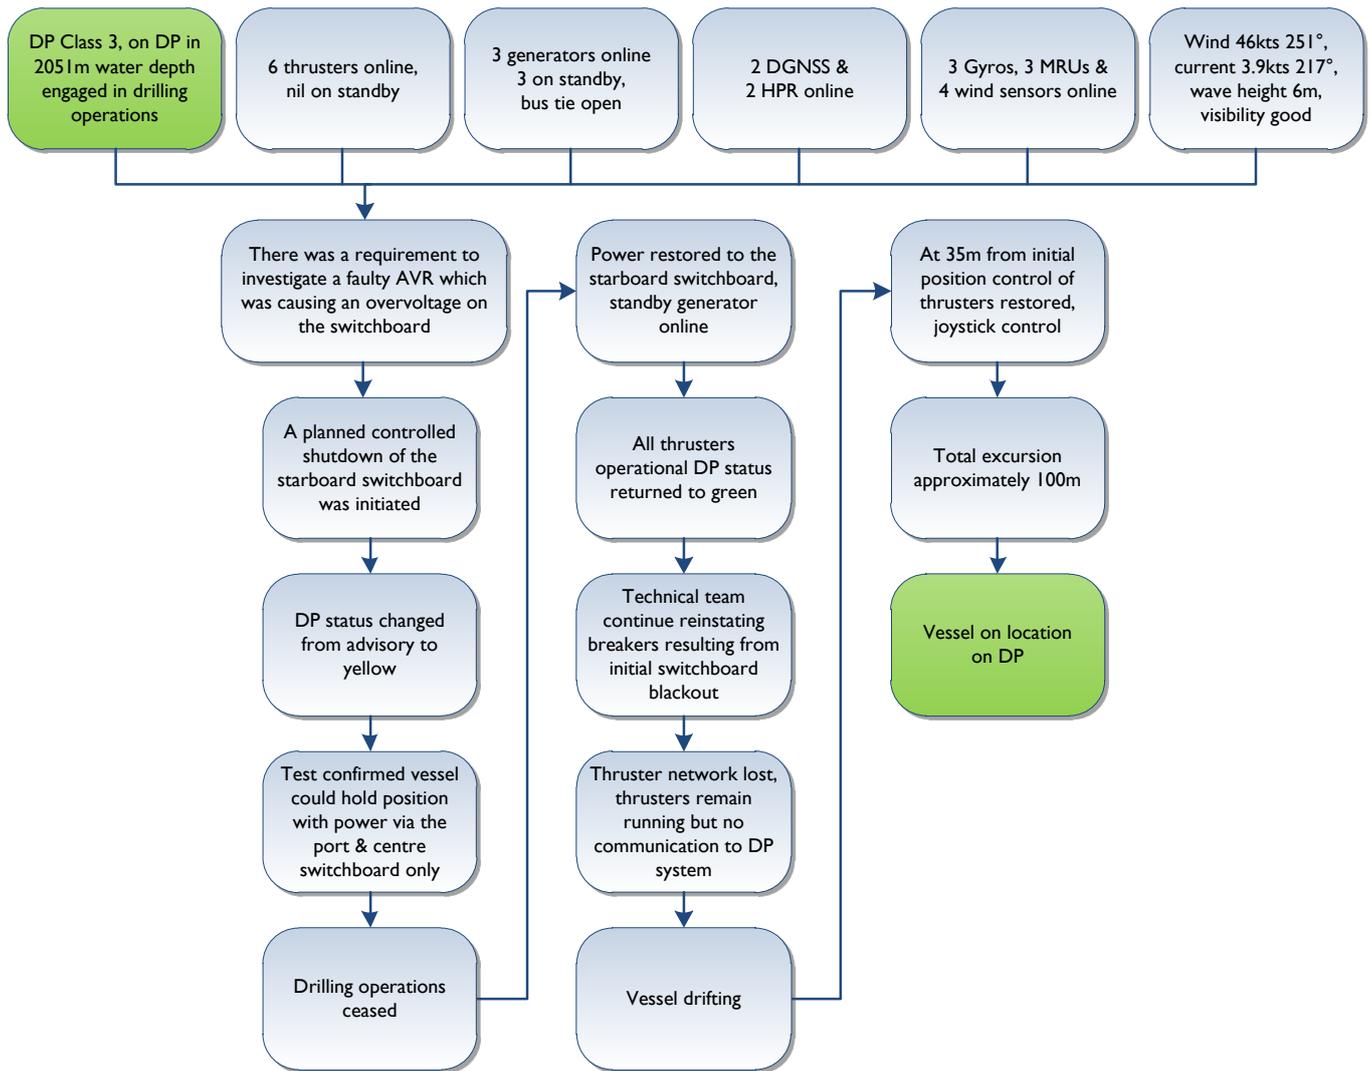
### Event 3: Planned Investigation Resulted in DP Incident

An AVR problem in diesel generator No. 1 engine caused an over voltage in the system. Due to increased voltage, the standby machine could not be brought online, and the switchboard required a controlled blackout. After this, many alarms from Network B were observed due to the supply being interrupted. An hour later, there was a total loss of network communication affecting many field stations together with loss of DP communication to all thrusters, which caused the vessel to drift off. The probable cause was accidentally resetting network A, when trouble shooting of network B was taking place.

Further investigation of the overvoltage issue found a 3-phase breaker was faulty to engine No.1; the breaker was replaced by an onboard spare. The DP system manufacturer concluded that the vessel was operational as designed, indicating a possible human mistake by rebooting network A.

Given the circumstances, it is evident the vessel returned to normal operations too quickly and whilst reinstatement of the system was still in progress. The root cause of the incident was not given in the report, but it is evident that work involving the resetting of the network caused the loss of DP communication with the thrusters and subsequent position excursion. While total network failure and subsequent drift off represents a DP incident, the initial failure of the AVR only represents an undesired event.

The vessel instigated a DP yellow alert whilst a fault was investigated. Considering the weather conditions and nature of investigation the vessel should have either abandoned operations or been fully prepared to do so.

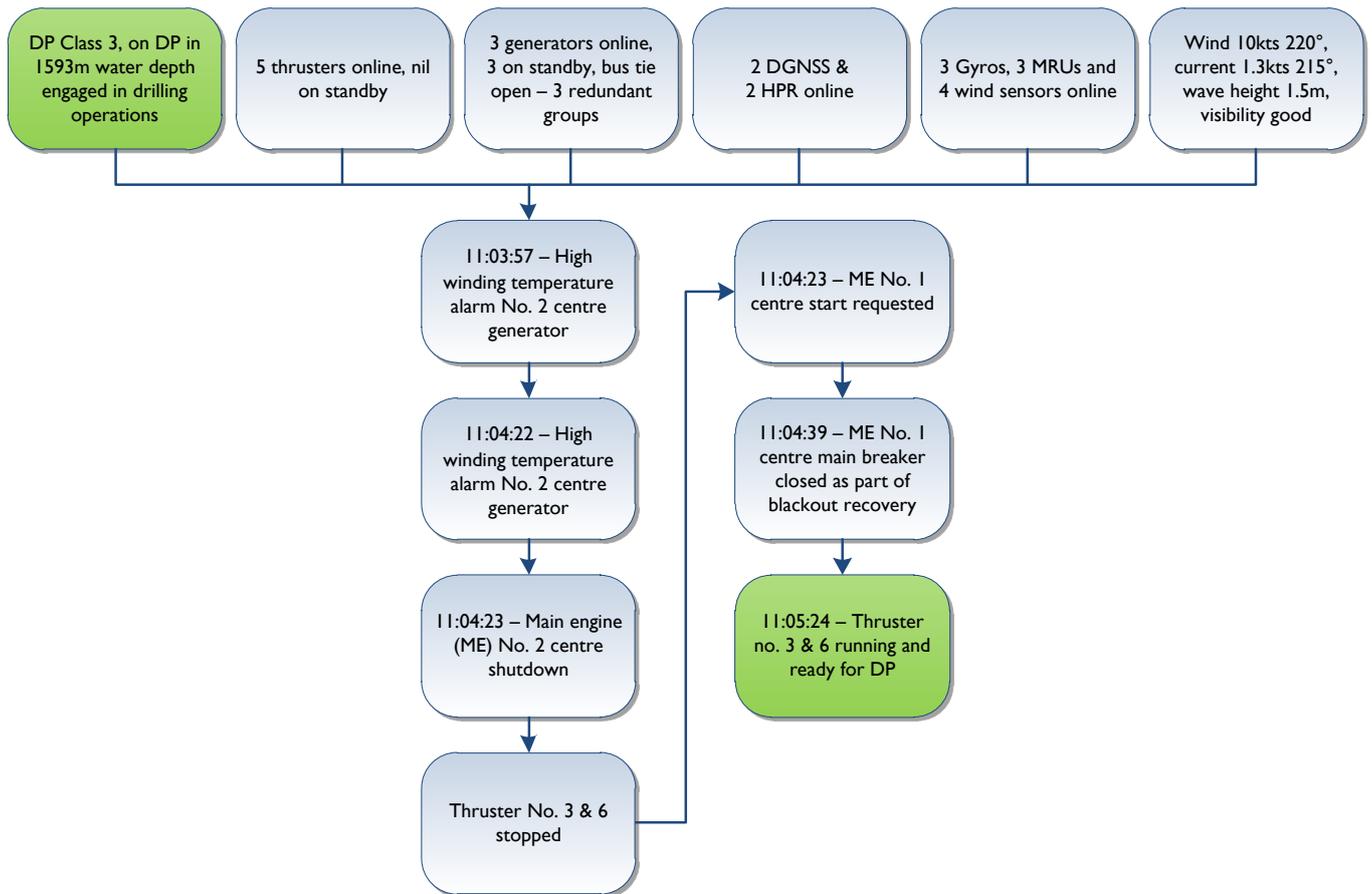
## Event 4: Loss of One Redundant Group – DP Undesired Event

A partial blackout of the centre high voltage (HV) switchboard at 11.04am caused by No. 2 generator. This caused the loss of the 440V distribution board and thrusters No. 3 & 6. The centre generator No. 1 started and connected onto the switchboard, there was no loss of power to the drill floor as this is fed from both port and starboard HV switchboards. The power management system worked as expected, investigation found a poor connection to the temperature sensor of No. 2 generator causing the temperature fluctuation.

There was no loss of position.

- ◆ With the loss of one redundant group DP amber alert should have been activated.
- ◆ The system reacted well to the loss of the centre switchboard however it was felt worthwhile to highlight the configuration in this case. The vessel was operating with one generator on each of the three switchboards. Therefore, it was accepted that if one generator failed then one redundant group would be lost.
- ◆ It is important that DP personnel are fully aware of the situation and recognise that there could be a degree of risk as the switchboard is brought back on line.
