IMCA Safety Flash 03/19

February 2019

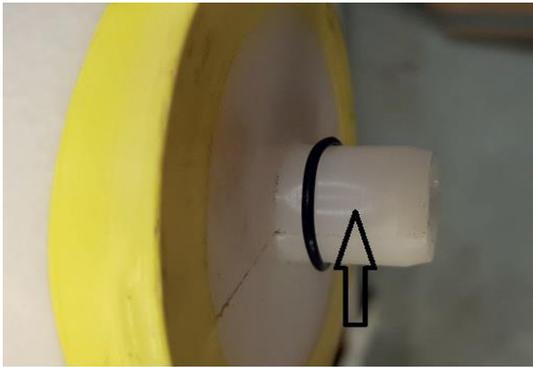
A manufacturing defect has been identified with a batch of the components used for the bottom nozzle of the cartridge. Some of these nozzles are misshapen and will not correctly seal the disposable cartridge into the stainless-steel pressure housing. This will lead to a certain amount of the non-treated gas bypassing the cartridge and not being subject to the treatment provided by the chemicals within the cartridge.

Figure 1: example of damage

Any unit which is found or suspected to be defective should not be used and should be returned to JFD for replacement. Any item of which the user is unsure of its suitability can be returned to JFD for assessment.

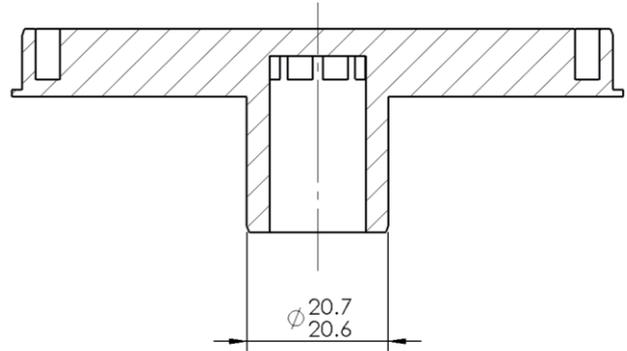
Figure 2: dimensions of nozzle

1. Visually inspect the nozzle on each cartridge to check for damage similar to that shown in Figure 1.
2. Grip the nozzle between the thumb and forefinger and rotate the cartridge to check for flat spots, out of roundness and any other damage missed during the visual inspection.
3. Using suitable digital callipers, check the OD of the nozzle is 20.7mm/20.6mm as shown in Figure 2. A number of different diameter measurements should be taken to confirm the roundness of the nozzle.

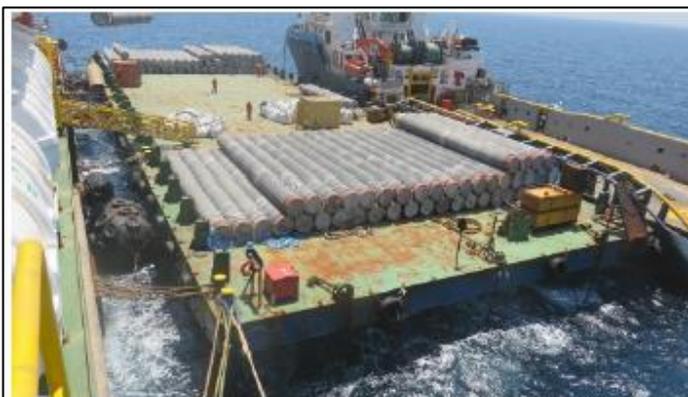
Image#1: Showing the bow-center bollard's position on the cargo barge.

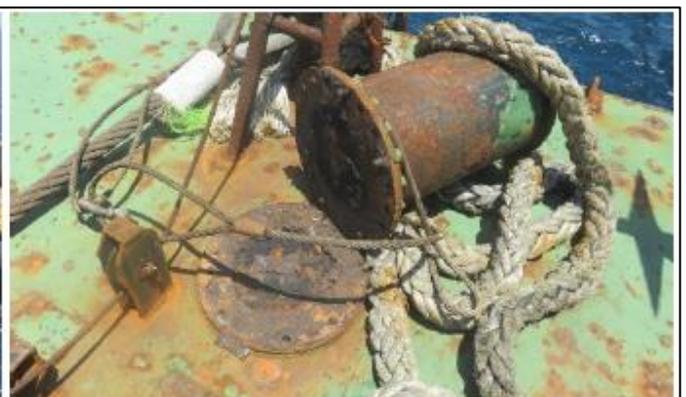
An all-stop was called and the winch was operated to slacken the mooring line. Upon inspection, it was found that the bollard was in very poor condition and that all of the securing bolts were corroded, to the extent that they were not connecting the bollard to the deck of the barge.

Image#2: Cargo barge bow-center bollard laying on deck following the incident.

- ◆ This centre bollard was not designed to be used for mooring operations. Instead, it was in place for the securing of the barge's tow bridle, when not in tow. This particular bollard, rated 25 T SWL, was not fit to perform its designed purpose and hold any weight;
- ◆ The condition survey for the barge did include inspection of all mooring bollard but not the bow centre bollard which was not designed or planned for use;
- ◆ NB: The classification certificate for the barge was valid and class inspection conducted in March 2017.

- ◆ Cargo barge mooring arrangements should be properly engineered, and clearly defined in any procedures, with usable mooring points clearly identified;
- ◆ Cargo barge condition survey process should include visual inspection of all items to be used during barge operations;
- ◆ Bolted load bearing structures, exposed to the marine environment, should be subject to detailed inspection such as removal and inspection of the bolted connection, which may have experienced corrosion and rapid degradation even within the certification validity period.

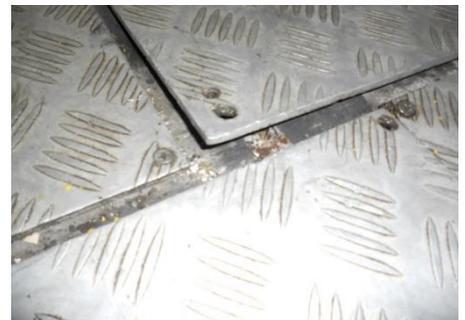
An engineer was injured when he stepped on a loose deck plate. The incident occurred during a dry dock, when an engineer was walking in the engine room searching for a tool and he stepped on a loose floor plate. The floor plate was not bolted down and slipped sideways. As the plate moved, his leg started falling to the bilge well below, and the opposite end of the plate flipped upwards and struck his abdomen. He sustained a large laceration to his abdomen which was attended to in the local hospital and required seven days off work to recover.

There had been recent overhaul of diesel generators; when completed, floor plates removed to facilitate that overhaul had been replaced but were not screwed down.

- ◆ Fitted stoppers (flat bars) for plates to prevent recurrence;
- ◆ Secured all loose floor plates by bolts;
- ◆ Conduct a hazard hunt inspection to identify all similar loose floor plates;
- ◆ Modified safety inspection schedule and risk assessment to include checking of floor plates, gratings etc.;
- ◆ Re-assess high level response to shipyard safety based on [IMCA guidance](#) to see if it can be more robust.

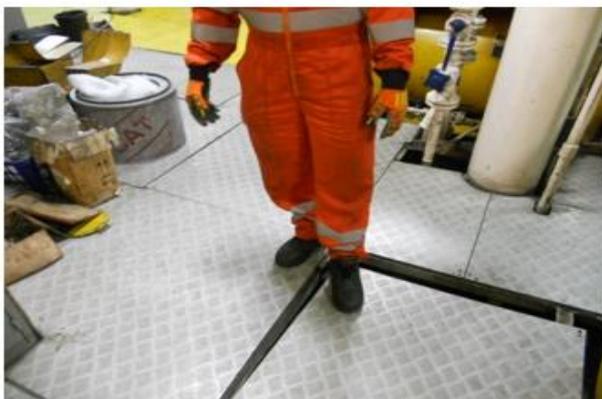
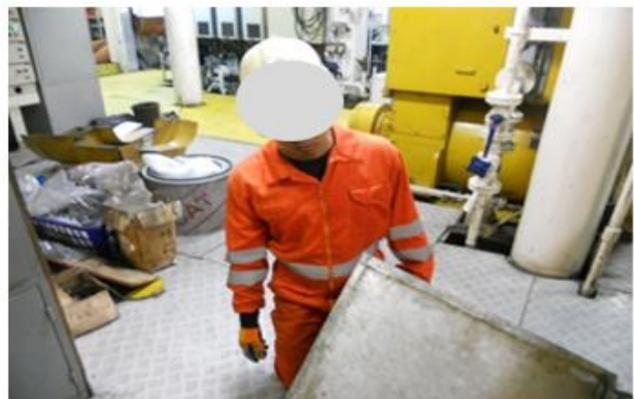
Reconstruction of events leading to the incident

- ◆ No stopping mechanisms were fitted on the supporting frames/bars of the plates in order to stop these plates from sliding to the side. One particular plate was bent upwards at one corner and was able to slide freely if not bolted down;
- ◆ An existing unsafe condition (the loose floor plate) had been spotted but had not been reported or addressed;
- ◆ The permit to work (PTW) closure protocol following the earlier generator maintenance was not followed. No check had been made that the worksite had been returned to safe condition;

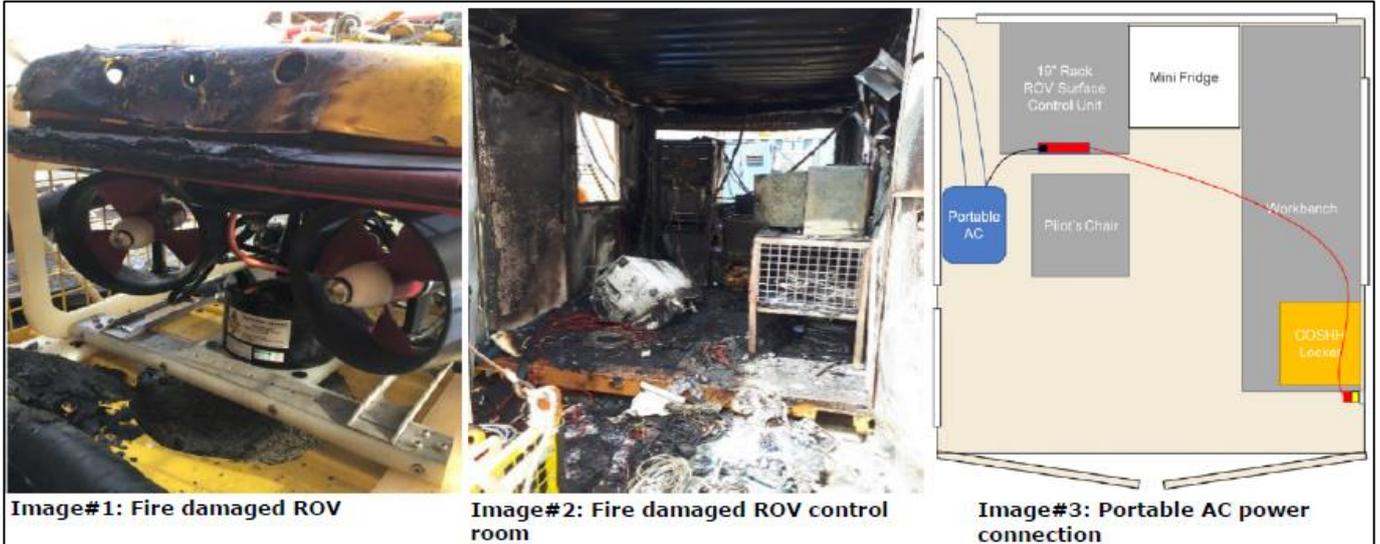
An unmanned ROV control room container, located on the deck of accommodation jack-up, caught fire. The fire team extinguished the on-board fire without any injury to personnel. However, the ROV control room, as well as the 'suitcase ROV' (buoyancy fairing and chassis) were badly damaged.

- ◆ The temporary container was not adequately fitted with fire protection. Only one battery-operated smoke detector and two portable extinguishers were in place;
- ◆ The layout of equipment and materials within the container, including the presence of oily rags, created a fire risk which was not identified or managed during mobilisation or pre-use inspections. There was no evidence of ROV System audit/pre-mobilisation checklists being completed;
- ◆ A portable air-conditioning (AC) unit that was being used within the container was not fit for purpose. The portable AC unit (that was fitted with a 13A fuse) was incorrectly connected using a British-to-M type adaptor, connected to a 16A outlet. An electrical fault from this connection was found to be the most likely source of the fire.

- ◆ Scope of work requirements issued to subcontractors should include project specific requirements and industry standards relating to the electrical safety and fire protection of portable electric equipment;
- ◆ Ensure that all third-party electrical equipment is inspected upon mobilisation to the vessel and confirmed fit for purpose, prior to use;
- ◆ Site inspections and safety inspections should include checking the condition of portable electrical equipment and electrical connections.
