IMCA Safety Flash 07/19

April 2019

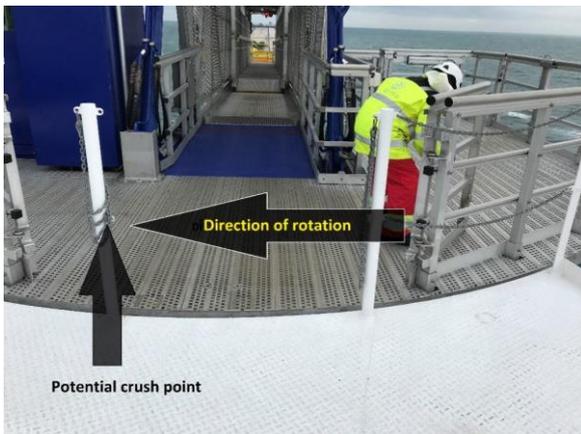
The equipment is programmed to slew to the right (towards stowed position on the vessel). As slewing occurred, the transferee continued forward to get off the gangway platform. While slewing, the guard rail of the rotating platform passed by the posts on the static part of the platform with approximately 19cm clearance between them. Since the transferee continued his transfer, he exposed himself to a potential crush hazard. The gangway completed its slew into its stowed position and the transferee safely exited the gangway platform.

Figure 1: Photo of gangway and railings

- ◆ The **immediate cause** was found to be failure to follow gangway instructions; the transferee continued to transfer from gangway to vessel;
- ◆ **Root causes** identified were:
 - insufficient awareness and lack of risk perception of transferee
 - insufficient design risk assessment – design of platform

- unclear instructions – induction gives ambiguous guidance on correct action if alarm sounds. Instructions are to transfer to vessel (when on static part of gangway), rather than continue to gangway platform and await instructions to continue transfer to vessel:
- ◆ Contributing **causal factors** identified were:
 - bad weather – wind noise contributed to confusion on the gangway;
 - unsafe construction – crush hazard was inherent to design of platform;

- ◆ The vessel Master noted that the post which forms part of the hazard is actually superfluous to operation and the necessary safety features of the gangway and platforms and could be removed without any effect. The post was removed;
- ◆ All crew were to refamiliarize with the gangway transfer safety video;
- ◆ Manufacturer of gangway contacted with suggestion to review/revise their design risk assessment with respect to position of poles on fixed platform in relation to proximity to gates on rotating gangway platform;
- ◆ A further lesson learned is that gangway instructions differ per gangway manufacturer/operator, which causes confusion amongst transferees.

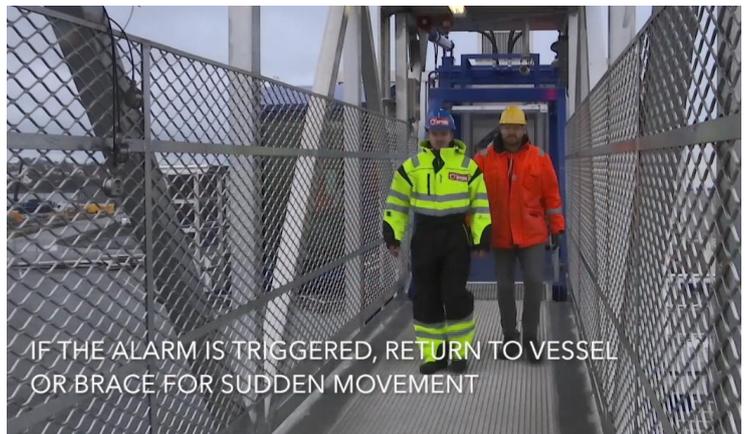
The gangway safety induction video stated to return to vessel or brace in case of an alarm, depending on the transferee position on the gangway (static part of telescopic part).

Figure 2: Screenshot from gangway operator's induction video

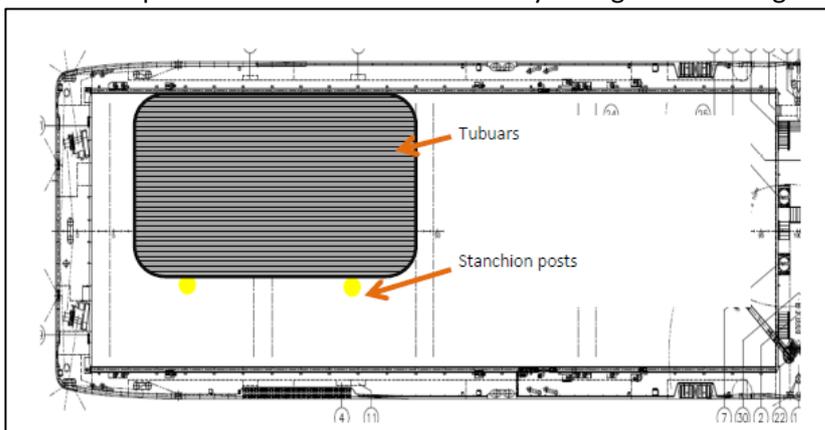
A platform supply vessel (PSV) was on ‘stand-by’ near an offshore Installation waiting on weather. Owing to the sea conditions, the vessel was pitching and rolling heavily. A load of 20" casing had been back-loaded earlier; this load covered two-thirds of the width of the deck on the port side and was stacked two layers high. The casing was secured with pipe stanchion pins. However, on taking a particularly heavy roll to starboard, the pipe stanchions sheared, causing the load to move/roll approximately 3m to starboard, ending up resting against other back loaded cargo.

- ◆ Increased focus on back-load planning and placement of equipment on deck:
 - box in loads with heavier back-load (this would have occurred on this vessel, however, in this case operations were suspended by the crane operator on the installation, due to excessive wind speed);
- ◆ Re-assessment of life-span of securing pins. All pins were replaced with new and welds were subject to non-destructive examination (NDE);
- ◆ During loading/back-loading of casing, risk assessment regarding possible additional stanchion pins was needed, especially during winter periods.

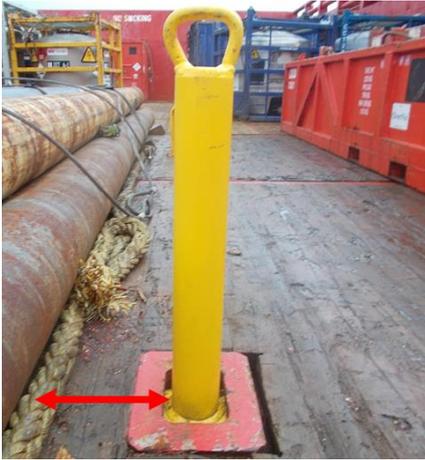
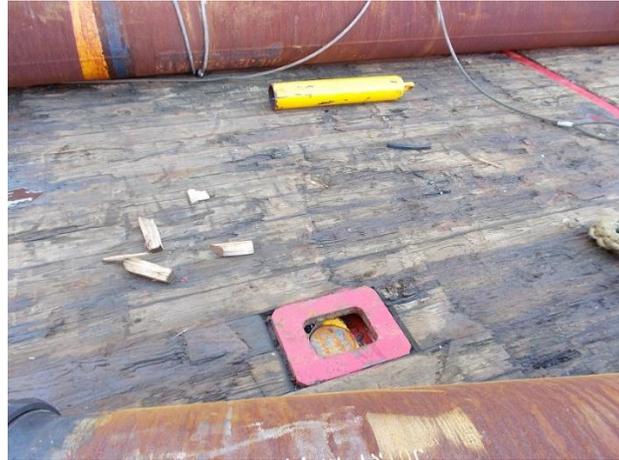
Both stanchion pins sheared at the base/weld (see images below).

It is believed this incident happened because there was a small gap of 10–15 cm between the forward pin and the casing, which allowed additional load on the after pin when the vessel was rolling, thus causing the aft pin to shear. The most recent visual inspections of the pins were within the last three months and were found to be in a satisfactory condition. However, it was later identified that the pins were several years old and had been in use frequently during adverse weather/winter conditions.

- ◆ Incorrect securing method;
- ◆ Poor back-load planning (space between tubular and stanchion pin allowed movement);
- ◆ The welds on stanchion pins failed;
- ◆ Weather and sea conditions.

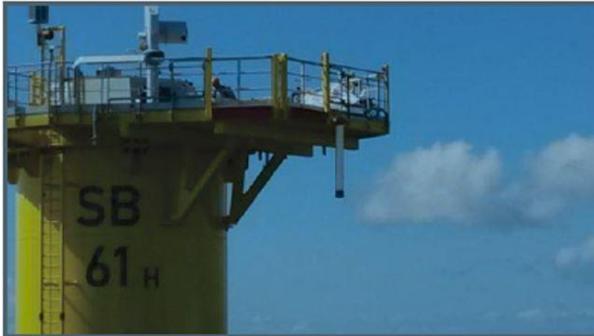
- ♦ The gangway system was tested before the incident and it was observed that the system seemed to be reacting slower than normal, but as it performed well under tests earlier that day it was agreed between operator and captain to start operations;
- ♦ There were slight differences in the push-on point design on this installation (a substation) than on the turbine towers (see illustration);
- ♦ The weather and sea state at the time was within the working limits for the gangway system (actual 1.5 m and 15 knots versus design 3m Hs & 30 knots wind).

Connection point on TP (painted red)

- ♦ AMC performance to be verified during annual inspection;
- ♦ Before connecting the gangway, position the gangway approximately 1m from connection point, visually verify that AMC is stable and that the control error is within reasonable limits;
- ♦ Verify that the connection point is designed to fit the gangway with respect to shape and load.

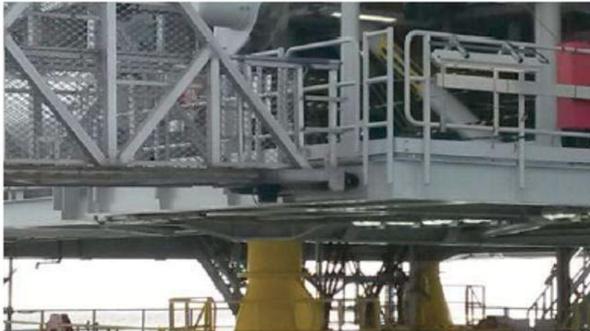
Connection point OSS (regular construction beam)

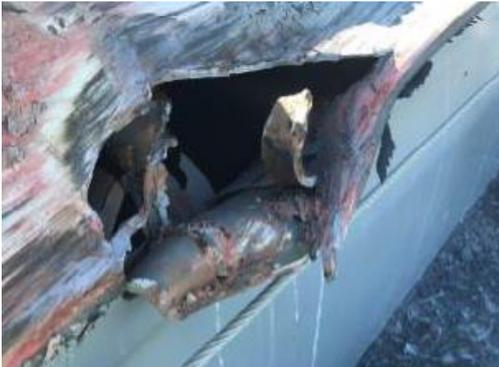
Whilst turning in a river port, a vessel collided with a moored barge. The vessel's port quarter grazed the starboard bow of the barge at around 0.1 knots. Damage to the vessel was not extensive, but the cost of repairing the damage to the barge was estimated to be US\$350,000.

Damage to the Barge

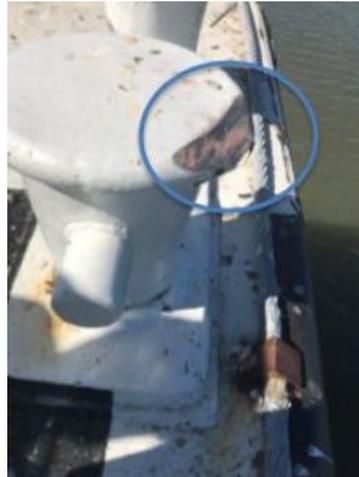
Damage to the Bollards

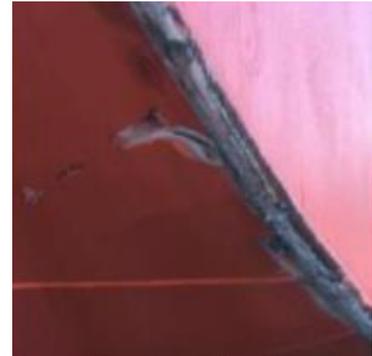
Damage to the vessel
