IMCA DP Station Keeping Bulletin 02/19

June 2019

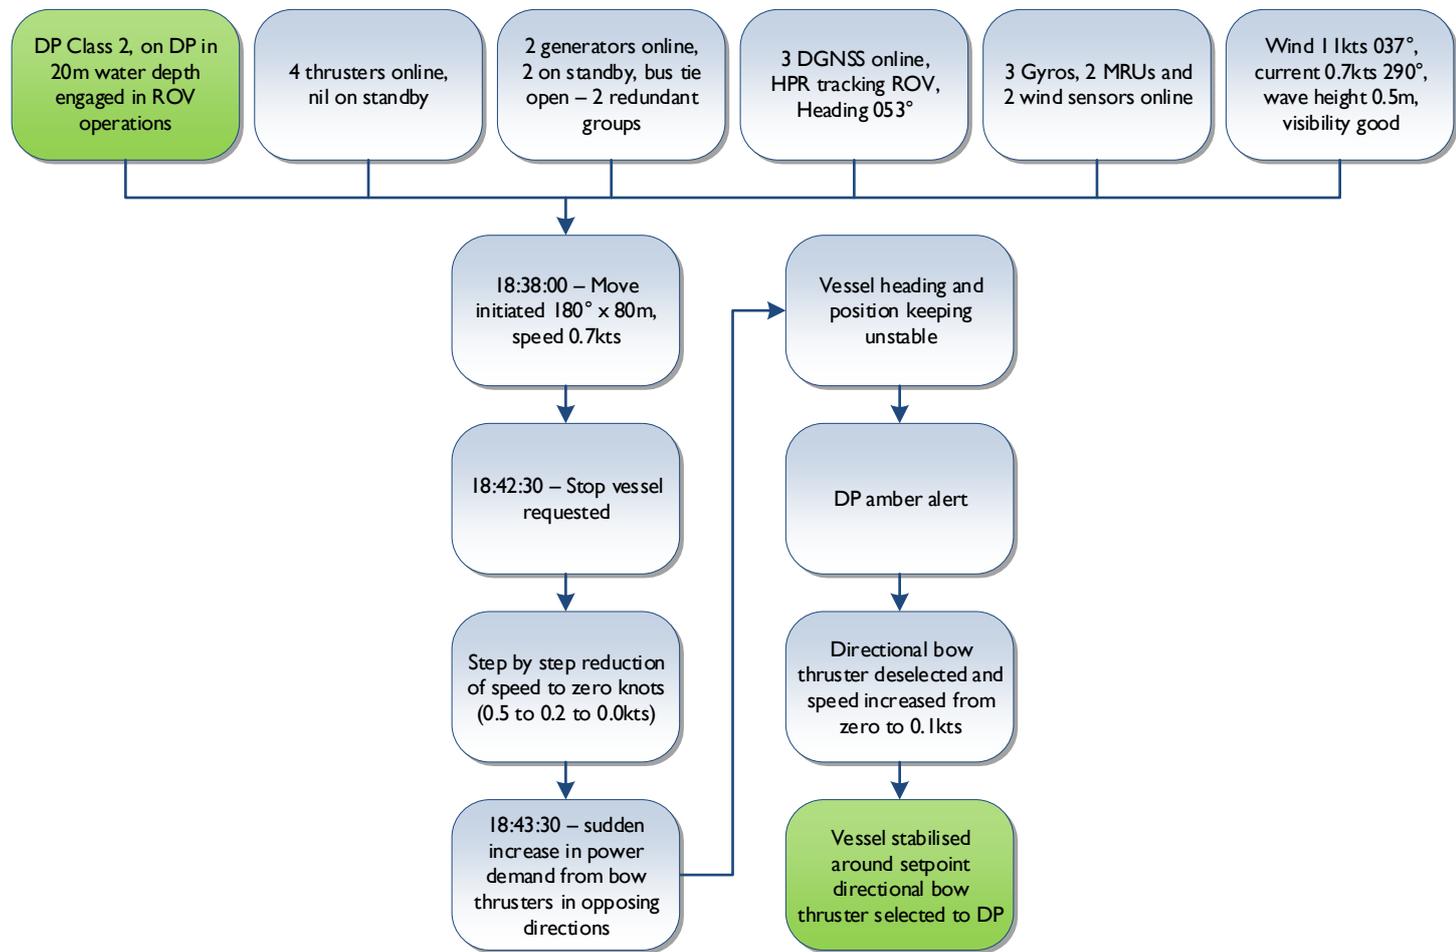
Unfamiliarity with DP System Leads to – DP Undesired Event

Both DPOs had several years’ experience but with a different DP control system where it is common to stop the vessel during a move by reducing speed to 0.0kts. However, on the system fitted to this vessel a retardation factor is used so speed is reduced automatically when the stop request is made.

Setting a speed at 0.0kt led to an unstable situation. The master instructed DPOs to keep a minimum speed on DP of 0.1kts and not set speed to 0.0kts

- ◆ Vessel specific familiarisation programmes and operation manuals should capture and make allowance for crew members not being familiar with systems. Each system/vessel has peculiarities which must be taught and learned by the crew onboard.
- ◆ The DP system manufacturer should be involved as it should not be possible for the operator to apply a valid setting which then causes an unstable DP system.
- ◆ It is recognised practice to slow down during a move, but it is not considered good practice to use zero speed.
- ◆ The use of the present position would maintain the vessel in the wanted position.

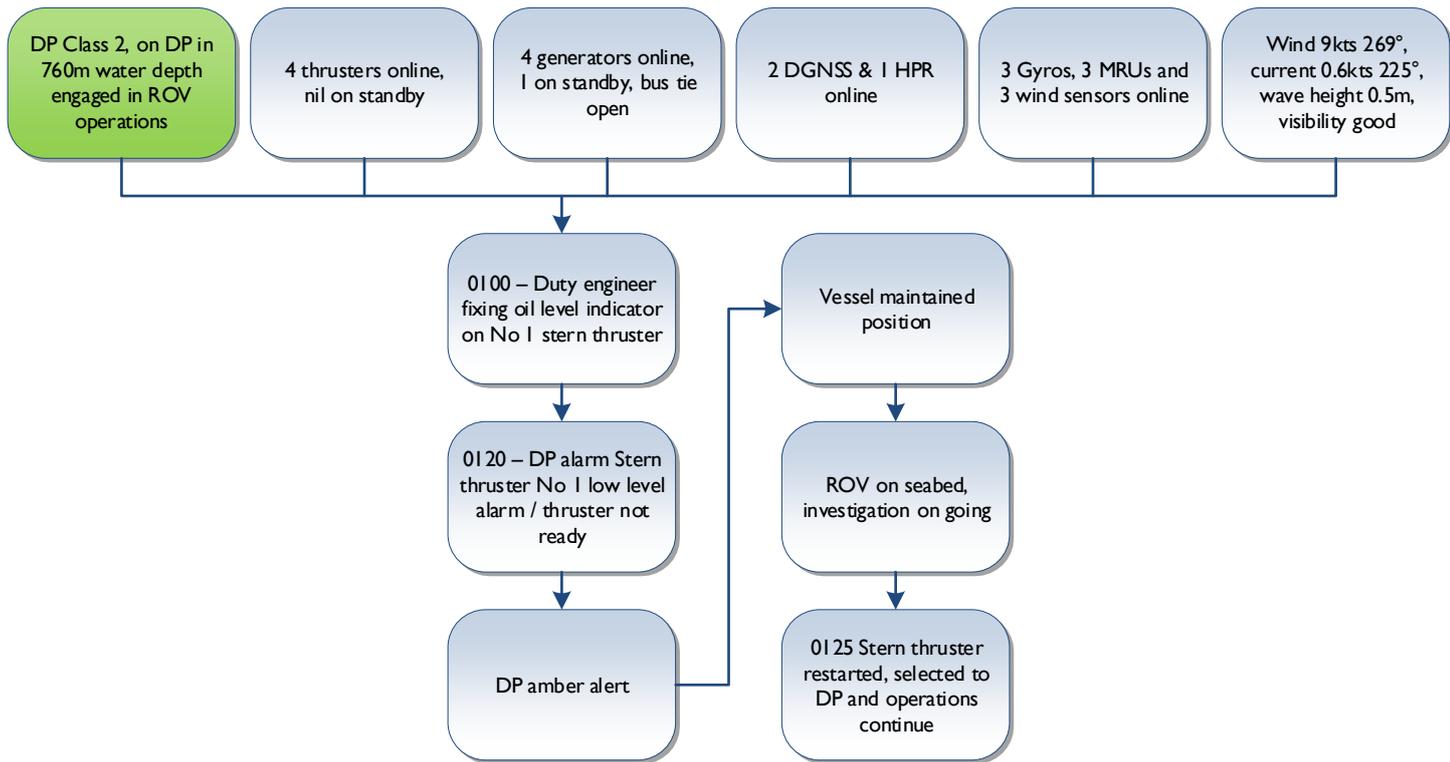
Maintenance During DP Operations Leads to – DP Undesired Event

The oil level gauge was not reading the actual level. The duty Engineer did not inform Bridge/DPO's of maintenance on the header tank of stern thruster. Future instruction was that the engine room would inform the bridge of scope of work of any maintenance to be carried out whilst the vessel was on DP operations.

- ◆ IMCA stresses the importance of sound operational activity planning, full understanding by all key DP personnel of the activity specific operating guidelines (ASOG) would have assisted in managing the operation.
- ◆ DP operations encompass the whole vessel and all personnel need to be trained as part of a team.
- ◆ Standing orders should stress that no maintenance is undertaken during DP operations.
- ◆ In exceptional circumstances and following a capability analysis maintenance could be considered. However, a permit to work (PTW) system should be used that involves and informs all departments.

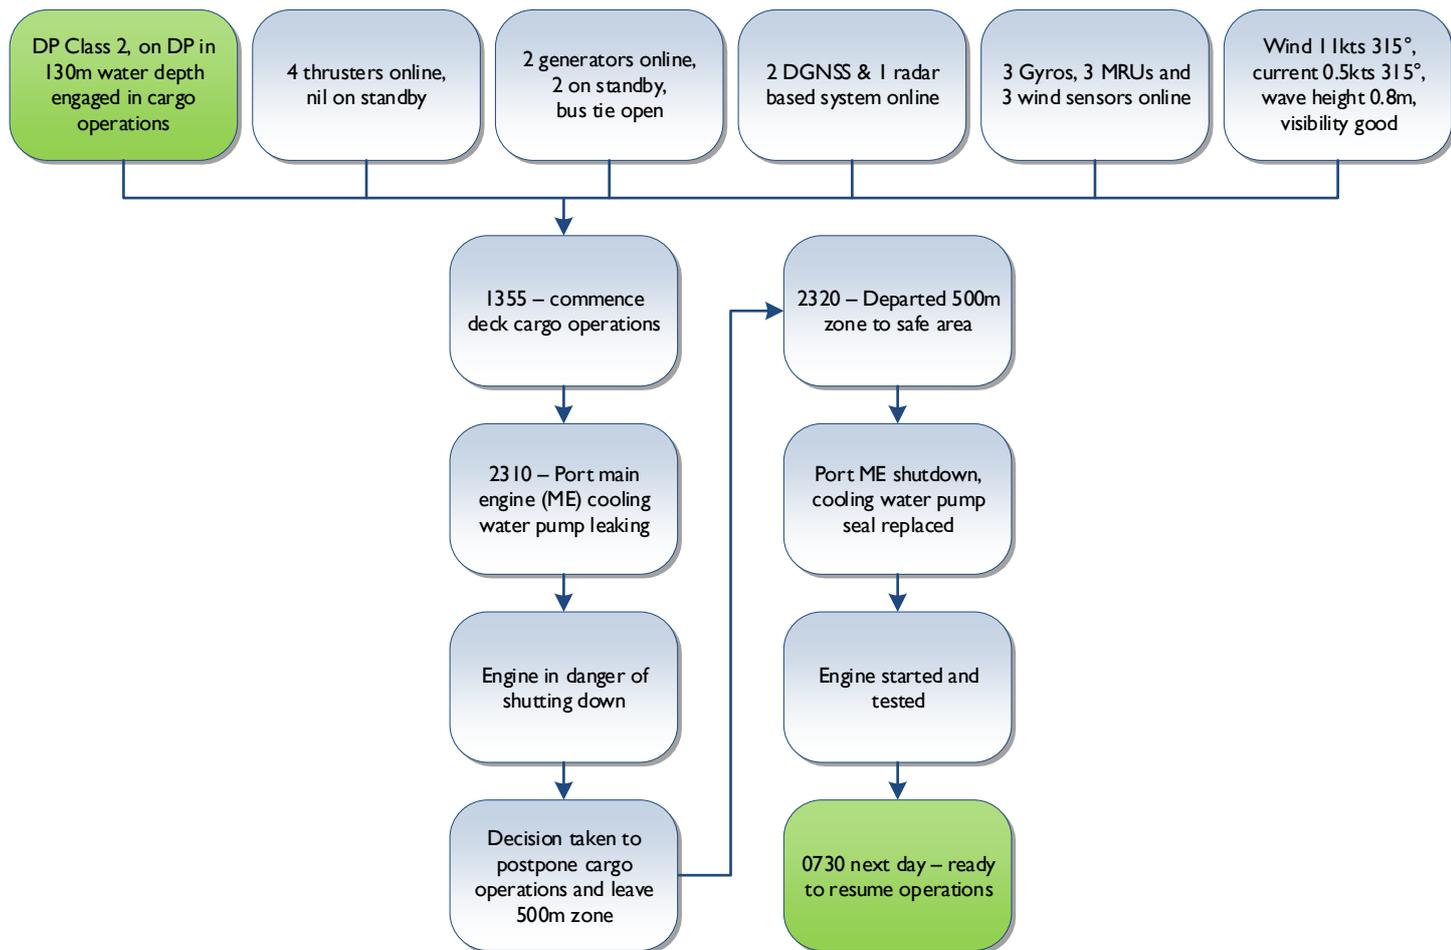
Leaking Cooling Water Pump Leads to – DP Undesired Event

A leaking seal was observed on the Port ME cooling water pump; it was replaced, and the engine tested prior to returning to operations.

- ◆ The event report did not detail the application of any decision support tools such as an ASOG, however the actions taken demonstrated a good example of safe practice during DP operations.

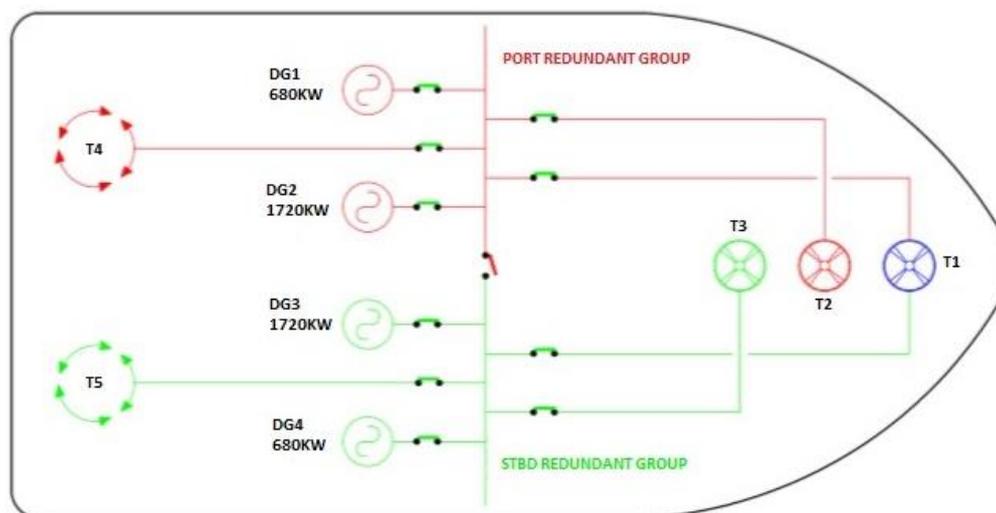
A DP2 platform supply vessel (PSV) was set up on auto DP whilst conducting trials in open water after extensive upgrades. The redundancy concept was based on two redundant groups with power generation, thruster supplies, and all DP consumers equally split between them. Bow thruster 1 was supplied from a dual drive which can be supplied from either redundant group. Each redundant group has dissimilar sized generators as shown in the graphic below.

The vessel was performing a turn when the DG2 breaker unexpectedly tripped, followed by DG4 breaker tripping a few seconds later. The DP operator received alarms indicating loss of the generators and engineers observed alarms for loss of generator protections in the engine control room. The vessel was able to maintain position due to the light sea conditions, but power limitations became active for thrusters in the port redundant group.

Subsequent investigation identified that DG2 breaker had tripped due to a defective Paralleling and Protection Unit (PPU). The PPU is a microprocessor-based protection unit containing all of the functions for protecting the generator. The PPU is set up to trip the generator in the case of over-current, under-voltage, short circuit, reverse power and excitation problems. It is important to note that a generator breaker will also trip if it's PPU loses power or reboots.

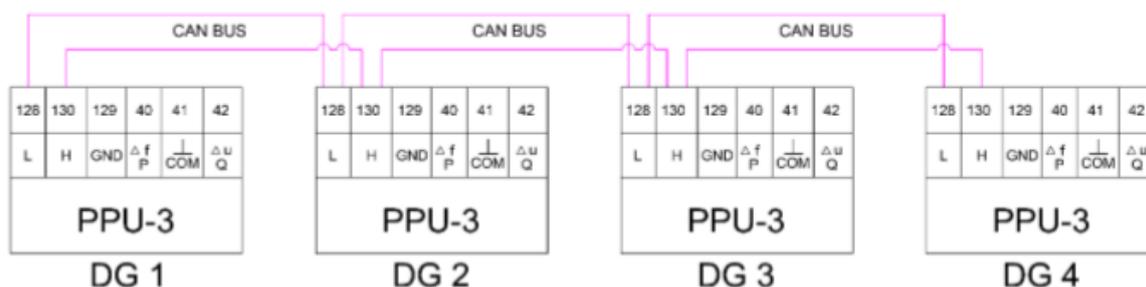
As well as generator protection, the PPUs were configured for load sharing, where the PPU will maintain the rated speed of the engine following an increase or decrease in generator load. The interface between the PPUs for active load sharing was via a 'daisy chained' CANBUS network as shown in the graphic below.

Further tests demonstrated that switching the power supply of DG2 PPU on and off would cause the screens of other PPUs to flash and reboot. This was observed to occur approximately fifty percent of the time. The flashing and reboot would cause the respective generator breaker to trip. It was noted that cycling the power of DG2 PPU could cause any other generator to trip, regardless of redundant group.

Analysis of the faulty DG2 PPU found that it had a defective power supply and a software error. An intermittent power supply fault had caused DG2 PPU to reboot during operation. A 'bug' in the software caused the PPU to boot up with the wrong communication settings and data was sent at the wrong speed to other PPUs over the CANBUS. Receiving data at the wrong speed caused errors in the other units on the CANBUS, causing breaker tripping. The root cause was a coding error in the boot loader software for the PPUs.

- ◆ Although testing of the PPU had been undertaken during FMEA proving trials, the hidden failure was only introduced during the software upgrade. The design of the CANBUS is being further analysed to determine the need for all PPUs to be connected together, rather than just those within each redundant group. The results of this analysis may allow the splitting of the CANBUS and the removal of any potential hidden failure in this system in the future.

The best form of prevention of such a fault is not having unnecessary network links across redundant groups in the first place. Such that any maloperation of software cannot propagate between one redundant group to another.
