IMCA DP Station Keeping Bulletin 03/19

September 2019

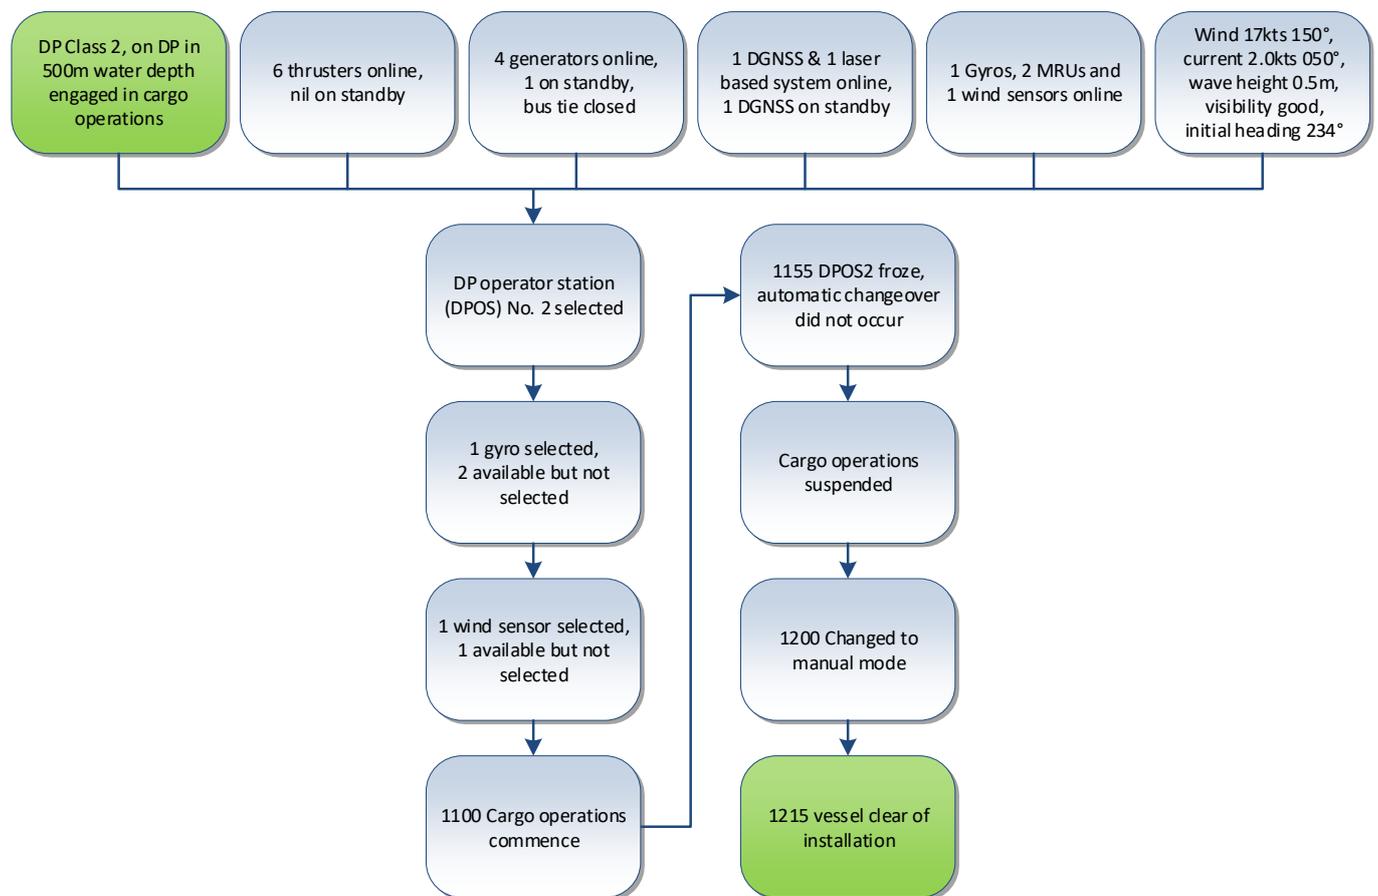
Operating Outside DP Equipment Class 2 Requirements – DP Incident

Although DP checklists were completed, the availability of the standby operator station was not confirmed. The most probable cause for DPOS2 to freeze and not auto changeover was traced to a faulty IO controller on DPOS2. The vessel replaced the controller with a spare held on-board. At the time of the loss of DPOS2, Gyro feed was not available in any one of the controllers. Various position reference systems (PRS) and sensors were deselected and that caused the vessel to go in ‘dead reckoning’ when losing the IO controller on DPOS2.

- ◆ There were not enough PRSs or sensors online to meet requirements for equipment class 2 DP operations.

- ◆ The setup of the vessel and the content of the incident report suggests insufficient understanding and training for both the DP control system and the DP operation.

- ◆ There seems to be some confusion about 'operator station' and 'controller'.
- ◆ The report states that the possible reason that the DP operator stations did not automatically change-over was a faulty I/O controller. A faulty I/O controller should have activated an alarm.

- ◆ If the single gyro online was not available to the DP controllers, it is unlikely that the controller/operator station will change-over to a controller that also does not have an available gyro input. This depends on the system architecture and the DP control system FMEA should have been used as part of the investigation process.

Gyro 1 and 3 were both serviced at the next port call. Vessel simulated auto changeover of the DP Operating system and bump-less transfer was confirmed after maintenance

- ◆ Test of the changeover function between DPOS consoles and DPC controllers should be part of the field arrival check list.
- ◆ The report is inconclusive and suggests that further investigation and testing is required.

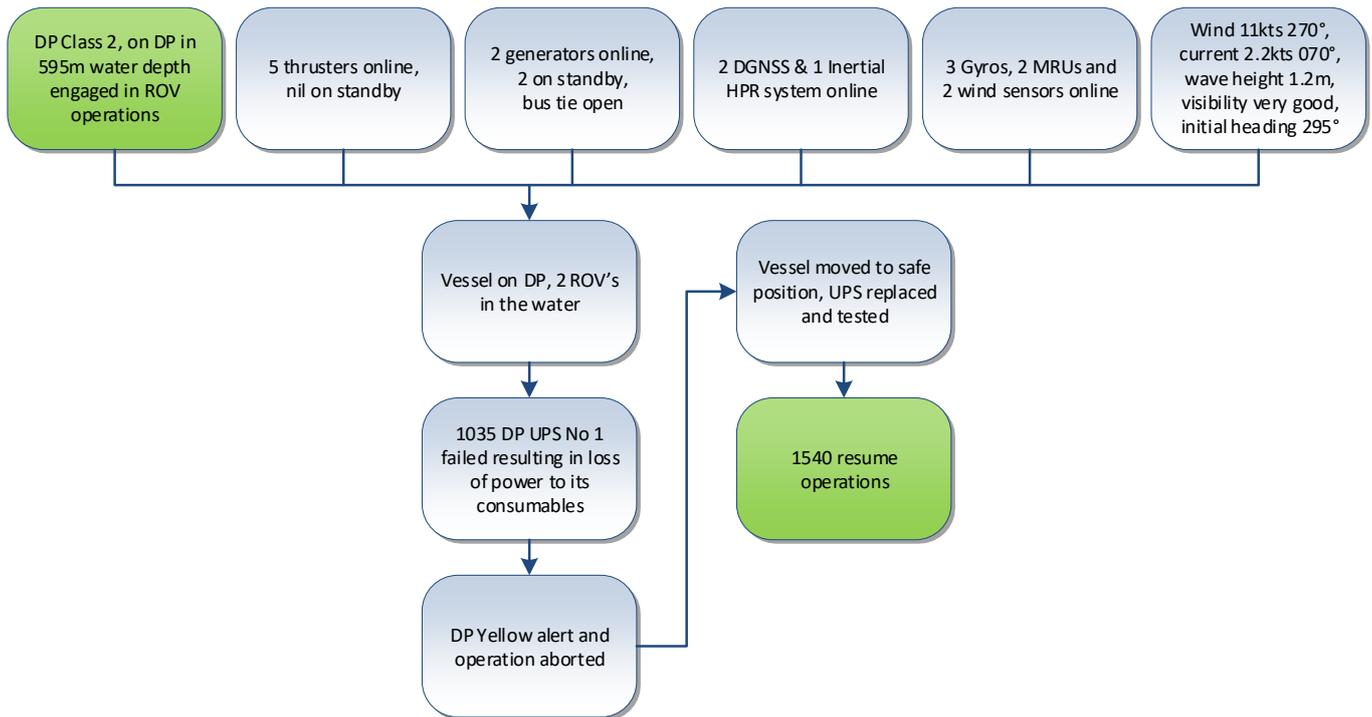
Failure of DP UPS – DP Undesired Event

The vessel maintained position but DP equipment class 2 capabilities were compromised. It was noticed that there was a strong burning smell from the UPS. The UPS was still powered up from the ships supply but it was in internal bypass. Tests were carried out and it was noted that there was no voltage or frequency output. The voltages on the eight external batteries were checked and all but one had 12+ Volts. One of the batteries had 10 volts.

The replacement unit was tested extensively, and it operated satisfactorily.

- ◆ The status of the UPS should be verified on pre-operational checklists.
- ◆ Battery and UPS tests should be part of the DP annual trial programme and subject to regular maintenance.
- ◆ It should be noted that with one diesel generator on each bus, a partial black-out may occur in case of failure. This should be included in the operational activity planning.
- ◆ It appears the vessel responded as designed and the situation was well handled by the vessel crew.

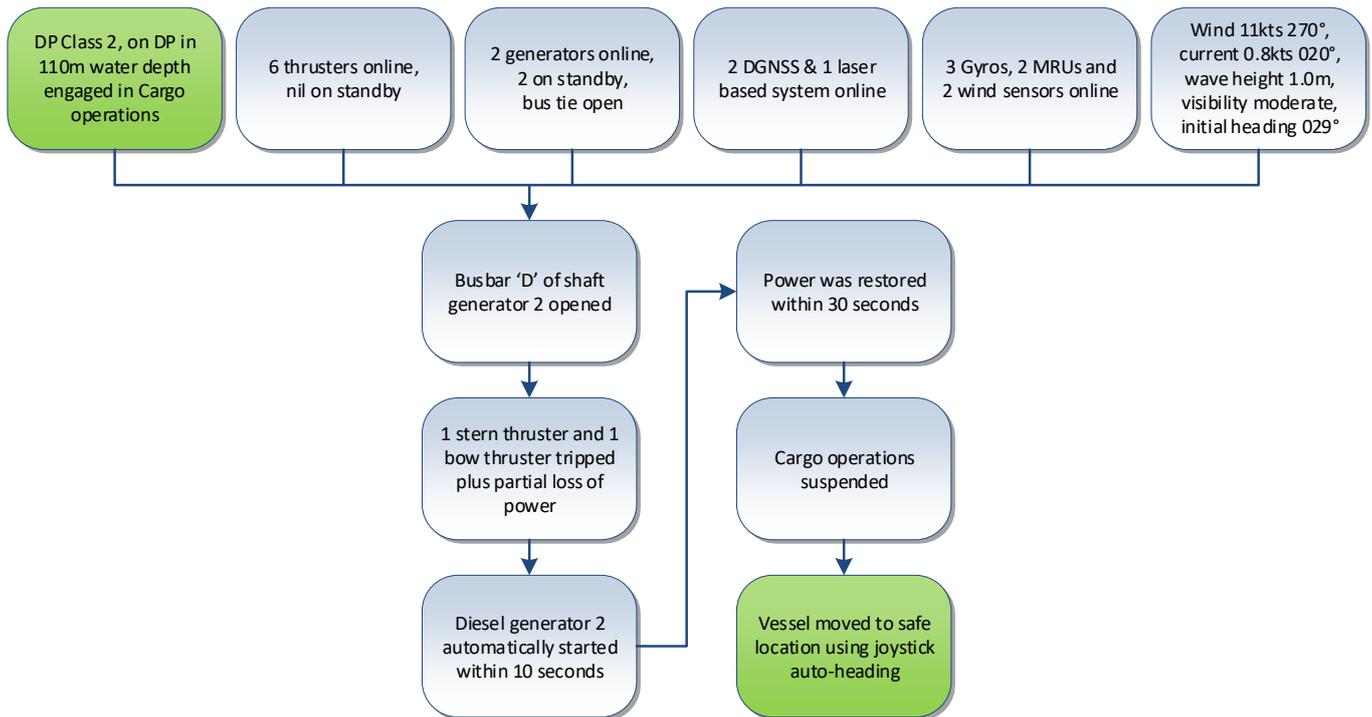
Accidental Breaker Trip – DP Undesired Event

The vessel was experiencing heavy rolling and pitching. The watch keeping engineer lost his balance and his hand made contact with the No. 2 shaft generator breaker push button, thus opening the breaker and causing the loss of power. The vessel has installed transparent covers over vulnerable breaker push buttons to avoid re-occurrence.

- ◆ Although the incident could have been avoided by better protecting the breaker push-button, the DP system responded as designed.
- ◆ Most regulatory authorities require covers to be fitted on emergency stops which have the potential to impact operations.
- ◆ The vessel could have moved clear while still on Automatic DP, instead of changing to joystick control.
- ◆ With only one generator on-line on each bus, failure of one may cause a partial black-out. It is assumed that this was included in the operational philosophy and activity specific planning.

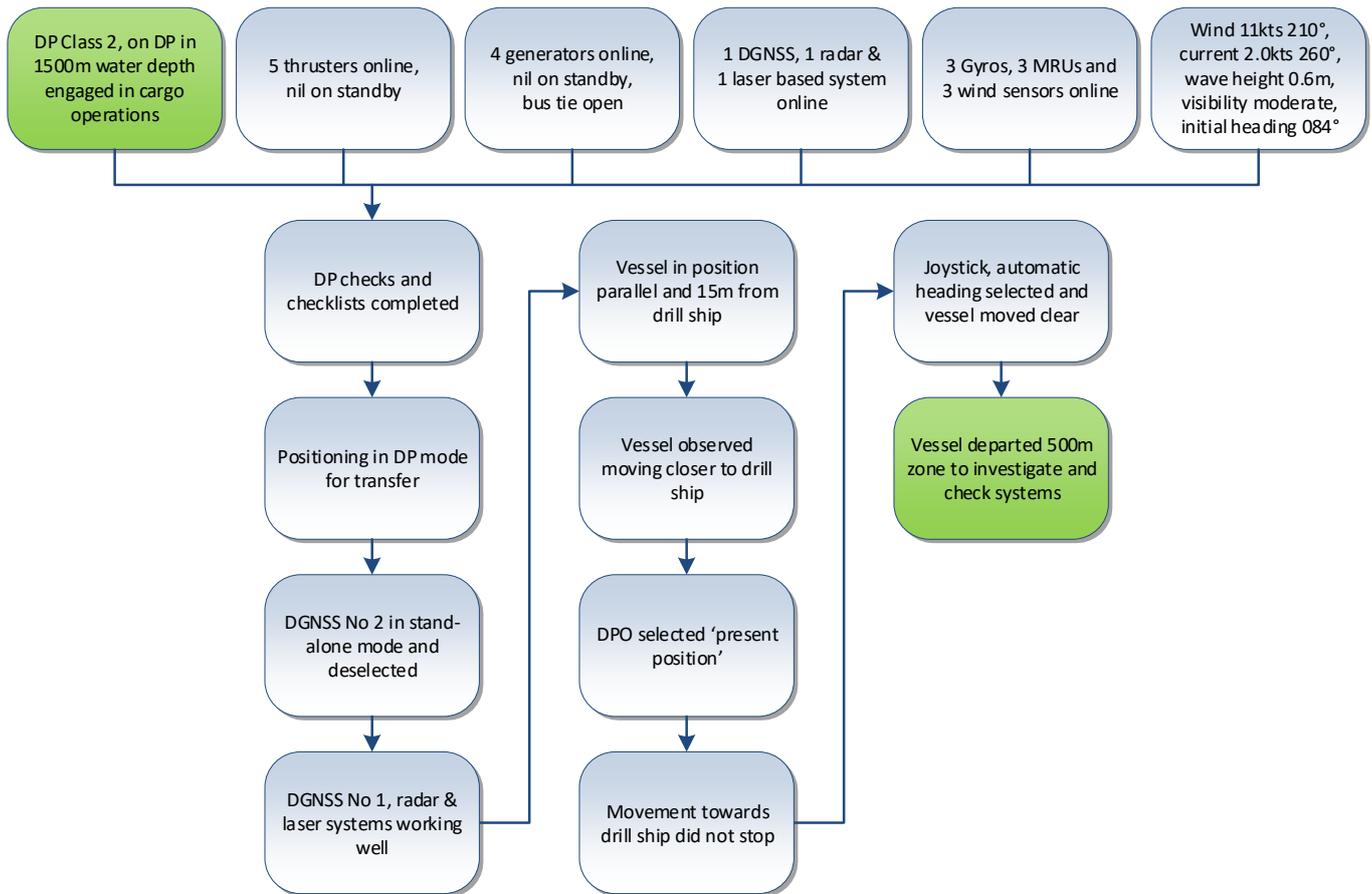
Mix of Absolute and Relative Position Reference Systems – DP Incident

It was considered that the movement towards the drill ship could have been caused by a combination of position reference system degradation and interaction from the Drill ship's thrusters. There was an advisory regarding service disruption from the DGNSS supplier in force at the time. It was stated that the DPO initially selected 'present position' to remove any doubt that he/she had entered an incorrect step movement for a change of position.

It was further noted that selecting 'present position' is not following DP watch-keeping procedures and is a fundamental error. Selecting 'present position' resulted in the thruster demand being reset with the momentum of the vessel still being in the same direction

- ◆ Operating on DP alongside a mobile platform which also provides the reference(s) for the PRS needs to be planned carefully. It is recommended that relative PRSs are used.
- ◆ Surface movement of the drill ship, position moves, and thruster interaction should be carefully considered during operational planning and in the decision support tool (ASOG).
- ◆ IMCA have received a number of reports this year where it has been noted that the DP Operator selected the 'present position' button as the best option for halting an unplanned move. It should be noted that this action resets the wanted position and therefore does not assist the DP System to maintain the original wanted position.

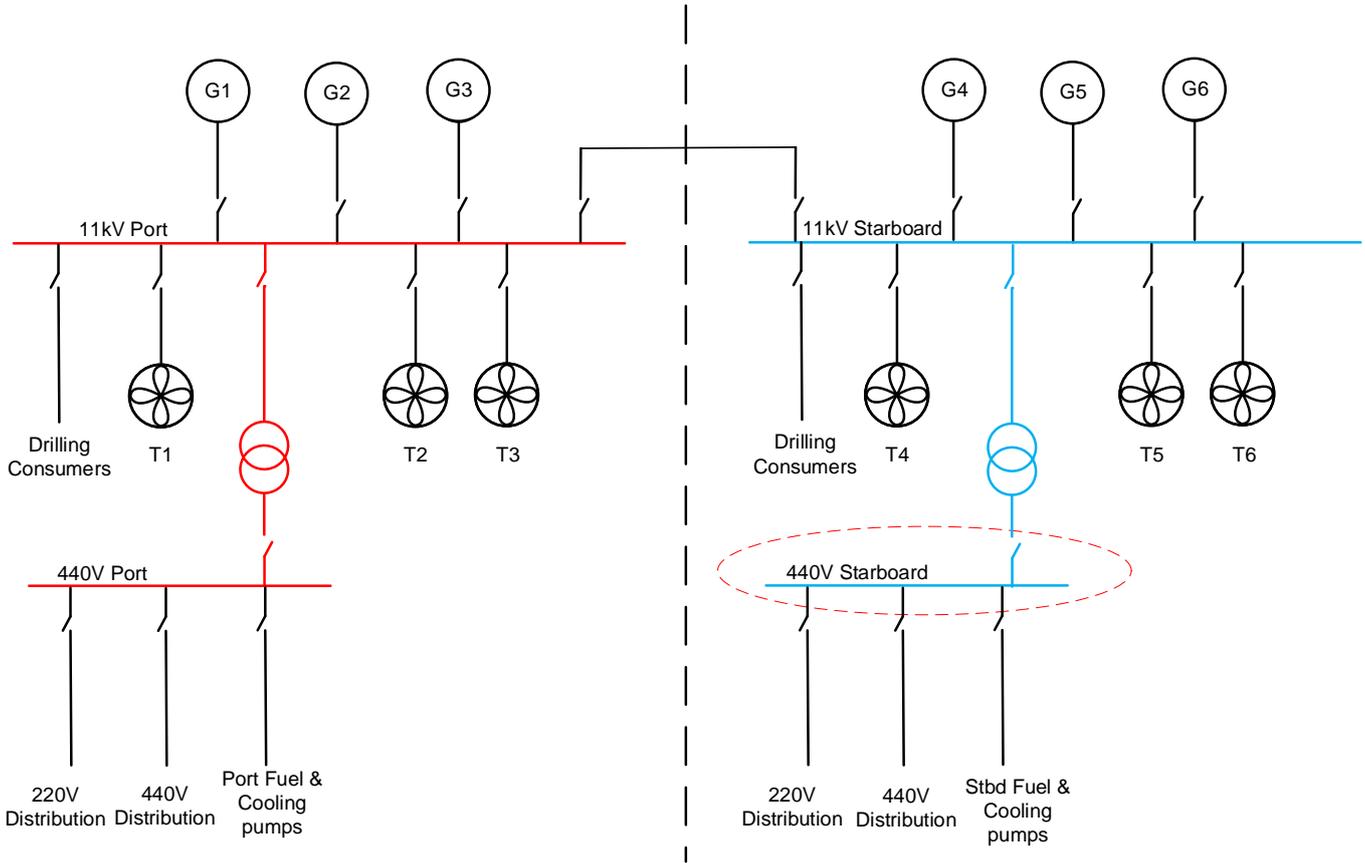
Figure: Simplified sketch of vessel's power system

Without warning, the Starboard 440V switchboard blacked out leading shortly after to the 11kV switchboard blacking out resulting in loss of power to all the respective main thruster drilling and auxiliary consumers. The Port switchboard remained online, and the vessel remained in position. Drilling operations were immediately suspended, and safety measures were actioned while the blackout was investigated, and power fully restored.

Investigation revealed that the loss of power generation on the 11kV switchboard leading to its blackout was caused by fuel pump failure and subsequent fuel starvation on the online Starboard engines. Fuel pump failure (and cooling water auxiliaries) was caused by the initial 440V starboard switchboard failure. The fuel starvation also meant that automatic blackout recovery measures (standby starting of offline generators) were unsuccessful.

The root cause of the loss of power to the Starboard 440V switchboard was found to be a faulty under voltage coil in the main supply circuit breaker. The fault causing the circuit breaker to open.

The investigation noted that the main circuit breakers on the 440V switchboards were obsolete and no longer supported by the original equipment manufacturer. Although a spare was sourced onboard the vessel, the event triggered a full review of onboard critical spares and the implementation of a regular third-party inspection and

testing regime over and above normal crew maintenance routines. The investigation also noted that budgets were being worked on for full replacement of all 440V main circuit breaker at the next SPS docking.

Although fitted, the air powered emergency fuel pump provided no benefit during the main power supply failure. The investigation revealed that the pumps operation was not as analysed within the vessel's DP FMEA and a programme of testing was planned at the soonest opportunity to ensure correct functionality/operation. The findings of such testing would feed back into the vessel's DP FMEA and any other relevant operations manuals and checklists.

The investigation considered drilling consumer supplies and noted that drilling variable speed drives were not segregated in line with the vessel's redundancy concept meaning that 50% of the drive cooling system were cross connected. The effect of this during the event was only unnecessary loss of consumers to the drilling system. In different circumstances, this cross connection may have impeded safety precautions being implemented or brought unnecessary risk to the DP system redundancy concept. The investigation report recommended that the drilling system distribution be reviewed with cross connections in mind and any enhancements actioned thereafter.
