# IMCA DP Station Keeping Bulletin 04/19

November 2019

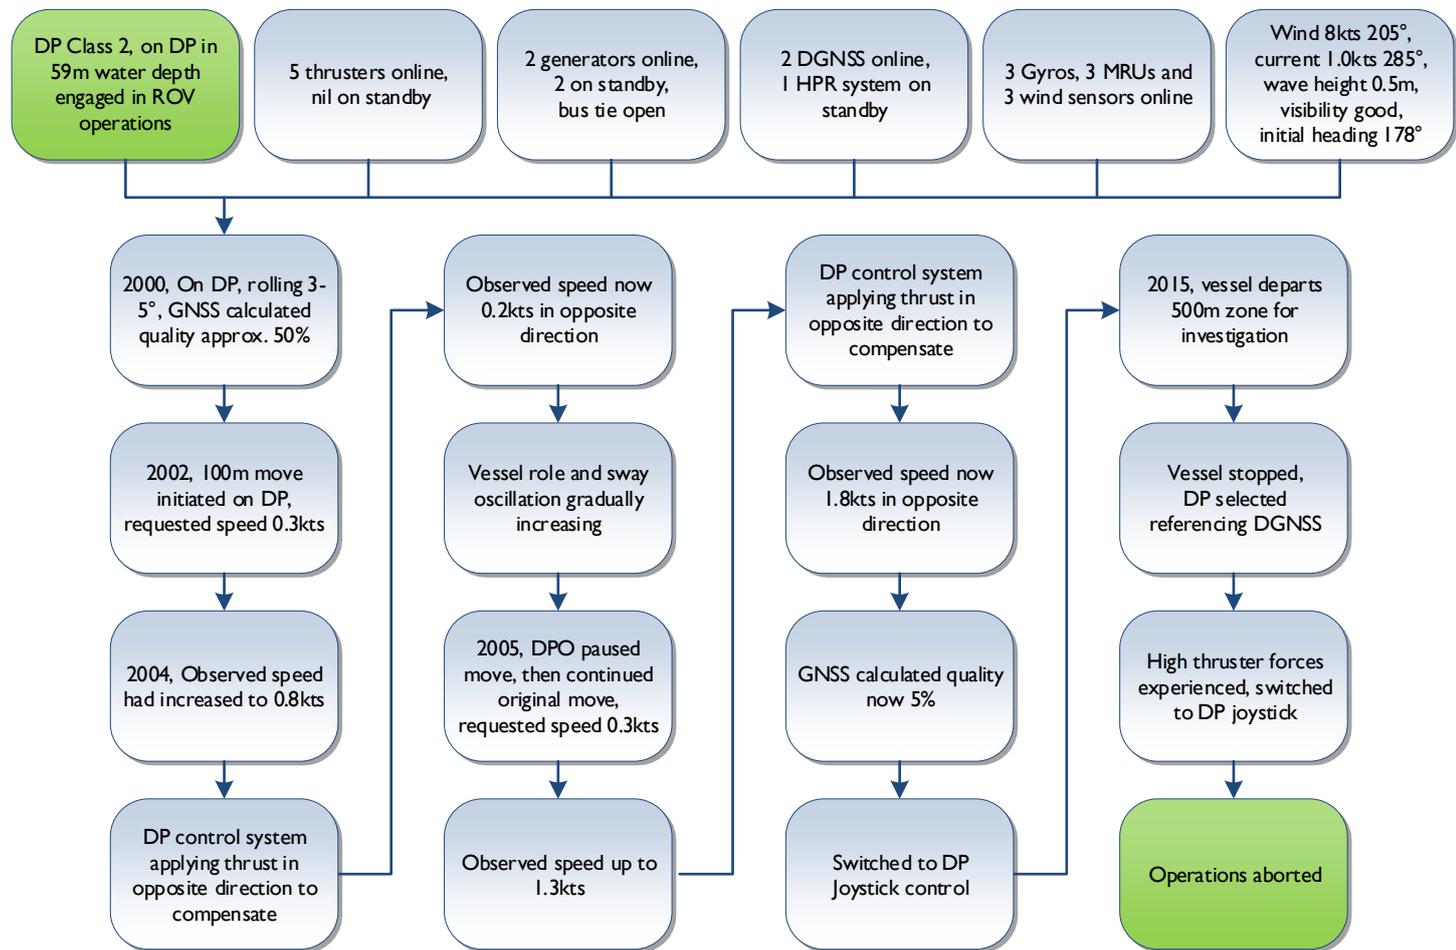
Only 2 DGNSS were online, with poor signal quality due to the location and environmental conditions. The end effect was that the deviation from the set point in surge and sway were increasing for each oscillation.

- ◆ For DP2 operations, the use of only 2 DGNSS systems is insufficient; a minimum of 3 systems are to be used based on 2 principles.
- ◆ The importance of monitoring the position reference systems (PRS) screen cannot be overstated; this then ensures that all the PRS agree on the position of the vessel.

- ◆ It is evident that the selected PRS were not providing reliable position information and highlights the problems that can be experienced when at least one reliable PRS is not available.
- ◆ It was noted that the move was paused at 2005; this should have provided the opportunity to investigate and correct the situation rather than continue with the move.
- ◆ It is also worth considering that the erratic movement of the vessel could indicate that the DP system needs retuning.

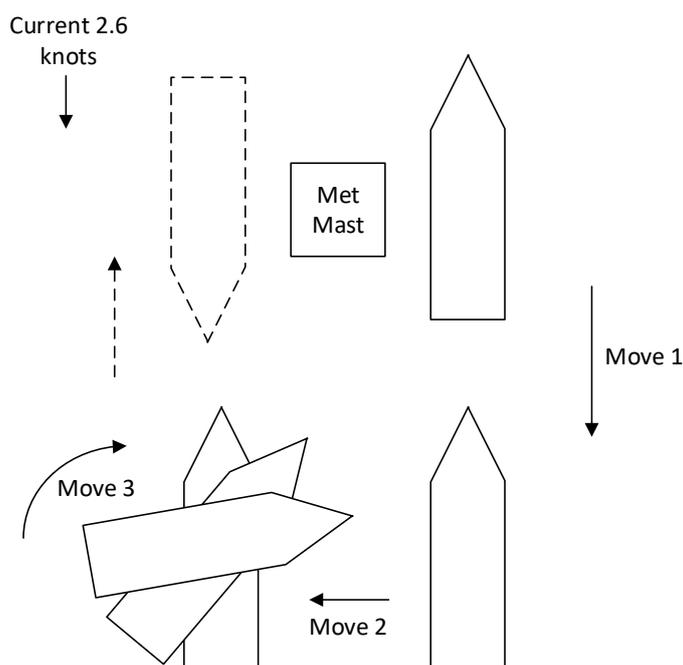
The vessel commenced relocating, moving astern on automatic DP control to clear the met mast to a safe position downstream (move 1). At that location, the vessel was then manoeuvred transversely to port on automatic DP control (move 2). At the end of this movement, the DPO commenced rotating the vessel through 180 degrees at a rate of turn of 40 degrees per minute using joystick control (move 3). In preparation for the vessel rotation, the DP operator did not change control to full joystick, electing instead to disable 'auto yaw' whilst leaving 'auto surge' and 'auto sway' enabled. Although not understood by the DPO at the time, this effectively meant that the DP system was still set to maintain a setpoint. Thruster loads began to increase as the beam of the vessel became perpendicular to the current. This resulted in the position set point alarm, DP overload alarm, thrust reduction alarms, and the loss of the starboard power system (50% of thrust capability), leading to a total loss of station keeping control.

- ◆ The overall manoeuvre had been risk assessed with the control modes of operation for each step detailed. However, the selection to joystick mode for move 3 was incorrectly executed by leaving 'auto surge' and 'auto sway' functions active.

- ◆ The vessel crew received additional training on the use and effects of 'auto surge' and 'auto sway' in high current environments.
- ◆ A specific risk assessment procedure has been established for the use of manual and joystick control within windfarm limits where major heading changes are involved. This will include verification of the operational procedures (including system setup) by the master or second senior DPO.

- ◆ The investigation also recommended a full review of the vessel's DP operating manuals, risk assessments and close proximity procedures, to assess if any improvements could be made.

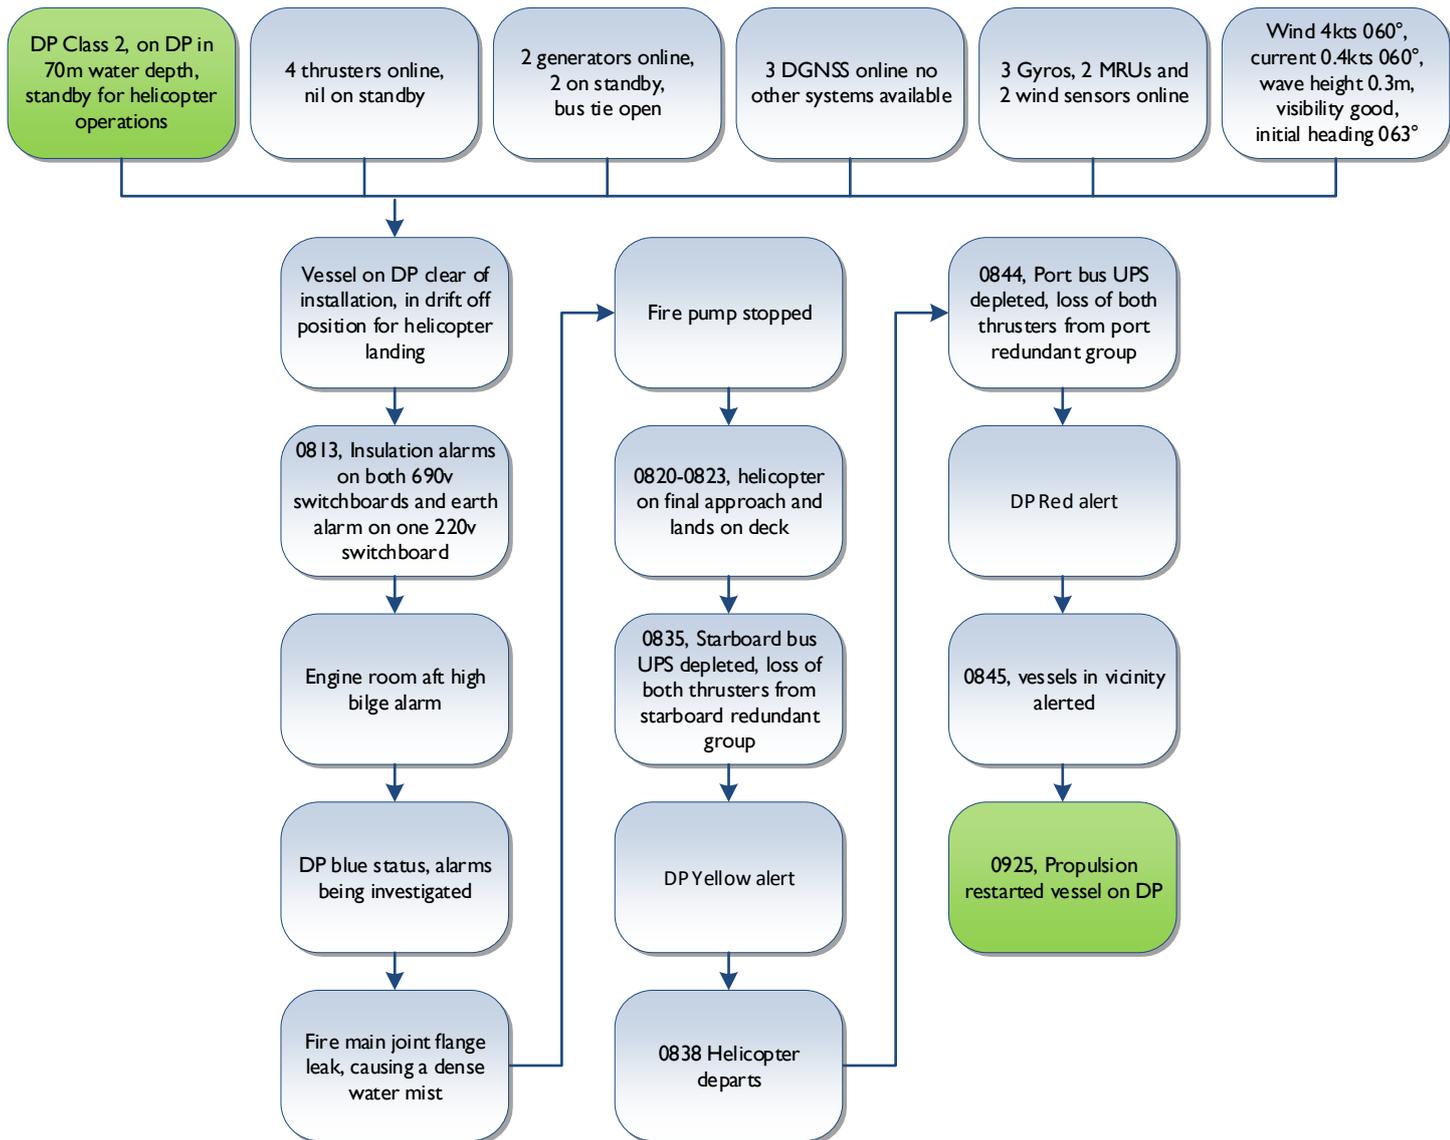
Whilst pressurising the fire main for helicopter operations, a gasket failure occurred on the pipework valve under the engine room floor in front of transformers 690V/440V T3 and T4. The spray created a water fog and favourable atmosphere for an electric arc on T3 and T4 transformers, leading to a loss of 440v and 230v on vessel power plant. Upon depletion of the UPS batteries, the thrusters were lost.

A detailed investigation was undertaken with many findings including adding ingress protection at the transformers, adding isolation valves in the piping and modifying procedures. One supplementary finding related to the UPS systems, as both failed before 30 minutes. Investigation revealed that the load on the UPS's was greater than when they were tested alongside during annual DP trials.

- ◆ It was questioned whether the DP alarm should have been yellow rather than blue and it is assumed that, for some reason, the alarms generated at 0813 were not interpreted correctly.
- ◆ There was concern that a fire main was passing through a transformer space. It was considered that if the vessel had been equipment class 3, it would have been subject to an assessment of the space so the danger of such an occurrence happening would have been noted.
- ◆ UPS battery endurance tests (30min check) should be performed with all UPS consumers connected and in use.

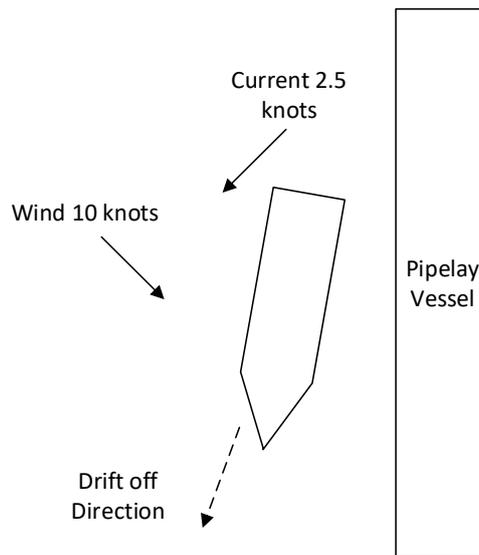
The port azimuth thruster failed as a result of failure of both steering motors. One of the two starboard azimuth thruster steering motors also failed; however, the thruster remained available due to the remaining healthy steering motor. Cargo operations were immediately ceased, and attempts were made to restart the port thruster unsuccessfully. During these attempts, the starboard thruster tripped due to a 'low hydraulic pressure' alarm.

With no aft thrusters available, the vessel drifted for around 200m before power was regained to one of the starboard steering pumps allowing the thruster to restart. The vessel was subsequently manoeuvred outside the 500M zone for failure investigation.

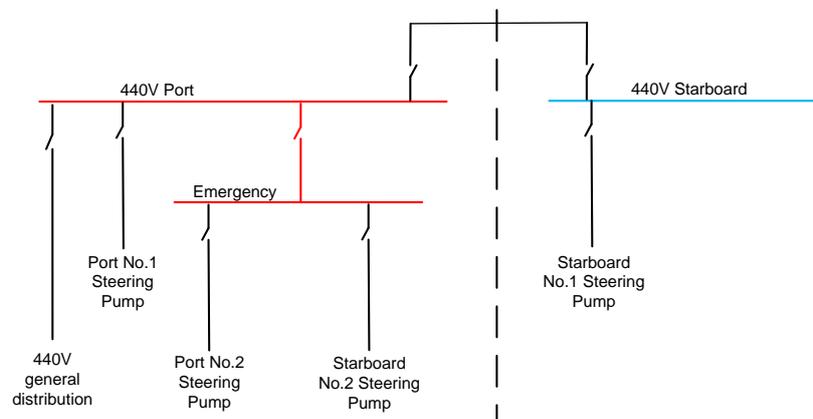
The supplies for port and starboard steering pumps were arranged in the same manner. Each pump was driven by electric motor controlled by variable speed drive (VSD). Steering pump no.1 for each thruster was supplied directly from the respective port or starboard main switchboard and steering pump no.2 for each thruster supplied from the emergency switchboard. The emergency switchboard was connected to the port main bus bar.

The investigation revealed a gradual but significant earth fault within a consumer supplied by the Port 440V general distribution panel. The Earth fault was caused by a trapped cable within a motor connection box. The cable had been trapped between the lid and body of the box during a recent maintenance inspection.

This earth fault had been detected by the sophisticated protection systems of the VSDs controlling the steering pumps on the port and emergency switchboards, but not the starboard switchboard as the bus tie was open. The VSDs tripped causing the three steering pumps to fail. Note that the VSDs are unable to differentiate whether an earth fault is upstream or downstream, therefore they will typically trip assuming that the earth fault relates to the equipment they control.

The remaining starboard steering pump tripped due to a low hydraulic pressure alarm. The cause identified in the investigation report as a faulty seal. Although there is no direct connection between this failure and the earth fault causing the other steering pumps to trip, the seal damage may have been exacerbated by the demand caused by the loss of the other starboard steering pump.

- ◆ The seal that failed on the starboard steering pump was found to be a known defective product. The investigation revealed that sister vessels had experienced the same seal failure and as such the investigation report highlighted the need to take a fleet wide approach to replacing the seals and ensuring critical spares were available on-board.

- ◆ Although there is no discussion regarding the DP system FMEA in the investigation report, the FMEA should have considered that there was the potential for cross connections and failure of port and emergency switchboards simultaneously. There should then have been FMEA proving trials confirming the outcome of such failures. This testing would have revealed that there was potential for loss of 3 out of 4 of the aft steering pumps.
