IMCA Safety Flash 03/20

January 2020

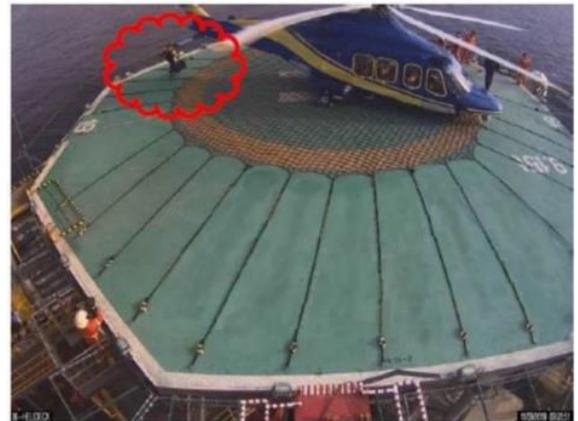
During helicopter flight boarding, a member of the crew crossed a hard barrier (stairway access chain) with a restriction sign and approached the flight deck from the aft stairway while boarding activities were ongoing on the forward side.

A member of the helicopter emergency response team – an offshore helideck assistant – attempted to intervene by shouting. The warning did not prevent the crew member from approaching the helicopter from the uncontrolled or prohibited direction and from passing beneath the tail rotor blades.

The HLO was controlling boarding from the forward stairway. From CCTV records, it is estimated that distance between the crew member and the rotor tail was approximately 1.5–2m. No injury occurred during the event.

- ◆ The crew member did not follow safety rules on helideck (i.e. to NOT pass under the tail rotor);
- ◆ The HLO lost control of situation;
- ◆ Employee removed a safety barrier (chain);
- ◆ There was no signalman available to guard the safety barrier (chain);
- ◆ Employee was not escorted when ascending the stairs.

- ♦ Changes to risk assessments, procedures and safety management systems (SMS) are omitted as understood;
- ♦ During helicopter briefing, ensure passengers understand reasons for following the rules and the consequences for deliberately not following them;
- ♦ Improve clarity on access route to use (e.g. flashing lights or directional signs) to identify the access in use for helicopter embarkation and provide dedicated embarkation/disembarkation facilities for personnel and baggage.

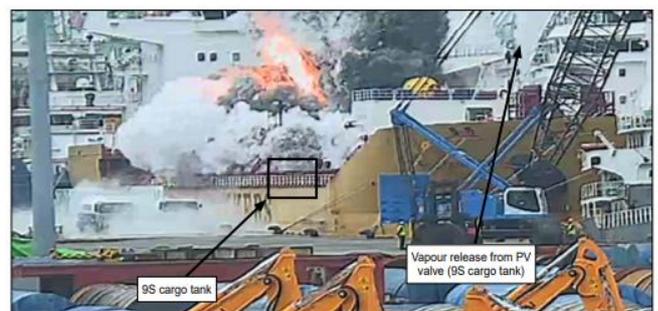
Figure 1: Tank rupture and ignition of released vapour

The MAIB's initial findings were that the explosions were probably caused by the rupture of the deck above the cargo tank, followed immediately by the ignition of the styrene monomer vapour that was then released. The rupture was due to over-pressurisation and the likely sources of the ignition were static electricity, sparks or elevated steel deck plate temperatures resulting from the tank rupture.

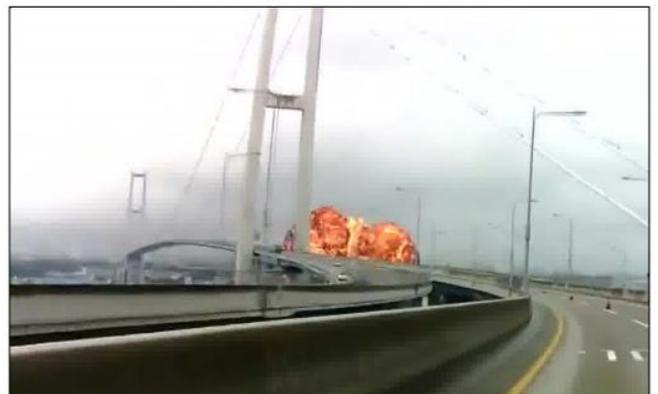
At 1050, two explosions were seen and heard in rapid succession in way of the tanker's cargo manifold. The resulting fireball passed very close to a road bridge above the quay.

Figure 2: Fireball viewed from the Ulsan bridge

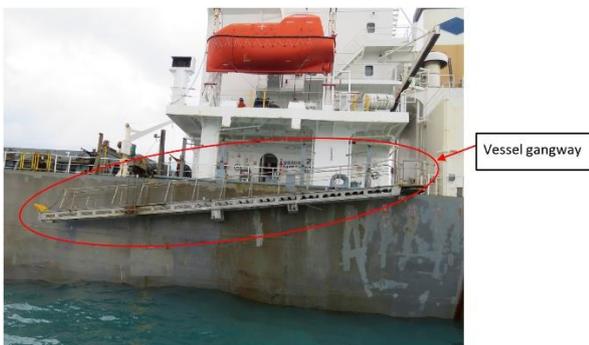
On 23 October 2019 around 5pm, a worker embarking onto a launch boat from a vessel gangway lost his balance and fell into the sea. The body of the worker was subsequently found in the sea.

Figure 1: Photo of the vessel and its gangway.

- ◆ Pre-embarkation briefing;
- ◆ Ensuring workers are physically fit for the transfer;
- ◆ Ensuring transfer takes place in favourable conditions;
- ◆ Ensuring all are properly briefed on safe use of gangways;
- ◆ Ensuring that there is sufficient and appropriate supervision of transfers;
- ◆ Wearing of appropriate personal protective equipment (PPE).

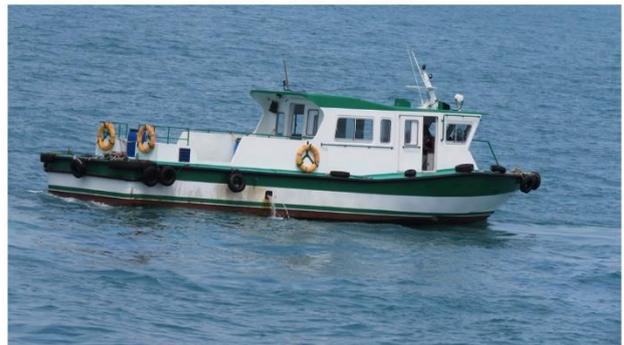
Figure 2: Photo of the launch boat

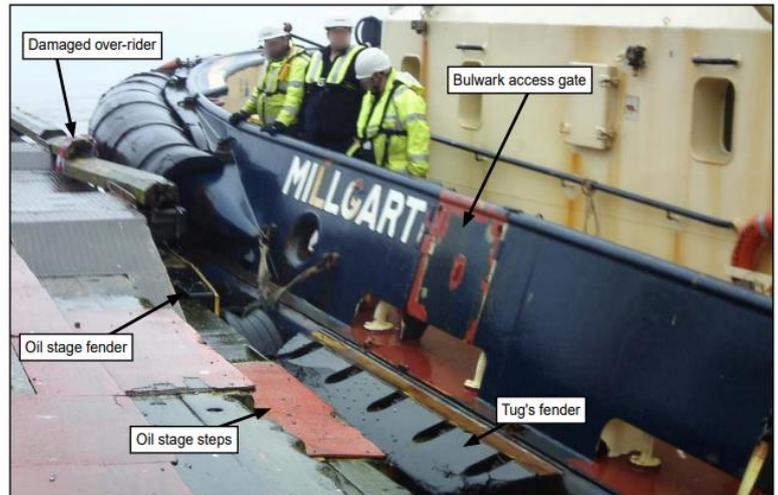
Figure 3: Oil stage steps and *Millgarth's* bulwark access gate (photograph taken during post-accident reconstruction)

- ♦ Accessing the tugs via the oil stage fenders at the Tranmere Oil Terminal was a common practice and was extremely dangerous, particularly in poor weather conditions;
- ♦ The lack of safe access to and from Svitzer tugs at Tranmere Oil Terminal had been recognised for at least 14 years prior to this accident and had been raised at safety committee meetings and during company inspections many times prior to this accident;
- ♦ Svitzer UK and Essar did not formally identify and evaluate the shared risks associated with access to and from an unmoored tug or discuss how these could be mitigated;
- ♦ The crew had not been fully prepared to deal with the emergency situation and were unfamiliar with the use of the tug's MOB rescue-sling

- ♦ On 14 June 2019, the MAIB carried out a preliminary assessment of a non-fatal man overboard incident on *Svitzer Victory*. Due to the similarity of this incident with the fatal accident on *Millgarth*, the Chief Inspector of the MAIB issued an urgent safety recommendation (2019/115) to Svitzer A/S concerning the safe conduct of tug access and egress;
- ♦ This report makes further safety recommendations (2019/121 and 2019/122) to Svitzer A/S regarding the dissemination and closure of audit findings, attendance at man overboard drills and the use of man overboard recovery equipment.

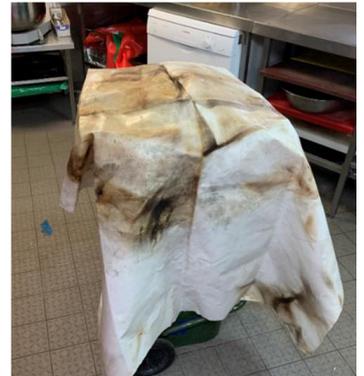
Fire blanket

A galley fire blanket had been used for fire extinguishing and packed away again, but no incident report was made of a fire having taken place. It was clear that the fire blanket had not been inspected for a long period of time.

- our members' internal instructions for master's inspections and fire prevention requirements had not been followed
- there had been no weekly inspection of fire blankets conducted by crew despite procedural requirements to do so;

- when conducting any inspection, ensure that all items on the inspection checklist are thoroughly checked – not 'just a tick box exercise'
- any incident (such as a small fire in this case) however trivial should be reported immediately
- further inspections of all on-board safety equipment was indicated in this case.

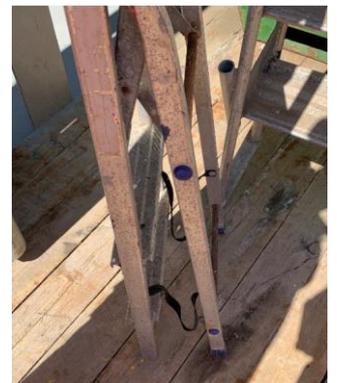
Step ladder

A damaged ladder was observed as in use on the vessel deck during vessel walk around. Further inspection revealed another ladder in similar condition in regular use.

- signs of corrosion on ladder
- plastic support missing on bottom of ladders legs;

- no regular and pre-use inspection of ladders established on-board
- fall prevention requirements not followed: inspect all ladders and lifting equipment regularly and perform the required maintenance;

- all on-board ladders to be inspected, numbered and labelled on a monthly basis
- all damaged ladders to be removed from vessels and replacements ordered
- crew to be refreshed on the importance of conducting pre-start checks on all ladders.
