IMCA Safety Flash 05/20

February 2020

1 Dropped Object Near Miss – Crane Boom Bumper Stop Falls Off

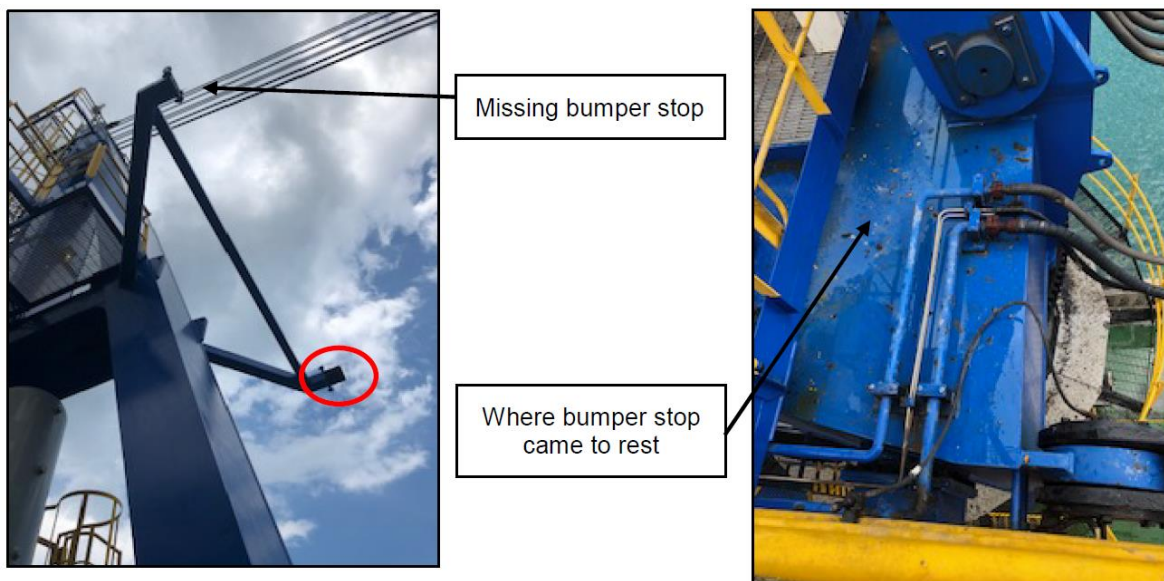
This was a high potential near miss dropped object incident in which a crane boom bumper stop fell onto the crane cab. No personnel were injured; however, there was potential for serious or fatal injury. The incident occurred during preparation for vessel reactivation following a period in warm stack; a crane mechanic spotted a part of one of the vessel cranes had fallen off and was missing.

The crane mechanic stopped his inspection and proceeded up the crane to investigate further. The bumper stop was observed laying on the crane cab level outside of the handrails. The bumper stop is made of vulcanised rubber that is bonded to a steel securing plate and fitted to the crane A frame with steel bolts. A steel wire secondary securing lanyard was fitted around the circumference of the vulcanised rubber and tied back to the A frame. The vulcanised rubber had detached from the steel securing plate which remained attached to the A frame; however, the secondary securing wire had corroded and parted allowing the bumper stop to fall.

- ◆ Continue existing dropped object inspections, and review existing dropped object checklists and/or work orders when next used and update if required;
- ◆ Identify equipment and structures that cannot be easily accessed for inspection and present a risk of dropped objects and determine the best means of safe access and frequency of inspection;

- ◆ Ensure exposed potential dropped objects are suitably protected from corrosion and ensure retention devices are of suitable strength and made from corrosion resistant material;
- ◆ Investigate the use of an alternative bumper stop material that does not degrade in sunlight and consider other components that are vulnerable to UV damage that could result in an incident;
- ◆ Consider if inspection or replacement frequency needs to be increased.

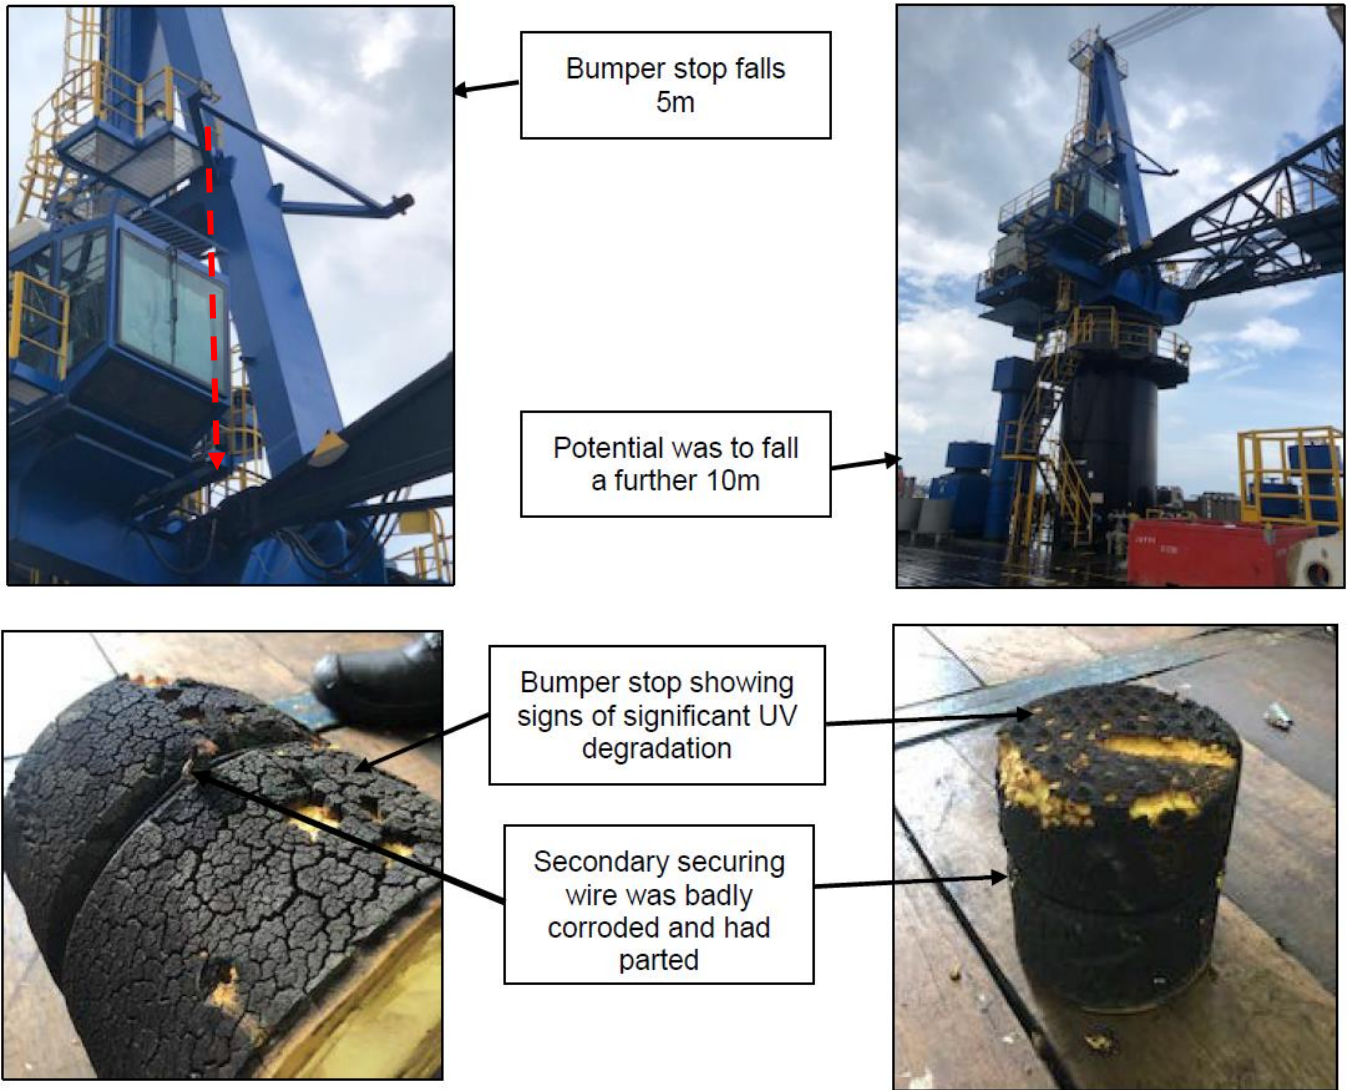
- ◆ The vulcanised rubber section of the bumper stops was vulnerable to UV light damage;
- ◆ Secondary retention wires should be manufactured from a corrosion resistant material;
- ◆ The location and lack of accessibility to the bumper stops prevented regular and sufficient physical inspection:
 - the condition of the bumper stops and the secondary retention device could not be fully assessed without scaffolding, rope access or alternative means
 - the secondary retention wire was not clearly visible from the closest point of inspection 2m away. Degradation of the wire could not be seen
 - the vulcanised rubber section of the bumper stop had deteriorated to an unstable condition and detached from the securing plate;
- ◆ There is potential for similar incidents to happen on other vessels, in areas where access to potential dropped objects is difficult.

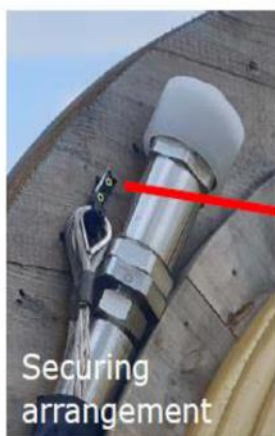
Picture 1 shows how 2nd end termination head end was secured

- ◆ The securing arrangement for the heads, in this case wooden screws, was inadequate. Additionally, a second barrier was not considered necessary.

- ◆ Termination heads on reels should be highlighted as potential dropped objects in the task risk assessment (TRA). A second barrier should be added before spooling if proper engineered solutions are not in place;
- ◆ Working closely to a rotating reel should be considered a high risk which should be properly mitigated;
- ◆ All personnel should be trained for the task they are performing. If there are uncertainties regarding their competence, a competence assessment should be conducted beforehand.

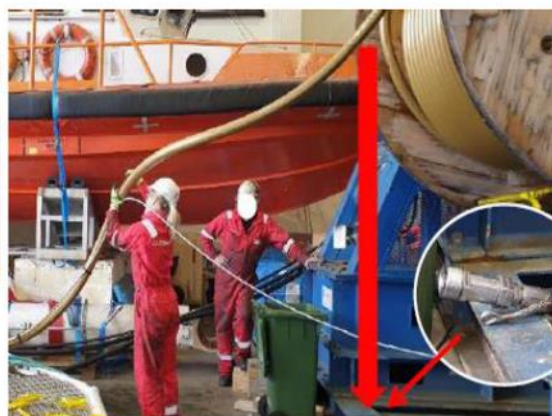
During trans-spooling of 1½” hydraulic jumper from a wooden reel to a subsea carousel, the second end termination head of the hydraulic jumper pipe released from the reel and fell to the floor. The end termination head, weighing 11kg, fell from approximately 3 meters down to the floor. It released during spooling of the first two of several layers. The securing arrangement consisted of a rubber covered metal band that was fastened to the wooden reel with 2 wood screws. Five people were working nearby and were in the line of fire; the end termination head missed them and there were no injuries.

Picture 2 showing the transpooling location and task

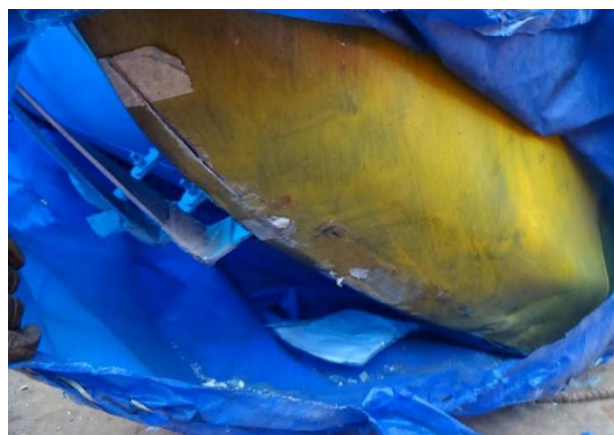
A large load weighing over six tonnes was dropped during loading operations. The item was a hot air duct. The centre of gravity (COG) of the load and the lifting points were marked on the tarpaulin wrapping the load and this information was used during the lift. The hot air duct was slightly tilted when lifted but within margins, and loading was continued. Although one person called STOP, this was immediately overruled by a supervisor. When the load was approximately 1.5m above deck and under the control of taglines from the riggers, the lifting sling slid towards the centre of gravity and one side of the load bounced on the deck, while the load was still hanging in the rigging. The rigging was not damaged or broken.

The damaged hot air duct was sent ashore again for repairs. No-one was harmed or injured.

The centre of gravity of the load and lifting markings were wrongly marked on the tarpaulin, resulting in the sling sliding during loading towards the centre of gravity and thus one side of the air duct bouncing onto the deck.

- ◆ Take care with supplied COG or lifting markings;
- ◆ Reiterate/discuss the standard operating procedure, and who will be in charge;
- ◆ ‘Stop work authority’ to be reinforced/explained by senior management.

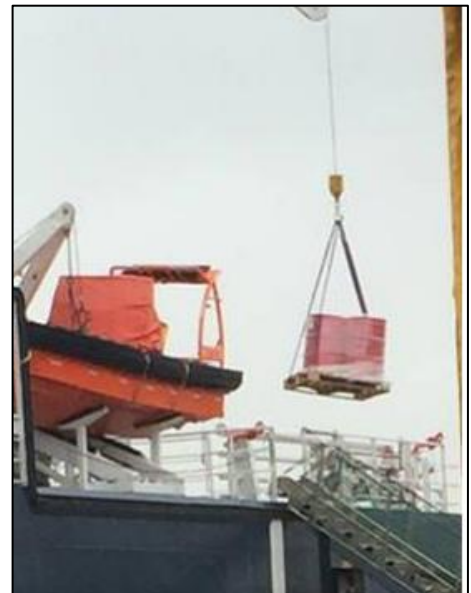
The Marine Safety Forum (MSF) has published [Safety Alert 19-15](#) relating to a potential dropped object during unsafe lifting operations. An observation was recorded during a routine vessel crane lifting operation. The lift was a pallet laden with chemical drums being lifted from the quayside onto the vessel using webbing slings. The only method of securing was plastic film and the lift was not lifting levelly.

- ◆ Significant potential existed for this lift to fail, resulting in the load falling from height;
- ◆ Slings are not considered a suitable method for lifting pallets by crane. Pallets have no safe working load (SWL) and are not designed to be lifted by crane with slings;
- ◆ Using slings to lift pallets can result in failure of the pallet structure, resulting in loss of loads.

- ◆ As a minimum, pallets should be secured with cargo nets to prevent loss of containment and dropped objects. Cargo nets are only to contain the load and prevent dropped objects; however, nets will not prevent structural pallet damage from sling lifts;
- ◆ Consideration should be given to the use of approved attachments (such as crane fork attachments) for the safe lifting of pallets by crane.

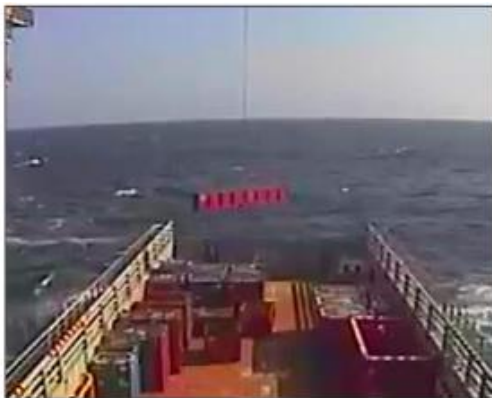
Basket being lowered to deck

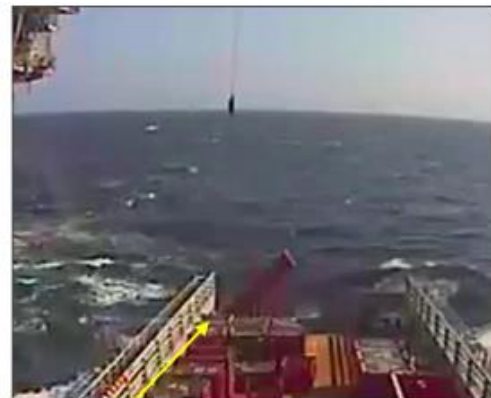
Basket snagged on protective rail

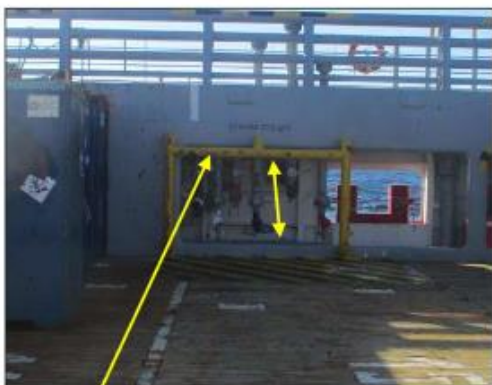
Basket swung under protective rail

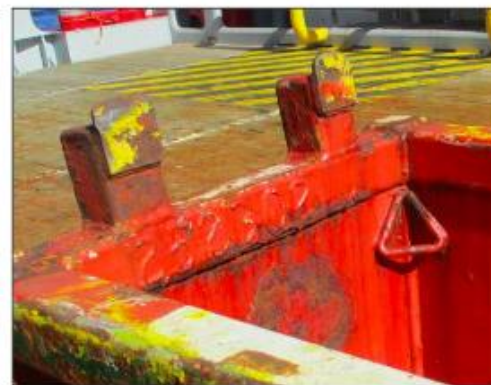
Basket stacking pins snagged on inside of protective rail

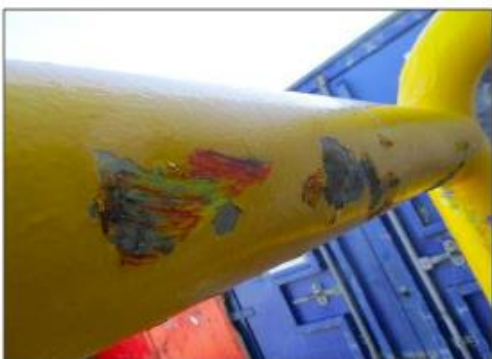
Damage to vessel structure

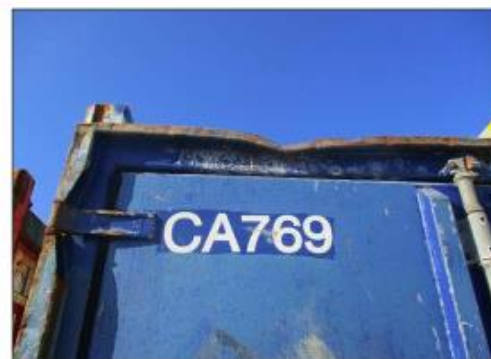
Damage to adjacent baskets
