IMCA Safety Flash 06/20

February 2020

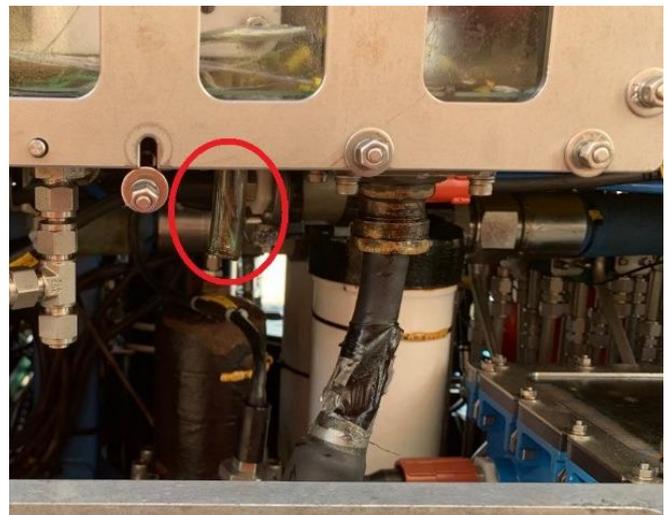
An ROV technician received an electric shock to his left arm beneath the elbow, resulting in a burn. ROV personnel were working in the technical workshop completing a non-electrical related task, bleeding air on top of the HP filter housing from the main hydraulic circuit, when the technician received the shock. The ROV single phase power was energized, but the area of the ROV (Phase 3) that was being worked on was isolated, de-energized and locked out.

Investigation established that a water drain tube had been used as a conduit for an electrical cable, both the drain and electrical cable had been cut in half, but it was unclear whether or not the cut happened during demobilization, transit, or during the skid and ROV segregation in the technical workshop. The cut cable exposed live electrical wires. Once the cut wires were isolated, personnel were able to identify that they were connected to a separate transformer, and thus the wires were found to be live even after isolating and locking out the area of work.

The system had been recently demobilized from a project. The routing of the electrical cable through the water drain was a modification to the system that had not been documented, communicated or handed over to workshop personnel after the ROV was demobilized. The electrical cable, which had been cut, exposed the bare wires rather than being disconnected and removed.

- ◆ All electrical cables should be properly disconnected and/or removed, not cut, when demobilizing equipment;
- ◆ ROV system modifications should be noted within drawings and ROV system paperwork. Major system modifications should follow a formal management of change (MoC) process, which is the responsibility of the supervisor on site;
- ◆ There should be a documented handover between the offshore supervisor and technical workshop supervisor, and this should include details of any system modifications and instructions for disconnection and removal (if not already completed).

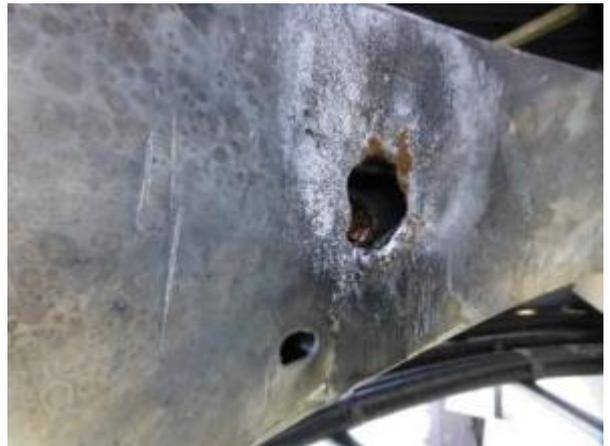
Two self-employed workers received serious burns to their hands whilst using a drill to attach a pre-fabricated cowling to a cable tray. The incident occurred when one of the fixings went into a live electrical cable, striking one of the phases and causing an explosion. See [here](#) for the full press release.

Investigation by the Health and Safety Executive (HSE) found that the company's risk assessments and method statements did not consider the risk of drilling into cable trays containing live cables, isolating the electricians to complete work, or other methods of fixing which did not involve drilling.

The HSE inspector noted: *“This incident demonstrated the importance of the role of those preparing the job. The company overlooked the 415V 3 phase cabling they were drilling in towards. A cable strike, even at this voltage, can cause a major explosion. This incident has left two men with long-lasting burn injuries and they are now unable to work for a long time.”*

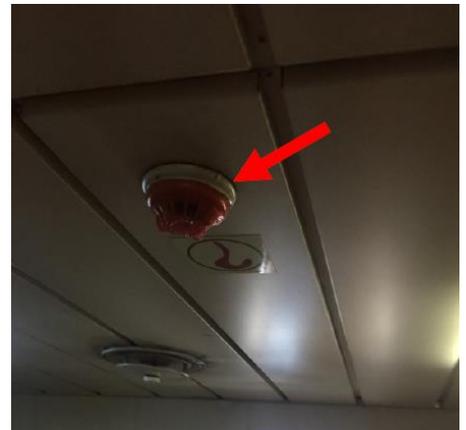
During an inspection of vessel accommodation by shore management, it was observed that a plastic cover was obstructing a smoke detector. During construction work in the area the cover was used to prevent activation but was not removed when the work was finished.

- ◆ Lack of risk perception – smoke detectors are designed to warn individuals that something is on fire. A plastic cover will prevent it from working;
- ◆ Stop Work Policy was not applied – crew must have seen it but did nothing about it! No-one challenged this unsafe practice;
- ◆ Inspections were not conducted – this illustrates the importance of periodic inspection of fire protection systems to ensure that they are maintained in serviceable condition.

- ◆ Our member arranged a “Time Out for Safety” with all vessels’ crew to emphasize the hazards associated with blocking and covering of smoke detectors;
- ◆ Further fire inspection on-board the vessel to check the condition of the other smoke detectors.
