## **IMCA DP Station Keeping Bulletin 01/20**

February 2020

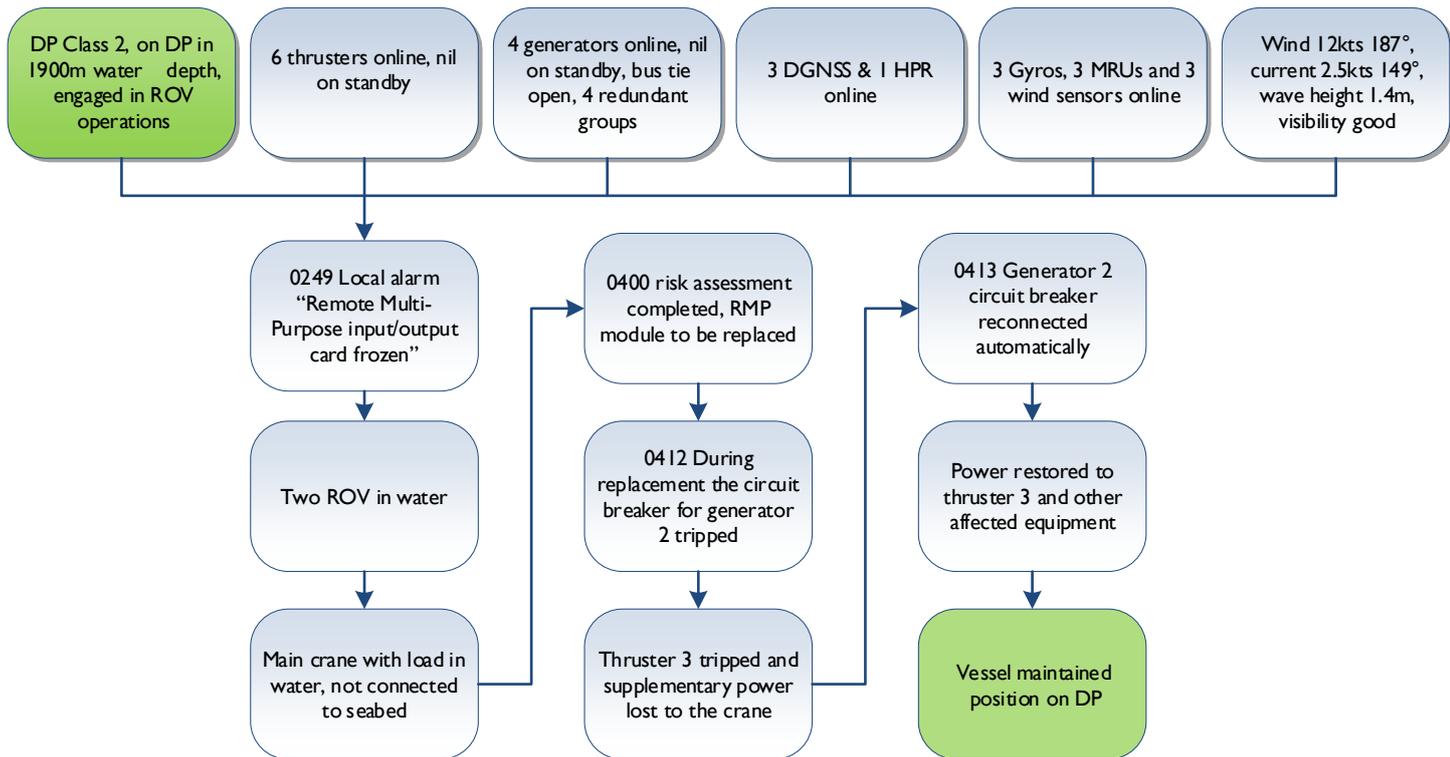
## DP Undesired Event Due to Online Maintenance Work

The vessel reported that they had changed these modules in the past whilst on DP without any issues. The risk assessment had identified that the consequence would not lead to loss of equipment greater than worst case and proceeded due to the status of the vessel operations, open water and not connected to the seabed.

- ◆ Incident validates the redundant capability of the vessel, but also potentially highlights a hidden failure leading to generator 2 failure;
- ◆ The report did not identify the root cause for the loss of equipment whilst replacing the RMP module, a successful online activity undertaken previously;
- ◆ This event highlights the benefit of considering mission equipment during risk assessments;
- ◆ It also event highlights that expected results of repairs are not always guaranteed;
- ◆ As far as is possible, maintenance or replacement of critical DP equipment should not be done while conducting DP operations;
- ◆ In this instance, it would have been prudent for ROVs to return to their TMS and the crane made safe prior to undertaking the work.

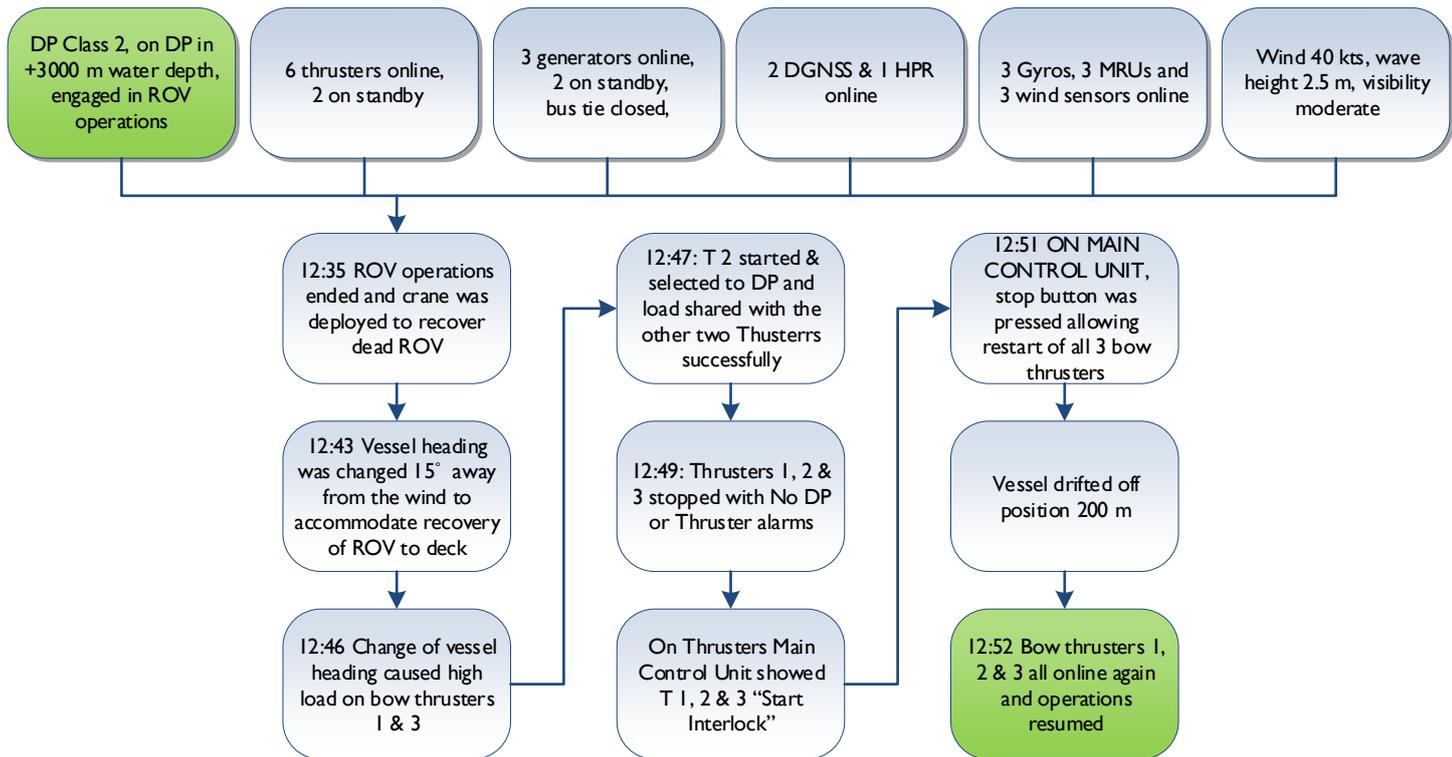
## Change of Heading Leads to DP Incident

The vessel had been on DP for the whole day and in order to lift the ROV on deck with the crane, vessel heading had to be changed 15 degrees away from the wind. This caused a high load on two running bow thrusters and the third bow thruster was started, selected to DP and successfully shared the load. Increased windward force on the vessel due to high wind velocity acting on it as it changed heading, caused all the three bow thrusters to trip on overspeed with no DP or thrusters' control system alarms! Further investigation revealed the overspeed settings were too tight and had to be increased in accordance with manufacturer's recommendation.

- ◆ It is not clear why the additional bow thruster was not put online before the heading change;
- ◆ A simulated alteration of heading and or referring to the vessel's capability plots should have been considered to ensure that the heading change could have been performed within vessel's DP capability;
- ◆ The overspeed trip of all thrusters during DP operations shows inadequate initial commissioning and full power testing during the FMEA proving trials and annual DP trials and following any modification;
- ◆ This incident further highlights the importance of equipment protection settings with respect to DP redundancy concept, in addition to equipment safety. DP FMEAs require to consider the effects of equipment protection system on the wider DP redundancy concept. Reference [Guidance on Failure Modes & Effects Analysis \(FMEA\)](#) (IMCA M 166).

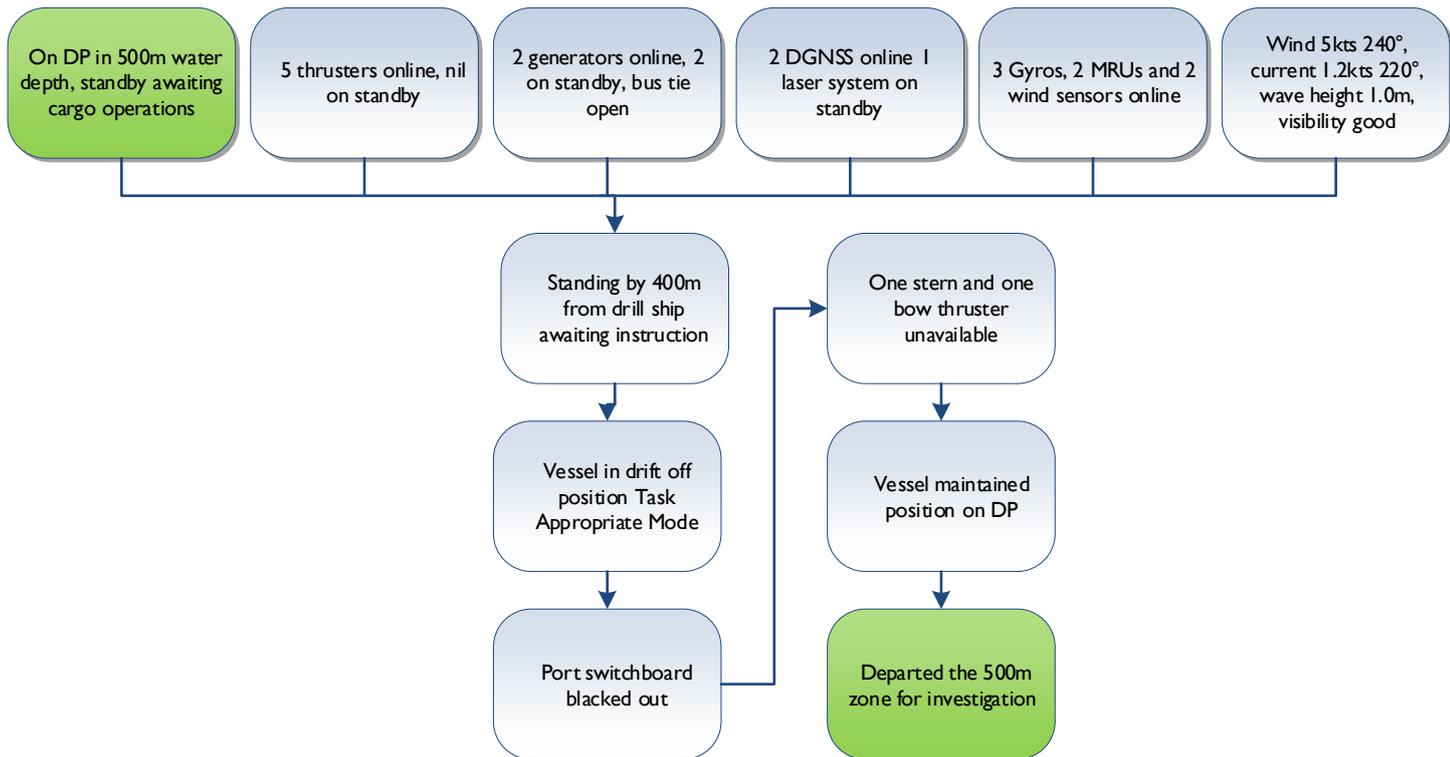
## Unreliable Component Causes a DP Undesired Event

Investigation found that a 24v bridge rectifier supplying voltage to the main generator switchboard breakers 1 and 2 had burned out. The age and quality of the rectifier was thought to be the main reason for failure. Planned maintenance routines were updated and shared with the fleet. It was recognised that the system was vulnerable due to a single 24v bridge rectifier supplying the entire port switchboard.

The vessel validated that it could maintain position following the worst-case failure of a complete switchboard. Though redundancy is a must in DP 2/3 designs, components quality may impact the likelihood of such DP events occurring.
