IMCA Safety Flash 07/20

February 2020

These three incidents have been shared with IMCA by the G+ Global Offshore Wind Health and Safety Organisation, and all relate to dropped objects in the offshore wind industry.

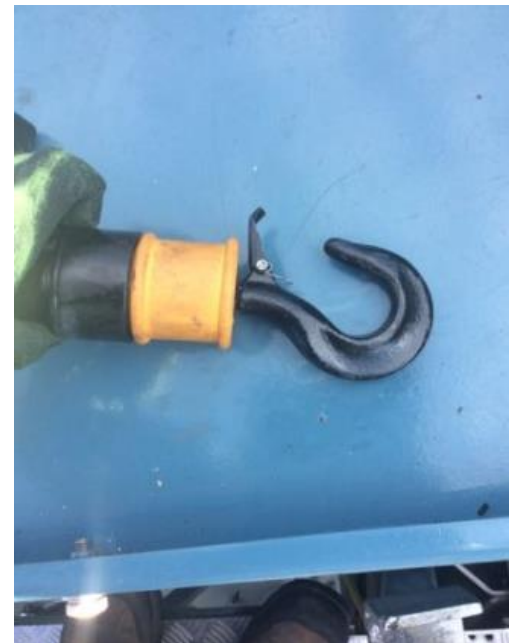
Two lifting bags detached and fell from the crane hook on a wind turbine tower. The incident occurred during lowering operations at the end of an annual service day in the wind turbine nacelle. A contractor technician packed up tools and equipment and loaded them into certified lifting bags. The bags were then loaded onto the nacelle crane hook for lowering to the transition piece. During the operation, two of the lifting bags became detached from the crane hook and fell approximately 60 meters into the sea. Both of the bags were recovered from the sea; there were no injuries or property damage.

- ◆ The safety latch on the lifting hook had suffered damage and failed. The investigation noted that this potentially indicated that the hook was incorrectly loaded, which had resulted in excess pressure on the safety latch of the crane hook causing it to become defective.

- ◆ Ensure any planned lifting operations are verified to ensure safe loading techniques are employed;
- ◆ A toolbox talk (TBT) to be delivered to all service technicians as a reminder of the correct procedure for rigging the nacelle crane and dangers of incorrect loading.

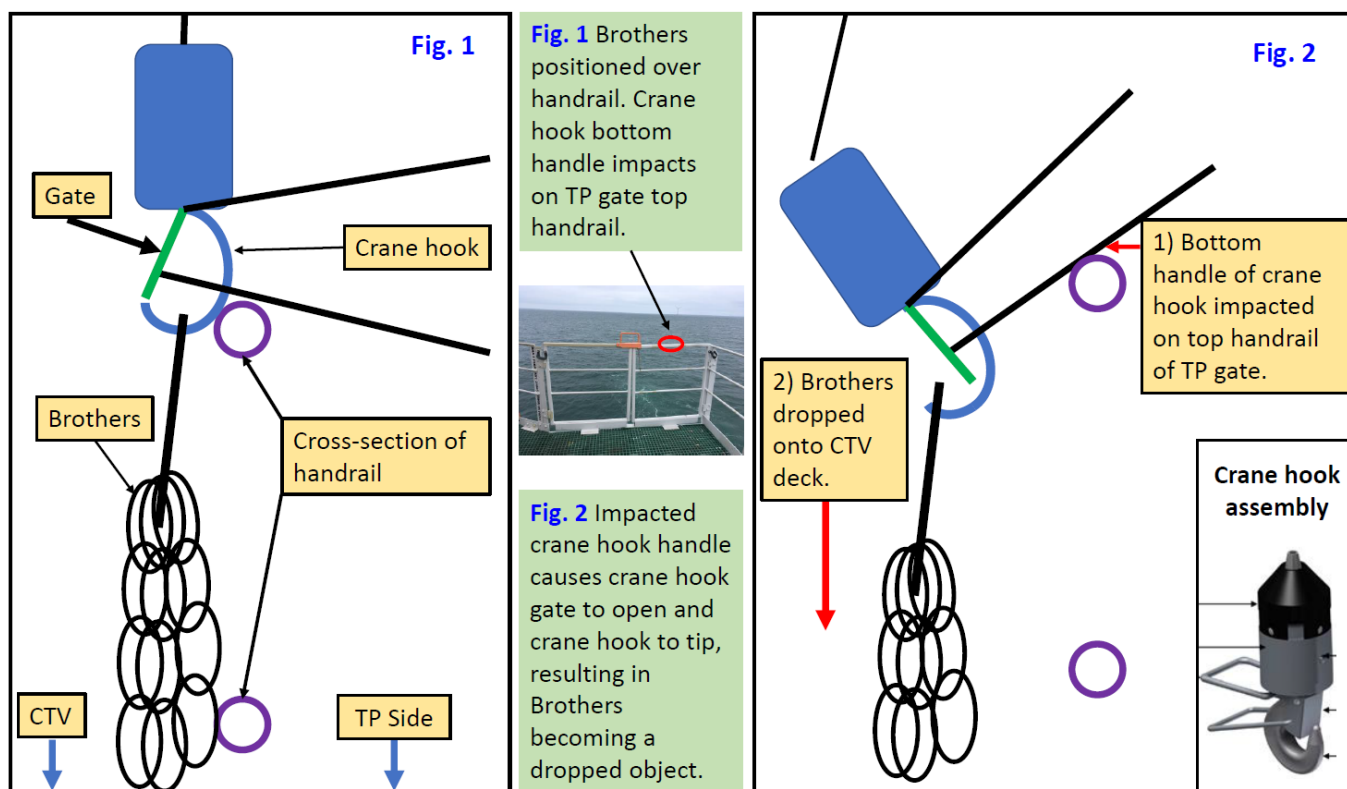
The practice of manually repositioning the 'Brothers' was intended to make the lifting operations slightly quicker; however, it resulted in the bottom handle of the crane hook impacting on the top of the transition piece gate handrail, making the crane hook open and the crane hook itself tilted. This then resulted in the set of 'Brothers' falling onto the front deck of the CTV below. There were no injuries.

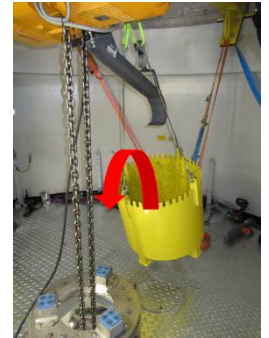
At a wind turbine tower, chains weighing 17kg fell 84m. The incident occurred during the pulling through of a 66kv HV cable during installation. The surplus chain came out of a storage bucket and spooled uncontrolled 84m down the tower to the entrance level. The noise of the chain spooling down the tower alerted the client's HSE inspector who went towards the tower to investigate. There were workers near the chain as it fell and as it landed, but no-one was hit or injured.

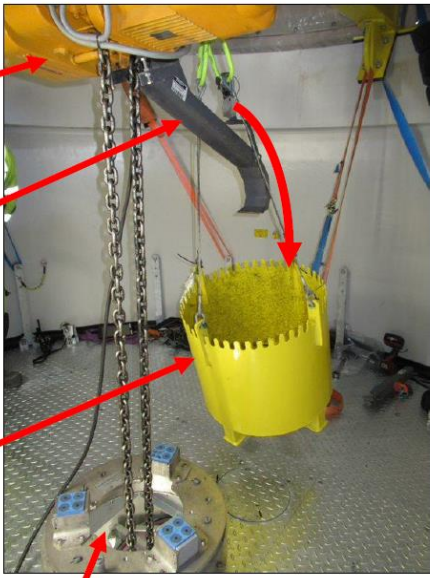
Winch System

Chain Feed Tray

Chain Collection Bucket

Void which chain and 66kV cable enters through and also dropped through after chain backed up in feed tray

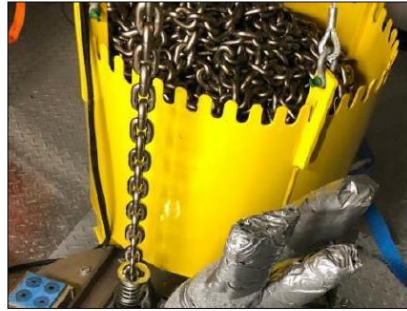
Example of bucket being filled with chain

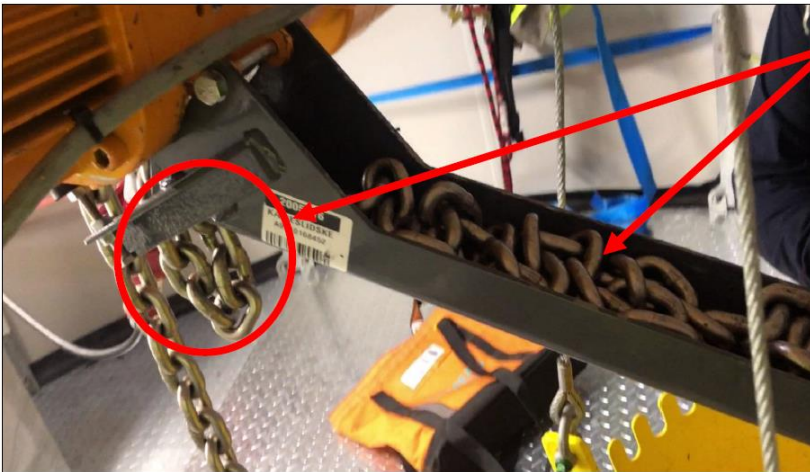
Example photograph showing how chain can kink causing it to back feed from feed tray due to the bucket being overfilled with chain

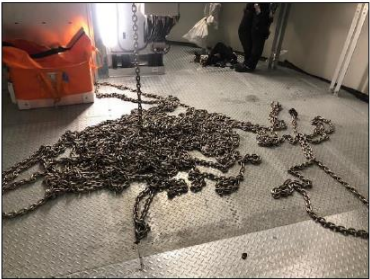
Example photograph from a previous incident showing length of chain that has the potential to drop
