## IMCA DP Station Keeping Bulletin 02/20

May 2020

### DP Incident Caused by Software Glitch

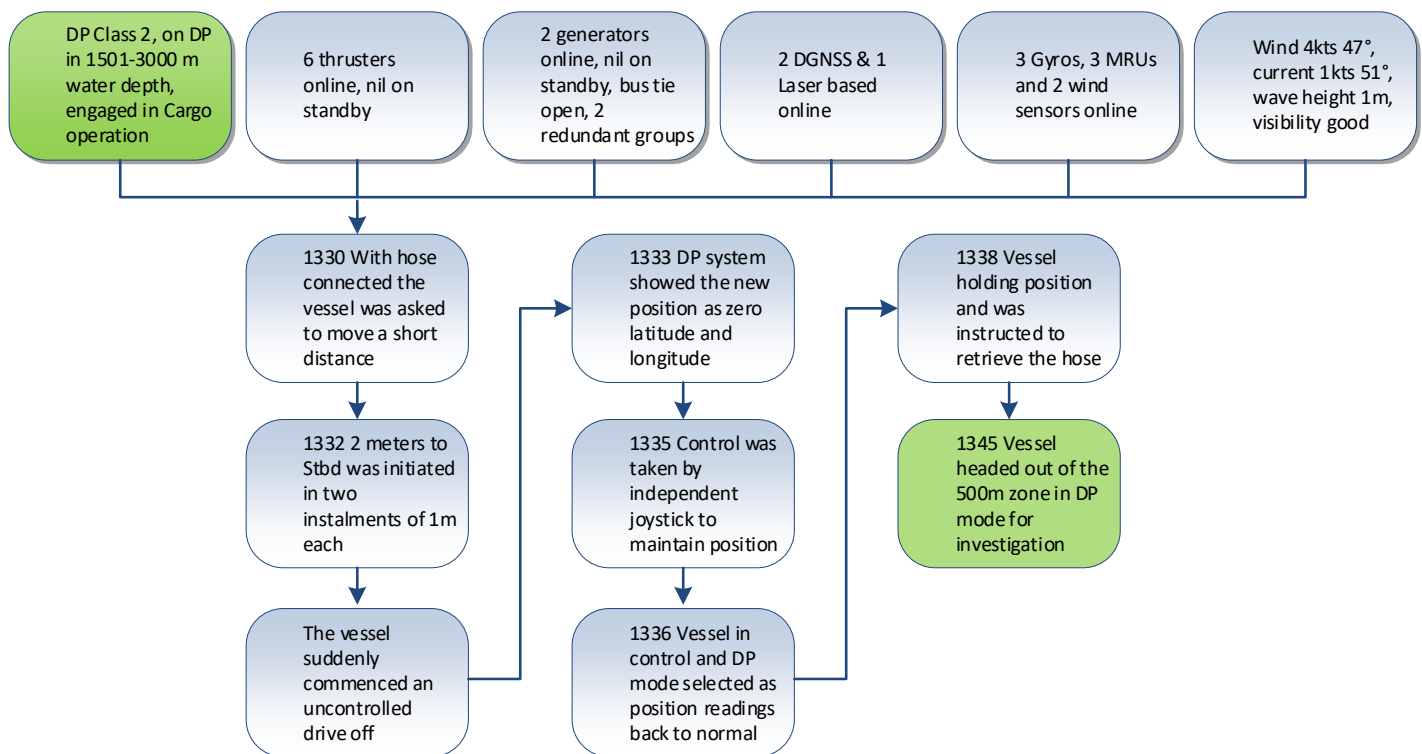
The two meters move command was given in two one-meter steps to the DP system by the operator with a time lapse of a few seconds. This was investigated by the DP system vendor and was identified as a software glitch. Two consecutive incremental move commands before the window screen has time to refresh resets the DP system to a zero position automatically. Instructions were put in place on-board this and similar vessels until the vendor remedies the software issue.

- ◆ This and similar incidents highlight the need for extensive testing of the software at all stages;
- ◆ Many vendors continuously update their software with patches, revisions, etc. Vessel operators must ensure a robust management of change (MoC) procedure and suppliers should provide an appropriate rigorous testing program;
- ◆ The DP operator(s) appear to have initially responded well to the incident and this is a credit to their training and competence;
- ◆ Reference IMCA documents [Guidance for developing and conducting DP annual trials programmes](#) (IMCA M 190) and [Guidance on failure modes and effects analysis \(FMEA\)](#) (IMCA M 166).

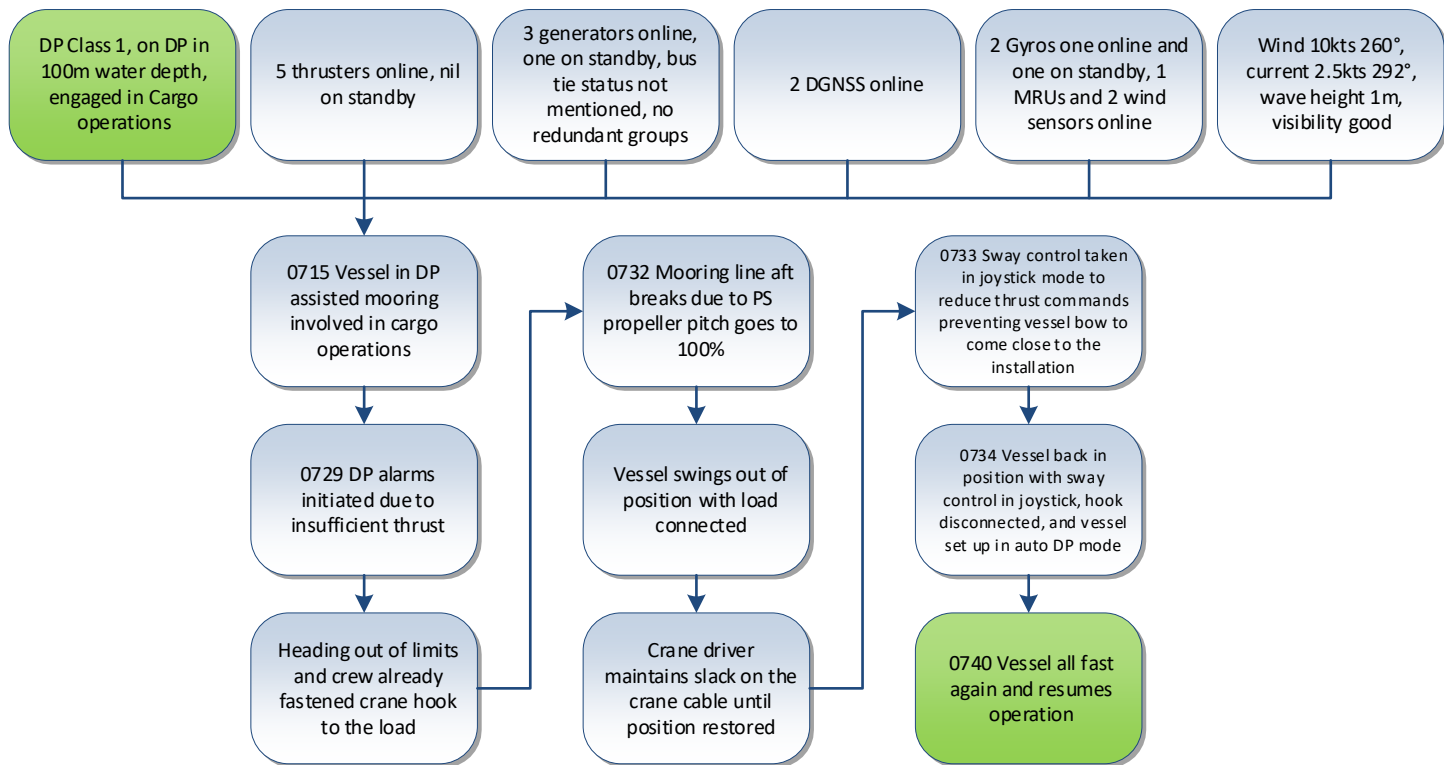
During cargo operations in DP assisted mooring, due to undefined information being fed to the DP system, the pitch on the port propeller increased to maximum. The vessel started to drive off the installation with the crane connected to the load, dimensions 3.5\*10.5\*6.5 m weighing 11 M Tons. All deck crew were already in safety area behind crash bar ready with tug lines for the lift.

- ◆ There appears to be no consideration to the external force being applied to the vessel due to the use of mooring lines when in DP;
- ◆ If an external force is applied to a DP vessel without feedback and correct configuration within the DP system, it will have unintended consequences;
- ◆ It appears an appropriate Activity Specific Operating Guideline (ASOG) was not in use.
