IMCA Safety Flash 20/20

July 2020

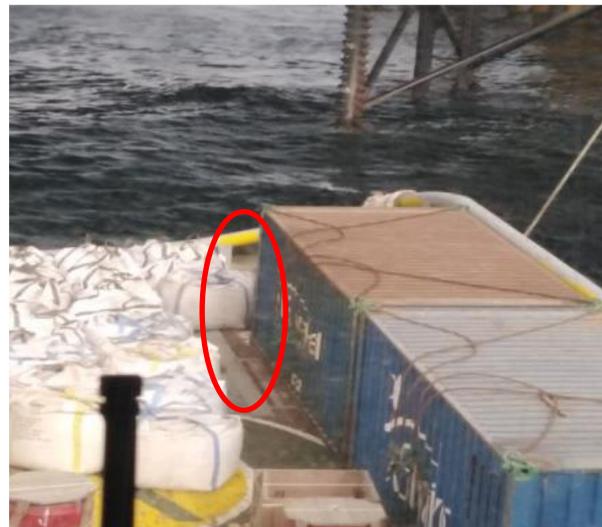
An AB got his leg entangled with a tag line during lifting operations. The incident occurred when a vessel was alongside a rig offloading cargo. The AB attached the aft tag line to a container, then laid out the tag line on deck and proceeded to inform the crane operator to lift the container. As the container was lifted from the deck, the tag line entangled the right leg of the AB and began to lift him from the deck. He was able to grab the tag line with both hands preventing it from constricting his thigh and so preventing a serious injury. Although he had a radio he was unable to use it as both hands were preventing the rope from tightening around his leg.

- ◆ Clear deck policy was not considered in the risk assessment in the context of cargo operations;
- ◆ There was limited situational awareness.

Approximate location of AB (red oval)

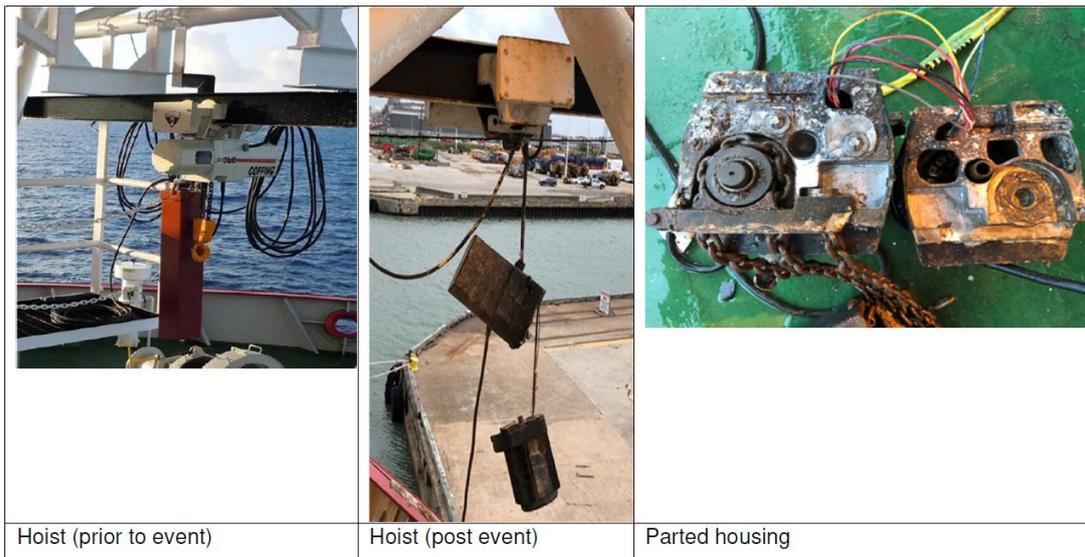
An electrically powered gantry hoist failed whilst under load dropping cargo and lifting equipment to deck. The incident occurred during a lift of 500kg of palletised provisions onto the vessel. The failure resulted in the provisions falling onto the deck. The gantry hoist housing included a chain box containing approximately 10m of 10mm chain weighing approximately 19 kg which dropped 4m (12ft) onto the deck.

The hoist motor / gearbox housing securing bolts failed due to excessive and previously unidentified internal corrosion.

- ◆ Review and improvement of:
 - Procurement process to emphasise the importance of ensuring that equipment is selected by a competent person, is suitable for its intended purpose and operating environment;
 - Mechanical lifting equipment procedure modified to further emphasise the importance of complying with the procurement process and the manufacture's installation, use and maintenance requirements;
 - Enhanced arrangements for the management and control of equipment maintenance and inspection records and general record keeping;

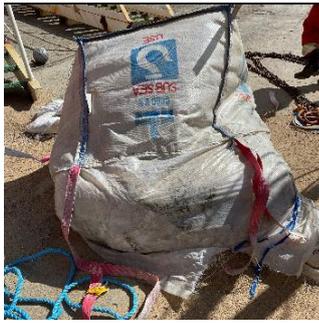
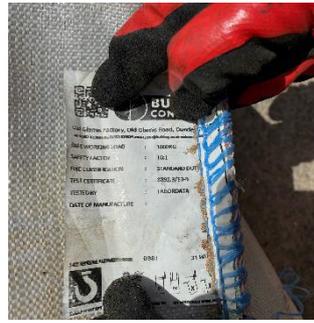
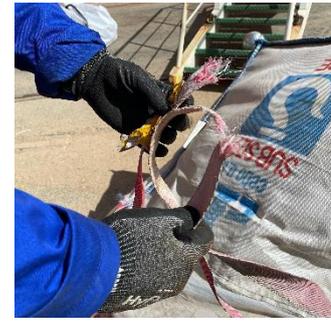
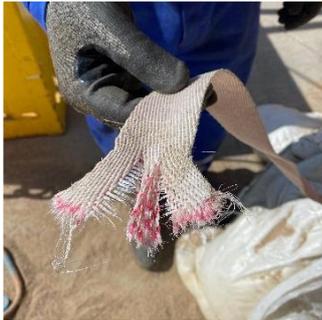
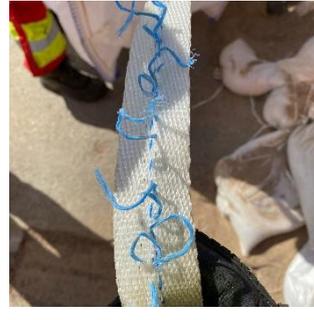
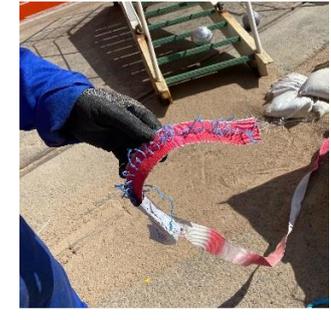
As the load was lifted to approximately 1 metre, there was a routine inspection of the load to check the handle loops and that the base of the bag was OK before lifting. The FIBC was raised to 3–5 metres when a distinctive tearing / ripping sound was heard, it was then the FIBC handle and stitching tore and the 900kg of sand bags fell onto the quayside. There were no injuries.

- ◆ Inspect prior to use ensuring they are:
 - free from damage that can compromise its strength;
 - free from any UV degradation (due to sunlight exposure);
 - free from chemical damage;
- ◆ Lift following manufacturer and supplier's instructions;
- ◆ Ensure the landing area is clear of sharp and protruding edges;
- ◆ Ensure the filled FIBC is stable and secure during transportation;
- ◆ Store in a suitable location protected from UV radiation and rain (long periods of storage);
- ◆ Pad out forklift forks when lifting through lift handles to eliminate sharp edges.

- ◆ Drag or push FIBCs;
- ◆ Stop/start suddenly when lifting (shock loading);
- ◆ Allow suspended load to swing uncontrollably;
- ◆ Lift by steel wires or similar devices which may present sharp edges or rough surfaces;
- ◆ Use an FIBC which has exceeded 2 years from the date of manufacture;
- ◆ Lift over personnel.

Note: If there is any doubt over the integrity of the FIBC, replace the FIBC or use a metal transfer basket/half height

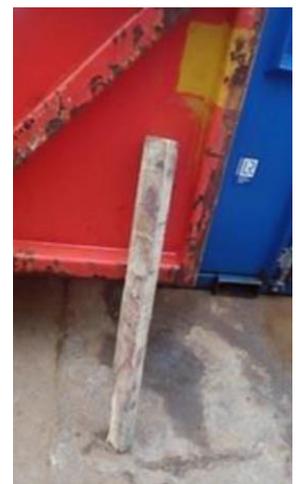
Marine Safety Forum Safety Alert 20-04 describes a potential dropped object (PDO) during cargo operations. A wooden baton of the type often used to support covers attached to open topped Cargo Carrying Units (CCUs), was discovered jammed against the underside of a cargo basket.

- ♦ Wooden batons are normally used to support the tarpaulin cover used on open top CCUs;
- ♦ Wooden batons are only held in place by being jammed against the sides of the open top;
- ♦ There is generally no securing mechanism holding the wooden batons in place;
- ♦ Batons need to be ‘knocked out’ before heavy cargo is lifted from the CCU by crane;
- ♦ Knocking out batons from high sided CCUs can result in the baton falling onto the persons removing it.

The MSF safety alert concluded: *Tarpaulins and batons do have their uses when required for covering cargo, but their use should always be risk assessed and evaluated against other cover types which may be readily available. The risk assessment should include but not be limited to:*

- ♦ *The type of cargo and the effects of its exposure to the environment;*
- ♦ *The manual handling issues that may be encountered by the end user;*
- ♦ *Consider the use of ‘cord strap’ or similar instead of wooden batons to support covers. (particularly on high sided open top units)*

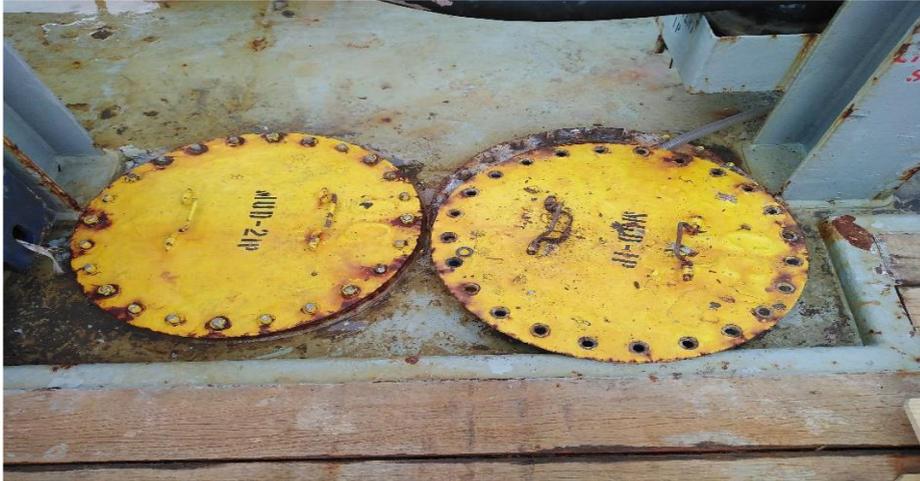
During a safety round on deck prior to cargo operations it was noticed that a manhole had been opened in order to pump out ballast water to replace a faulty valve.

The manhole cover or hatch nuts had been completely removed and the cover was only placed back on top and was left completely unsecured. There was no barrier tape nor any warnings placed to indicate that the cover was open and unsecured.

- ◆ Bypassing safety controls:
 - Crew did not follow company procedures;
 - No warnings were posted;
 - It did not occur to the crew doing this work to consider the potential risks of persons falling inside or slipping from standing on the manhole cover while so placed and not secure.
