1 Follow-Up to Toxic Gas Emission from Transponder (Lithium Batteries)

2 Near Miss involving Winch Failure

3 Punctured Aerosol results in Chemical Burns

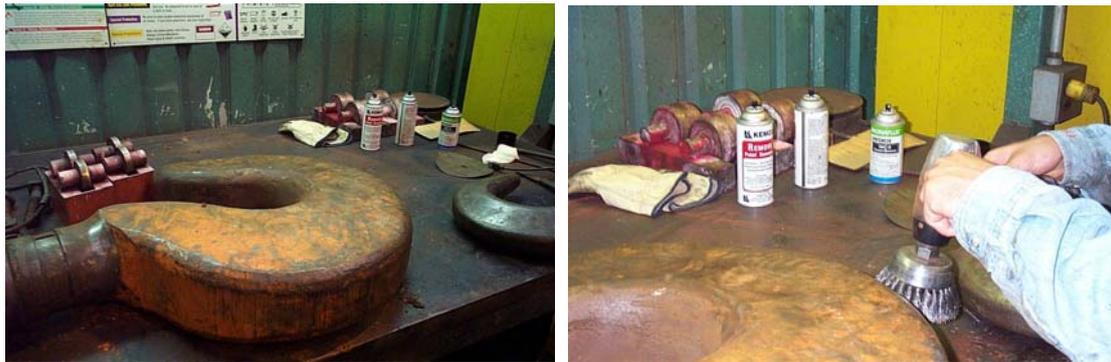
A large hook was being stripped of paint in preparation for inspection. Aerosol paint stripper was being used, with a technician then using a 6000rpm grinder with wire brush cup attachment. The work area is shown below, including the relative positions of the hook and the aerosol.

As the technician was brushing the bottom of the hook, hard particles or brush wires were projected, striking one of the nearly full paint remover aerosol cans sitting on the bench nearby. The particle punctured the can about 1" up from its base and caused the contents to violently spew from the can while it spun wildly on the bench. This happened so quickly that the technician was sprayed around his head, shoulders and back with paint remover before he could move away.

He moved as quickly as he could to the wash basin in the workshop and thoroughly rinsed himself off which, along with the protection of his safety glasses, hard hat and shirt contributed to him only experiencing slight chemical burns on the upper portions of his body.

Fortunately, the gaseous contents of the aerosol can did not ignite as they spewed from the can. If they had, the employee could have been engulfed in fire and suffered much more extreme injuries.

The company concerned has restated the importance of removing aerosol cans, returning them to proper flammable storage areas/containers when carrying out work of this nature. Returning to the picture above – to the right of the work bench is a yellow flammable container storage locker. Had it been used, this incident would not have happened.

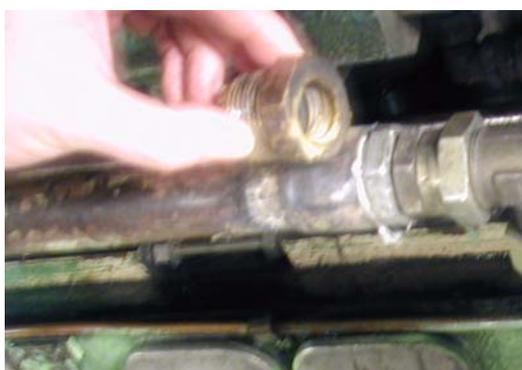
A member has reported the following serious near-miss which occurred in the engine room of one of its vessels. A high pressure air fitting (25 bar) failed and blew out, narrowly missing the face of an engineer.

- ◆ A steel fitting had been used to join the swivel hose end to the union fitted to the hard pipework. The constant engine vibration over time had caused the harder steel component to erode the threads on one side of the brass union, thus weakening the joint;
- ◆ It was thought likely that the 'male' fitting had not been properly aligned when initially tightened. This could have sealed adequately, as the steel fitting would have cut its own thread, but would also have resulted in an inadequate join;
- ◆ The pressure caused by the two previous situations, combined with the loading of the line with 25-30 bars of air pressure, was too much for the joint, which finally failed. This could have happened at any time that the engine was started.

The vessel's other engine air start line fittings were inspected and nothing detrimental was found. However, concerned that the above combination of events could occur on other ships or barges, resulting in damage or injury, the company involved has circulated details of the incident to engineers on all of its other vessels. Its chief engineers have been instructed to check all such fittings on their respective engines and to advise maintenance staff of the need to be vigilant when dealing with high pressure fittings.
