I Diver's Lost Gas Incident

2 Gas Release from Pipeline During Diving Operations

3 Near-Miss During Connector Pressure Tests

4 Oxygen Near-Miss

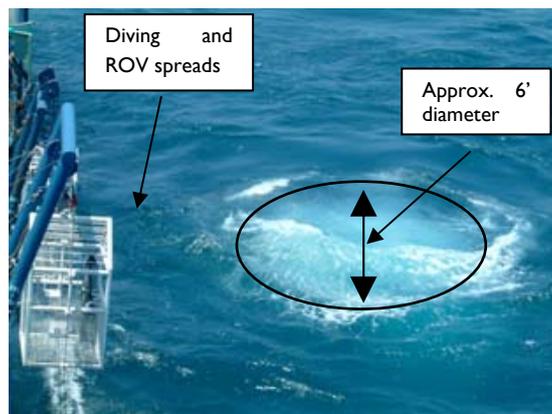
The following day when the diver had removed all but two of the bolts and the flange was loose and a couple of inches away from the end of the pipeline, the diver reported discharge from the open face and that bubbles of gas were clearly visible from the flange.

During recovery of the bell, the gel plug passed an increasing volume of gas to surface. The escaping gas was clearly visible in the area around the diving bell and remained visible for approximately 40 minutes until the pipeline was depressurised from the shore. It was fortunate that the diving bell was recovered to the surface just moments before the gas escape, as the bell was in close proximity to the open flange face.

- ◆ Lack of understanding of the gel mechanism. The gel slug was not designed to withstand pressure differential.
- ◆ The management of change process did not undertake sufficient engineering analysis before being approved.
- ◆ Lack of pressure control and monitoring mechanism during increasing the pipeline pressure, e.g. the scales of the gauges were not appropriate.
- ◆ The risk assessments of the work scope had failed to integrate the onshore aspects.
- ◆ The toolbox talk did not communicate the identified risks from risk assessment exercises to the divers undertaking the work.

- 1 Establish a completely integrated team with clear roles and responsibilities to execute the work scope. Ensure all parties involved understand the complete scope and the interactions

An integrated, early understanding of the work scope is essential in ensuring effective risk assessments and to help manage future changes during execution.
