I Serious Injury in Towing Operation

2 Diver Struck by Lifting Frame while Installing Concrete Mattresses

3 Late Onset of Decompression Illness (DCI)

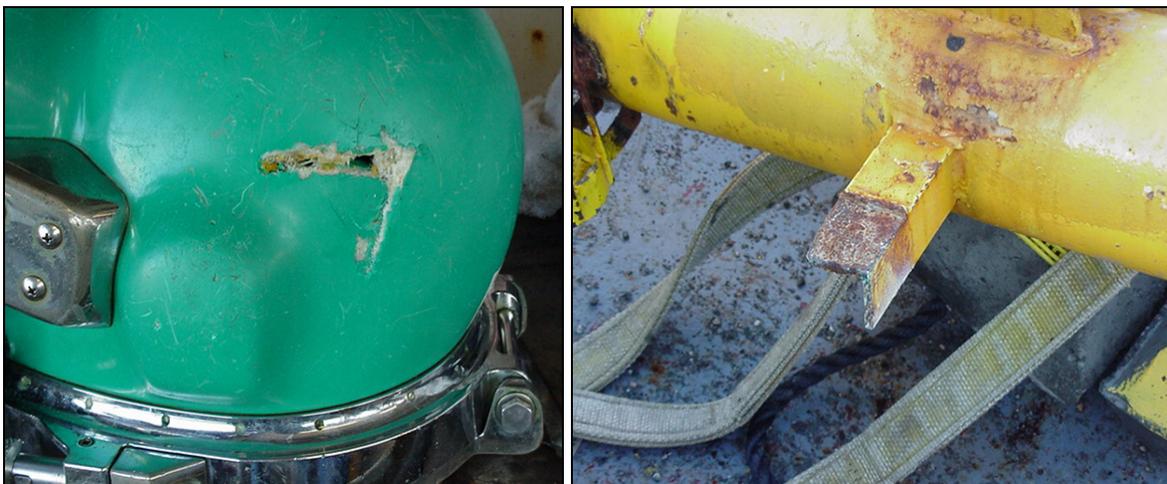
As a diver confirmed that the last mattress in a spread was centred over the proper location, he called for the crane to lower the load. When the initial weight of the mattress was off the handling frame, an unexpected vessel motion caused by swell forced the frame to move towards the diver and into the side of his helmet. The diver's helmet was penetrated above and below the diver's left ear by a piece of angle iron protruding from the middle of the mattress installation frame on the opposite end from the release lever.

The diver had been bending over, attempting to move the mattress into position, with his right arm resting on two previously installed mats behind him. The protruding piece of angle iron was one of several remnants of reflector mounting brackets that had inadvertently been left in place from a previous job.

Besides the damage to the diver's helmet, the diver received a bruise to his shoulder/forearm when he was caught between the swinging mattress frame and the previously installed mattresses. Had the piece of angle iron further penetrated the diver's helmet, or had the diver's head turned in a different direction, the incident could have resulted in a fatality.

- ◆ The mattress manufacturer/owner was contacted and permission given to cut the angle iron protrusions from the mattress installation frame;
- ◆ Further, the mattress manufacturer/owner involved has stated its intention to remove all non-standard protrusions from its installation frames before they are re-let for subsequent use and asked lessees to assist in this. It notes that the welding of brackets can assist in easing installation procedures, through the use of pingers, transponders, ROV grabber holes, etc., but notes that the safety of divers and ROVs is paramount to be considered above any and all other considerations, with heightened awareness of the dangers leading to this action. Members should review their own procedures to ensure such hazards are considered and addressed;
