I Possible Choking Incident – Diver’s Helmet

2 Pipe Handling Frame Incident During Diving Operation

3 Uncontrolled Decompression During Gangway Move

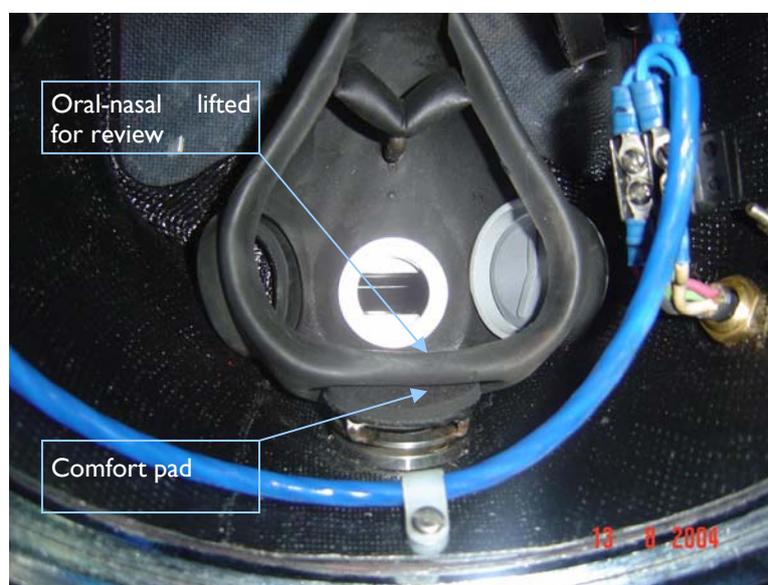
While performing a task during a saturation dive, a man inhaled a 45mm diameter neoprene component from a diving helmet. The component has been identified by the supplier as a ‘comfort pad’, which had been installed to protect the diver’s face from abrasion and cold.

As can be seen in the photograph the part is located on top of the retaining nut at the bottom of the oral nasal piece, in close proximity to the diver’s mouth. In this incident a choking incident was avoided as the part was caught in the diver’s teeth during inhalation. The cause of the detachment appears to have been a loss of bonding from the adhesive which attaches the two components.

The supplier of the helmet was notified and they have advised that a ‘Correct Memo’ is to be issued to the manufacturer ASAP. The manufacturer advised the application of an approved wet suit cement to reattach the pad.

The company concerned is in contact with the supplier and manufacturers of the equipment, and there may be a following note to advise of progress. The company has recommended that close scrutiny is given to checking this part and other

similar components prior to every dive. It has advised its crews that a spare nut with the pad attached will be made available for quick turn-a-rounds should this be required.

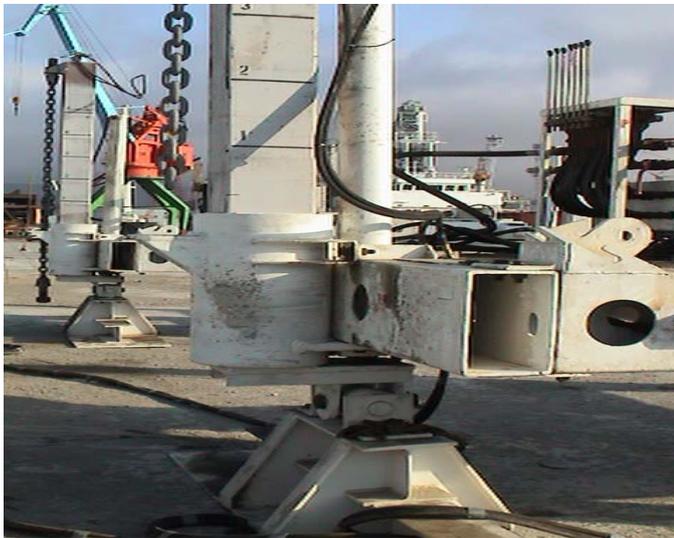
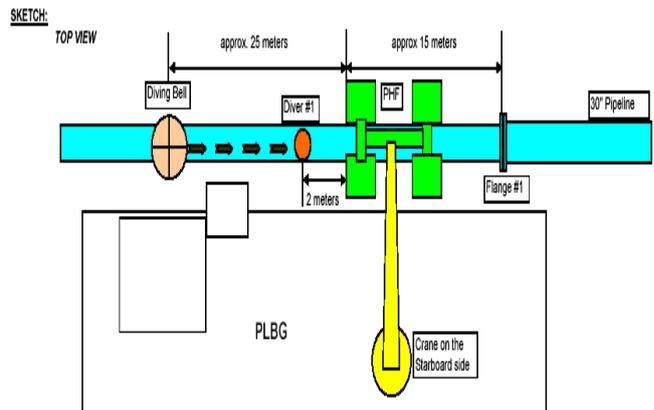
A member has reported an incident while a pipe handling frame (PHF) was being lowered to a depth of 100 metres from a barge using its starboard crane when a shift change was in process onboard. At the same time, a diving bell was at the depth of 155 metres, 25 metres away from the descending PHF area.

He immediately stopped and informed his supervisor. In the process, he made physical contact with the PHF, which had settled half on the pipeline and the seabed.

- ◆ at the time of the incident, a shift change was in process;
- ◆ the PHF dimension was 5.60m 5.20m 2.50m, its weight in air 18 tons and its weight in water 16.5 tons;
- ◆ the PHF was being lowered at a speed which was disabling the transponder needed to update the survey system;
- ◆ the transponder used to monitor the lowering and rising of loads and crane wires malfunctioned (sending intermittent signals).

- ◆ The diving supervisor taking over shift and managing the subsequent lock-out of the diver could not reasonably be expected to know the situation of the PHF, other than that it was as planned, without another person informing him of any subsequent change, i.e. the deck foreman or the survey operator;

- ◆ The action to over-board the PHF and 'park it' at 100m until the supervisor could take control was a sensible and prudent administration strategy;
- ◆ The fact that the PHF was not parked at 100m should have been noted and passed to the supervisor by the crane operator and the survey team.

- ◆ The diving supervisor should have verified the position of the PHF prior to locking out the diver. Instead, he relied on the crane operator and the survey systems to manage the position of the PHF.

- ◆ The diving supervisor was negligent in locking out the diver and progressing the diver to the work location with the PHF suspended at the proposed 100m level.

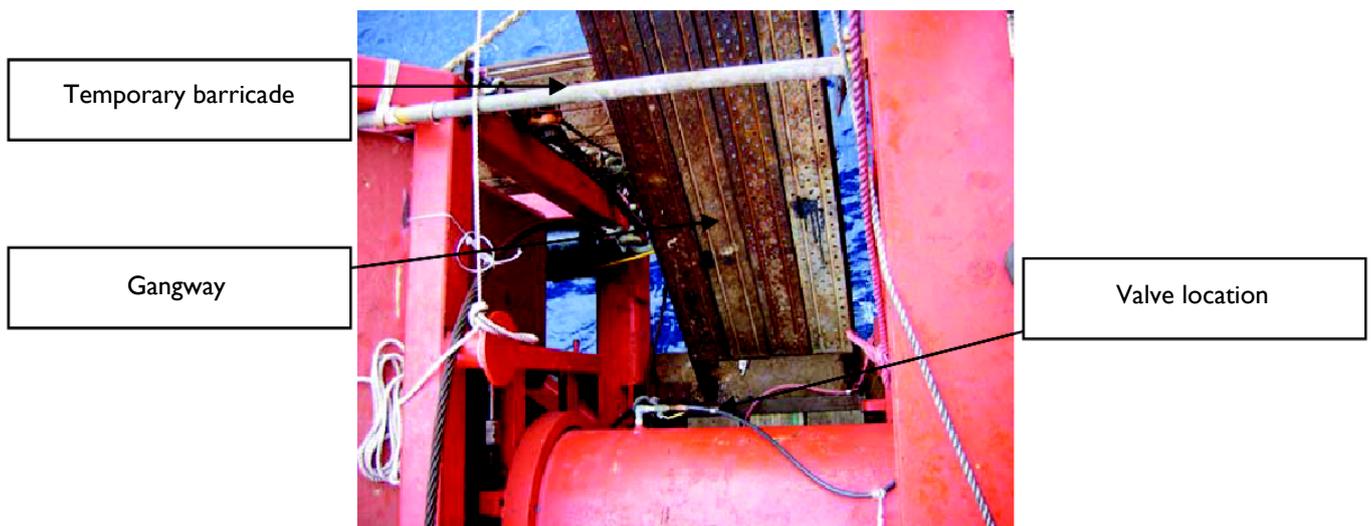
A member has reported that a man-way trunk and its adjacent entry lock on a hyperbaric chamber were depressurised to surface when a fitting on the man-way was struck by a gangway. The system was pressurised to 270fsw and vented to the surface in ten minutes through a 1/4" penetrator. The system held four divers in saturation.

- ◆ the trunk fitting was unprotected from direct contact with the gangway;
- ◆ the crew had lost control of the gangway while raising it to allow a materials barge alongside;
- ◆ there had been a valve on the internal aspect of the trunk, but this had not been secured after the valve was hit;
- ◆ the loss of pressure in the adjacent entry lock was attributable to a misalignment of the chamber inner door, which was immediately and easily realigned following the incident.

In the meantime, it has passed this alert to IMCA as a 'heads up' and a reminder that to expect and prepare for the unexpected is good advice. The company has asked all of its dive team members to scrutinise the arrangement of similar fittings on other diving spreads and to report any results which could predict the occurrence of a similar incident. Any proposed system modifications will then go through the company's management-of-change process.

- ◆ hyperbaric evacuation systems and other dive equipment on deck should be adequately protected from being struck by other objects;
- ◆ all internal doors within a hyperbaric system should be aligned properly.
