Safety Alert

Sikorsky S76A+ and S76A++ Helicopters

Turbomeca Service Bulletin 292 77 0330 (Incorporation of Modification TU 330)

ARRIEL 1**No. 292 77 0330****Subject: Installation of a sealed Power Turbine (PT) overspeed tachometer box.****Incorporation of modification TU 330.**

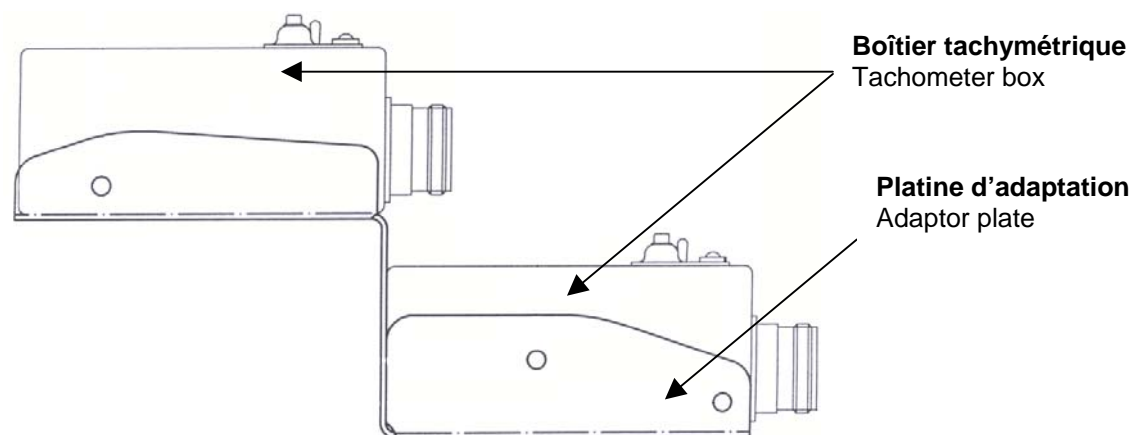
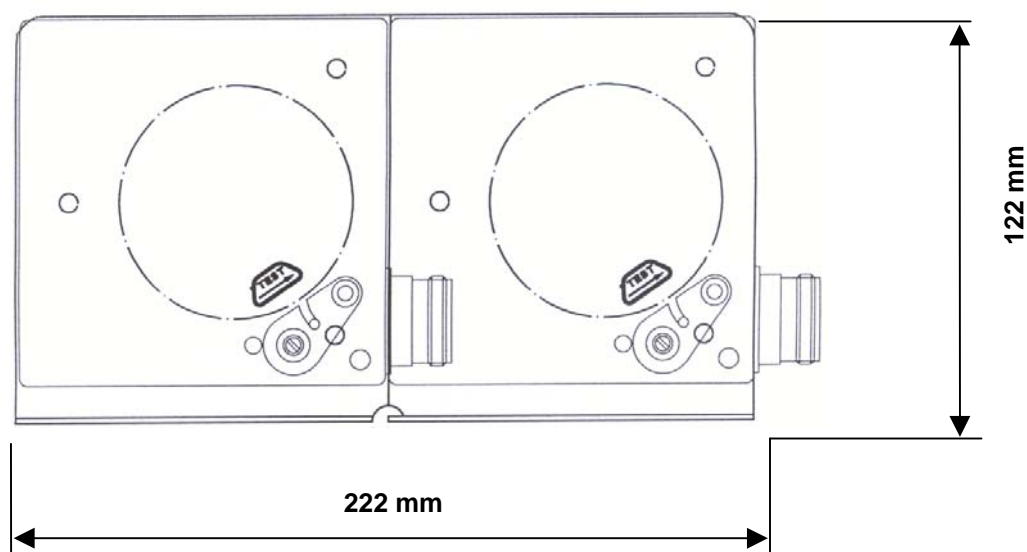
ANNEXE 1 / APPENDIX 1

BHP Billiton has experienced two separate over water in flight engine shutdowns resulting from false overspeed indications. In both events the helicopter was flown back to an onshore location and landed safely with the one remaining operative engine. Investigation by the engine manufacturer, Turbomeca, revealed that failures of the overspeed protection system resulted from ingress of moisture and internal corrosion.

This modification consists of introducing the post TU 330 tachometer box as an option in order to allow the replacement of pre TU 330 boxes that show traces of corrosion or that are used in humidity-saturated atmospheres.

Boîtiers tachymétriques pre TU 330
Pre TU 330 tachometer boxes

(a) Remove pre TU 330 PT overspeed tachometer box: refer to the Helicopter Maintenance Manual.

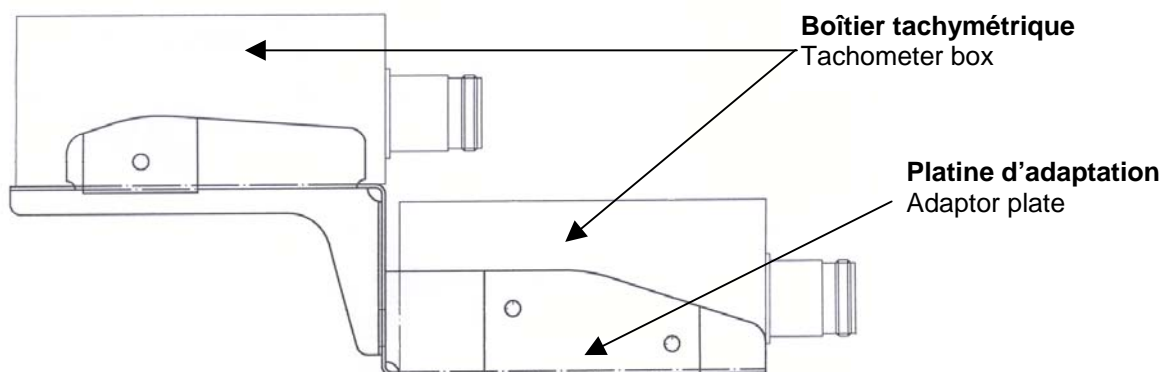
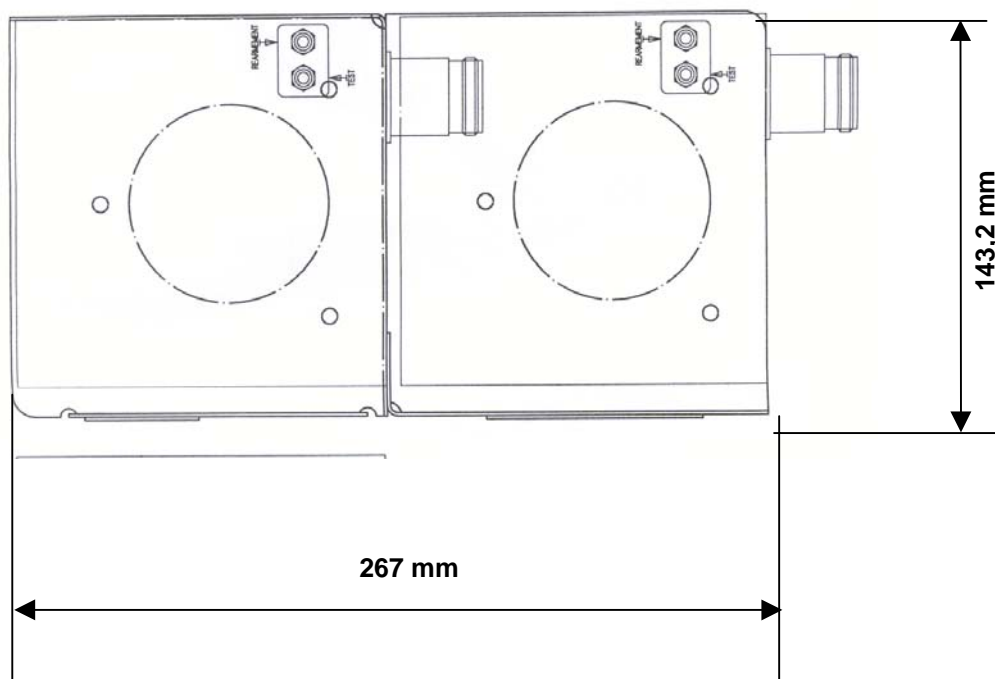
ANNEXE 2 / APPENDIX 2

To improve the sealing of tachometer boxes.

Boîtiers tachymétriques post TU 330
Post TU 330 tachometer boxes

(c) Install post TU 330 PT overspeed tachometer box: refer to the Helicopter Maintenance Manual.
