# The Loss of the “Bourbon Dolphin” on 12 April 2007

Report from a Commission appointed by Royal Decree of 27 April 2007.  
Submitted to the Royal Norwegian Ministry of Justice and the Police on 28 March 2008.

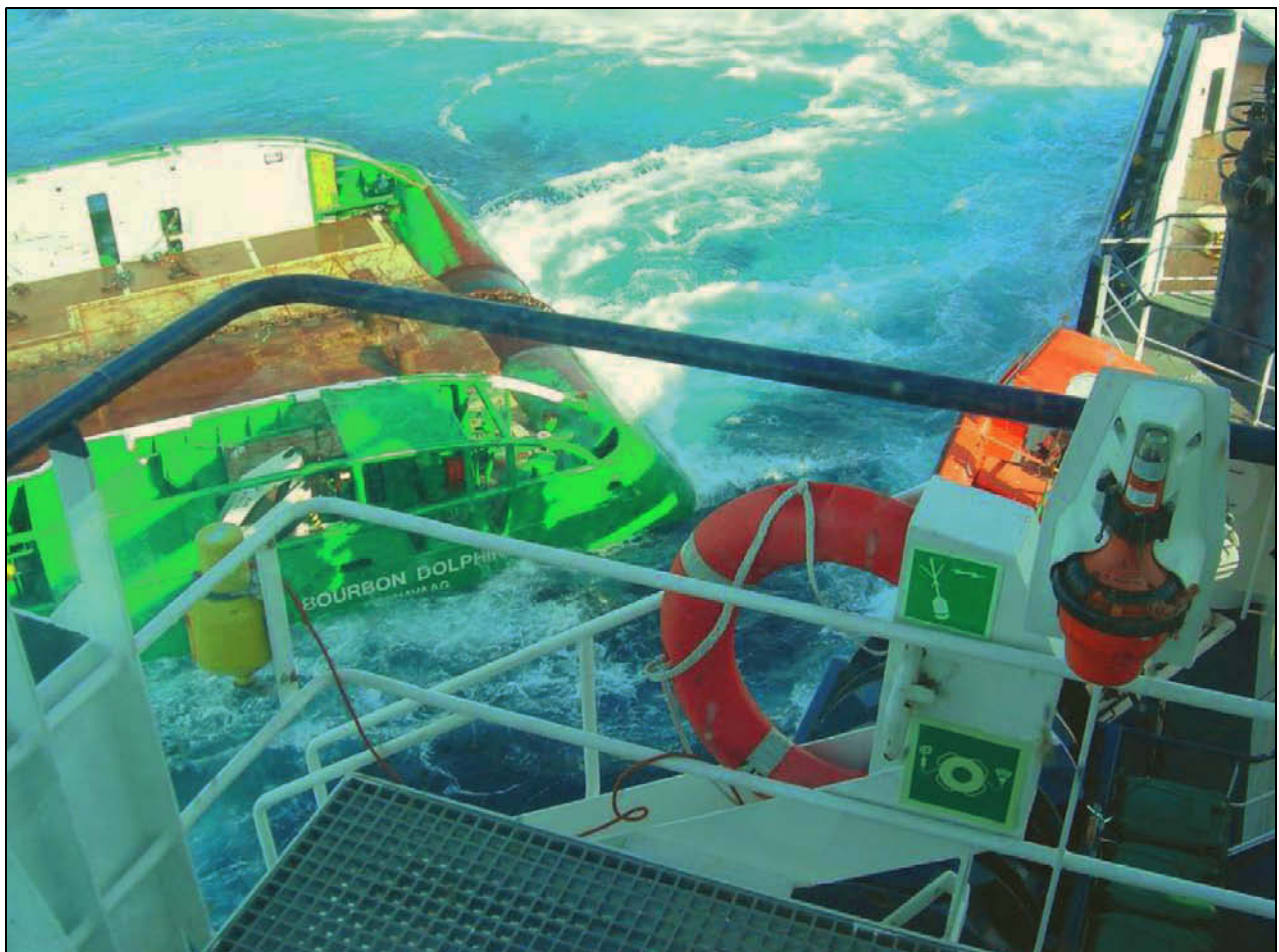
Figure 9.2 The near-miss

The “Bourbon Dolphin” continued to drift further and further off-line, at the same time as she was making little headway. From 15:30 to 16:00 the distance from the rig had increased by a little over 30 metres, whereas her drifting had increased from 650 metres to 730 metres, that is, an additional 80 metres from the line.

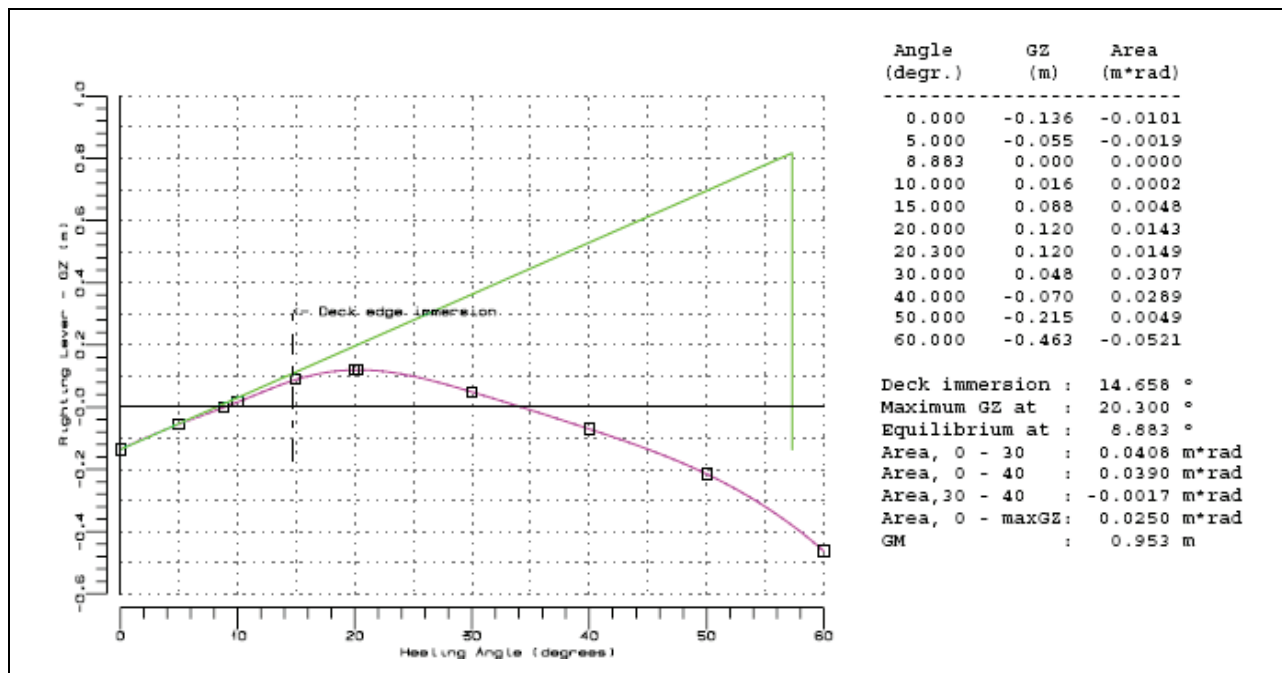
Figure 9.14 Correcting and heeling arms for load condition 3.1 after towing-pin is depressed. 40% angle of attack, 126 tonnes tension

In this situation the vessel has some stability left with a positive reach of the GZ curve to 34°. This is in a situation in which the vessel is stressed with a mean tension. When the pin is depressed the vessel, in consequence of the dynamic conditions, may acquire a list angle of 15 to 20° before she rights herself and acquires a permanent list angle of 7-9°, depending on the anchor-line's angle of attack. For example an angle of attack of 40° gives a permanent list for this condition of about 9°. See Figure 9.14, also Annex 1, Section 1.12 (pages 10-15) for more details.

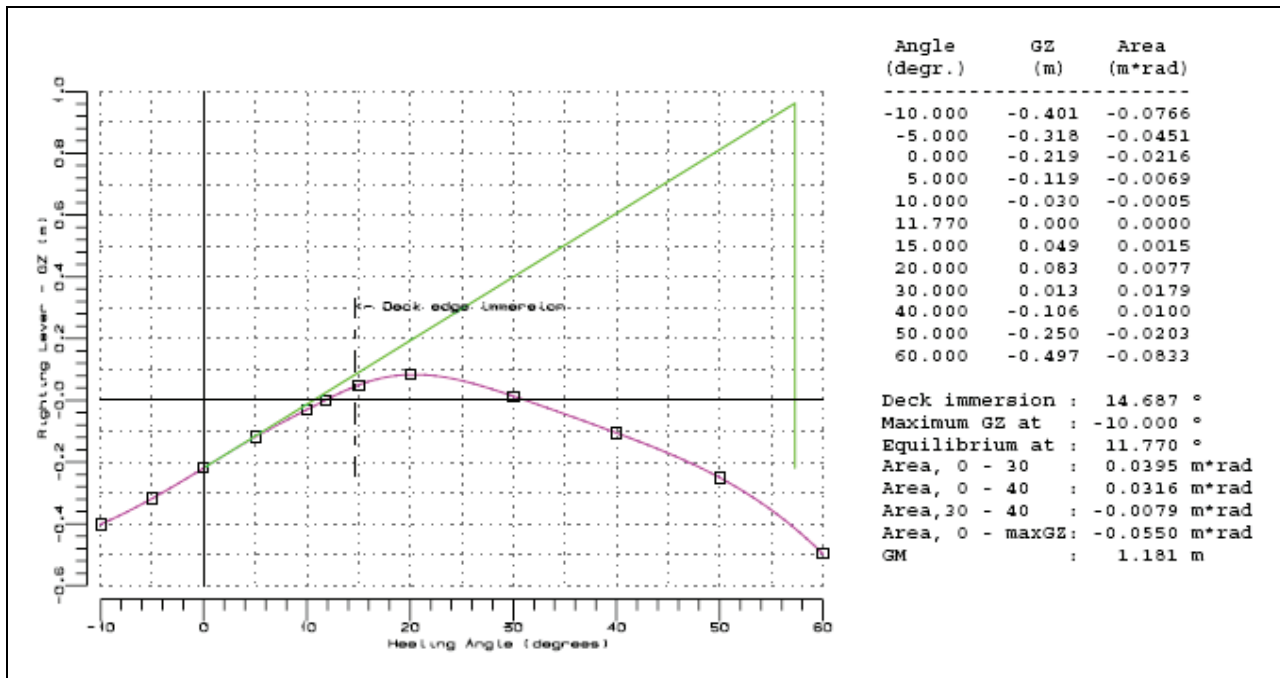
Figure 9.16 Correcting and heeling arms for load condition 3.2 after towing-pin is depressed, 60% angle of attack, 180 tonnes tension

Mooring line's angle of attack (°)	Horizontal transverse force (tonnes)	Vessel's list angle (°)
20	37.9	7.3
25	46.8	8.0
30	55.4	8.7
35	63.6	9.3
40	71.2	9.9
45	78.4	10.4
50	84.9	10.9
55	90.8	11.4
60	96.0	11.8
