## ADCI

### SAFETY ALERT!

#### DDC Chamber View-port catastrophic failure

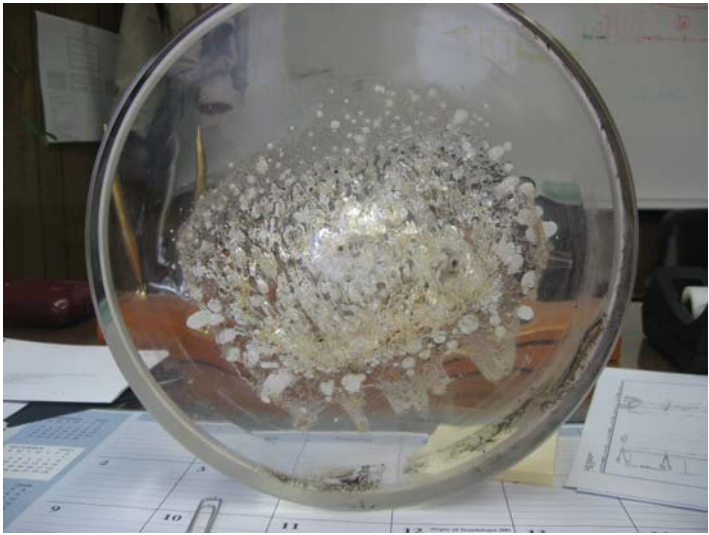
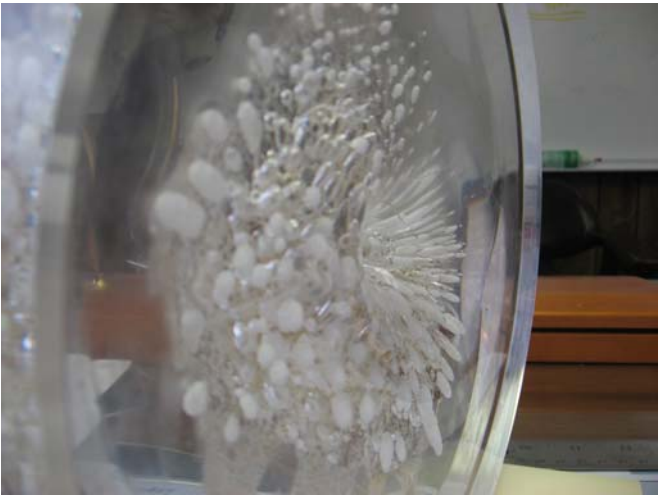
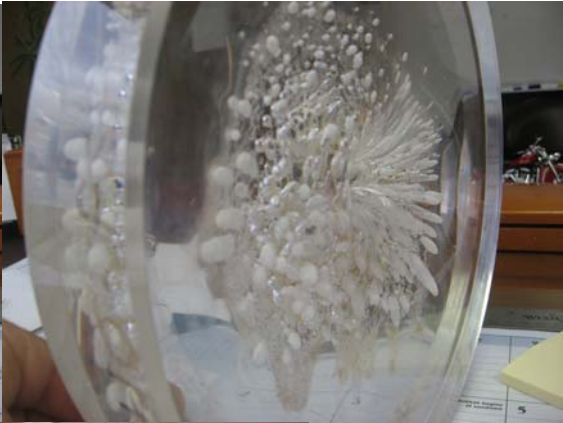
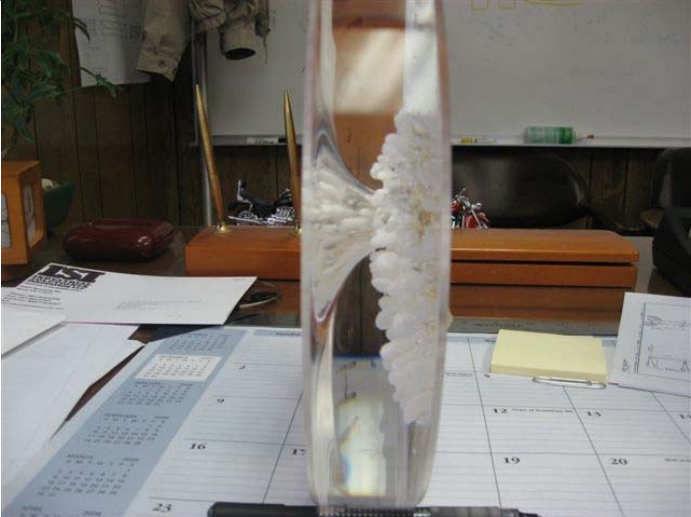
This view-port was in a deck chamber where someone had placed droplight too close to the port. The resulting radiant heat from the lamp exceeded the design temperature of the view-port (125 deg. F / 51.6 deg. C.) Enough heat was generated to allow the view-port to become soft and pliable enough to allow the pressure in the chamber to flow towards atmospheric pressure. (See pictures attached) The pressure boundary was breached and the chamber vented through the view-port to atmospheric pressure. No further information on this incident is available. The danger of incandescent light bulbs in close proximity to chamber ports is well known in the diving industry. To mitigate this danger, many diving contractors have changed to the fluorescent bulb drop lights, with the understanding that they operate at a lower temperature. **WE HAVE NOW DETERMINED THAT FLORESCENT LAMPS CAN ALSO GENERATE HEAT IN EXCESS OF 140 DEGREES!**

Measured temperatures from florescent drop lights have averaged 145 deg. F / 62.7 deg. C. (20 deg. F / - 6.6 deg. C. over maximum design temperature)

LED drop lights are exhibiting temperatures under 100 deg. F / 37.7 deg. C.

Do not put drop lights in contact with chamber view-ports, even florescent drop lights can generate enough heat to cause the view-ports to overheat. You must always assess the heat generated from any bulb and make sure you position the bulb a sufficient distance away from the port to eliminate the possibility of any heat build-up on the face of the port. If the port feels warm to the touch, the bulb is too close!!

LED lamps are under close investigation and will most likely replace the commonly used florescent droplight.
