# SAFETY CIRCULAR ON A FATAL ACCIDENT DUE TO BREAKDOWN IN COORDINATION AND COMMUNICATION

< OSD / SY CIR / 04 / 2003 >

By Shipyards Branch, Occupational Safety Department  
Ministry of Manpower

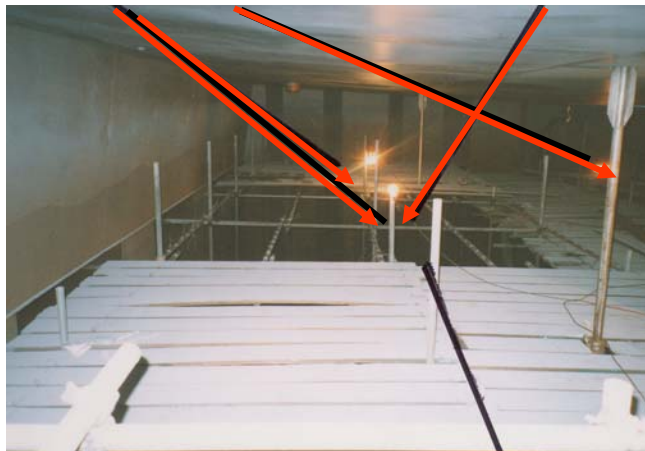
Two hand-held lamps  
& a flood light were  
provided

Opening in the scaffold

- While he was inside the tank, the deceased fell through the opening on the scaffold work platform. The opening was due to the removal of scaffold planks during the dismantling process.
- Although the "**NO ENTRY**" and "**DO NOT USE THE SCAFFOLD**" signs were clearly displayed at the entrance to the tank, the deceased still proceeded to enter the tank to carry out the touch up work.
- Illumination (lighting conditions) inside the tank was poor.

- Investigations revealed that the cause of accident was attributed to a lack of coordination and communication between the relevant trades which resulted in the concurrent execution of scaffold dismantling and painting works inside the tank. Coordination of work activities established at the vessel safety co-ordinate committee meeting should be properly communicated to all affected parties, including their foremen and workers.
- Shipyards are reminded to instill their workers on the importance to observe strictly all safety signs such as "**NO ENTRY**" signs into confined spaces and tanks.
- Adequate lighting should be provided while work is being carried out inside the tank.

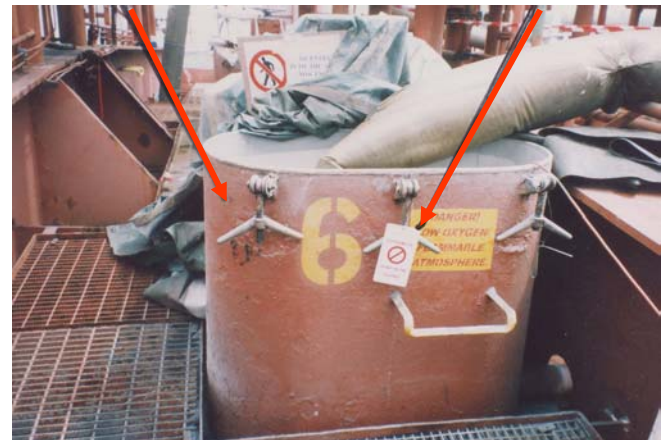
The deceased had  
gained access from this  
manhole

The signage "**DO NOT  
USE THE SCAFFOLD**"
