MAIB SAFETY BULLETIN 2/2011

Malfunction of a proximity switch, which resulted
in failure of a fall wire with the loss of one life
on the car carrier *Tombarra*

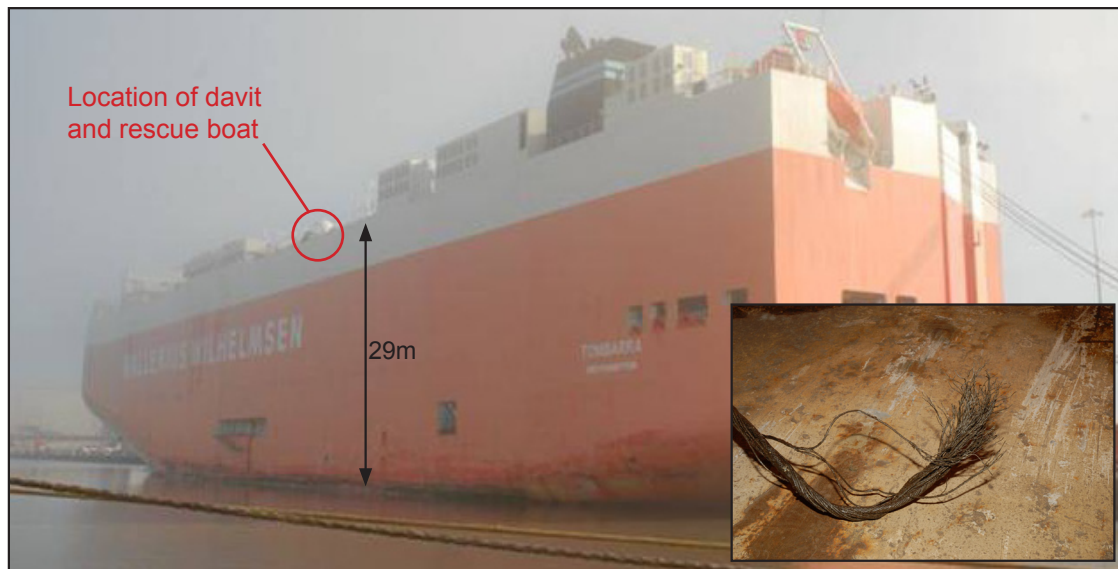
Figure 1

At approximately 1550 (UTC) on 7 February 2011, the fall wire of the rescue boat on board the UK registered car carrier *Tombarra* parted when the vessel was alongside in Royal Portbury Docks, Bristol, UK. The accident occurred as the rescue boat reached its stowed position on the davit following a monthly drill. Hoisting was not stopped before the davit reached its stowed position. The proximity switch, that should have cut electrical power to the winch motor before the davit reached its stops, failed to function. The rescue boat and its four crew fell nearly 29m (**Figure 1**) into the water below. One of the boat's crew died and two were hospitalised.

Vessel and parted fall wire

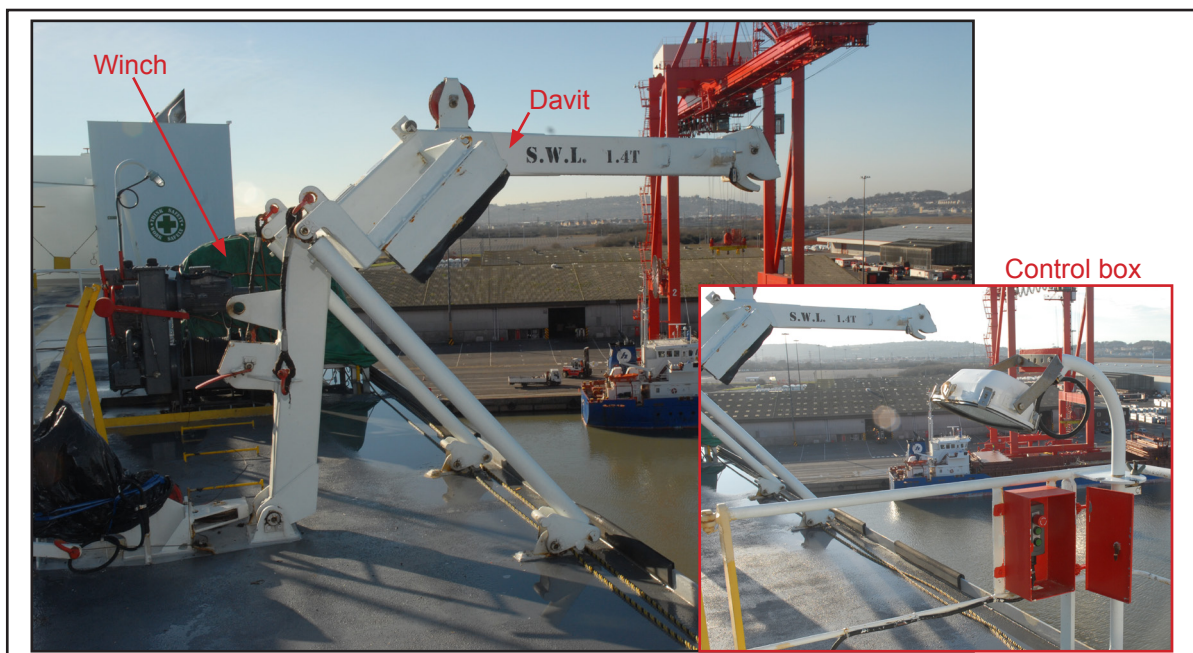
Figure 2

The 12mm diameter fall wire had a certified minimum breaking load of 141kN. Its safe working load (SWL) was 23.5kN based on a factor of safety of six. The wire was fitted to a single-arm davit (SA 1.5) (**Figure 2**), manufactured by Umoe Schat-Harding Equipment AS (Schat-Harding). The davit system was powered by a Schat-Harding W50 two-speed electric winch with a nominal pull of 50kN.

Davit system
